# Manhole Inspection Report

Date:	<b>05/04/2018</b>	Weather:		Coding:	<b>RZMACP</b>
MH#:	<b>M-705-022</b>	Owner:	<b>NA</b>	Len. Surveyed:	<b>7.6</b>
P.O.#:		Surveyor:	<b>Jen Costello</b>	Rim to Invert:	<b>7.8</b>
Customer:		Cert. #:	<b>U-907-5518</b>	Wall Material:	<b>Brick</b>

Street:	<b>Lake St. 49' South of 5th St.</b>	Project:	<b>Hobart, IN</b>
City:	<b>Hobart, IN</b>	GPS Northing:	<b>2905818.531</b>
Location:		GPS Easting:	<b>2905818.531</b>
Drain Area:	<b>South</b>	GPS Accuracy:	<b>Sub-Meter</b>
Cover Shape:	<b>Circular</b>	Evidence of Surcharge:	<b>No</b>
Cover Size:	<b>22.5</b>	Potential for Runoff:	<b>None</b>
Comments:

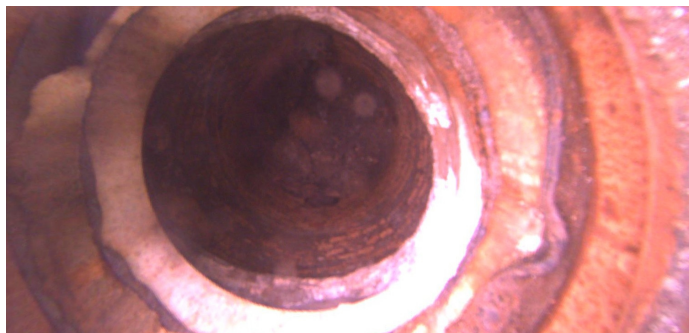
Code: **MGP**  
Description: **General Photo**

Distance (ft): **.0**  
Structural Grade: **0**  
O&M Grade: **0**  
Clock Start/From:  
Clock To:  
1st Value:  
2nd Value:  
Value Percent:  
Step: **NO**  
Remarks: **access mh**

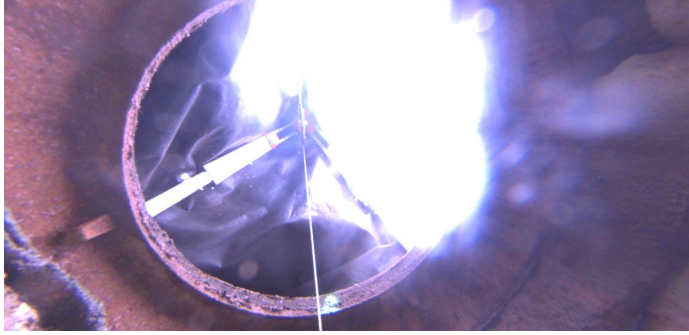
Code:	<b>MGO</b>
Description:	<b>General Observation</b>
Distance (ft):	<b>1.7</b>
Structural Grade:	<b>0</b>
O&M Grade:	<b>0</b>
Clock Start/From:	
Clock To:	
1st Value:	
2nd Value:	
Value Percent:	
Step:	<b>NO</b>
Remarks:	<b>underside of frame</b>

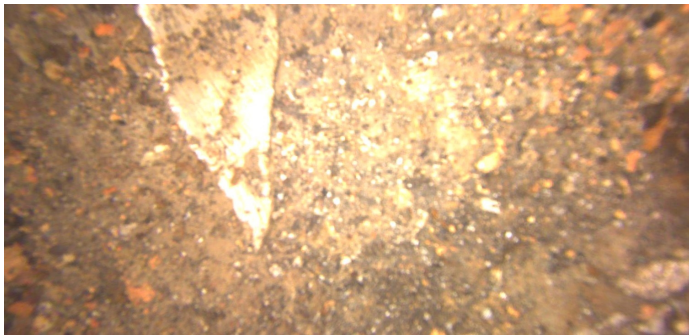
Code:	<b>DSF</b>
Description:	<b>Deposits Settled Fine</b>
Distance (ft):	<b>7.6</b>
Structural Grade:	<b>0</b>
O&M Grade:	<b>2</b>
Clock Start/From:	<b>12</b>
Clock To:	<b>12</b>
1st Value:	
2nd Value:	
Value Percent:	<b>10.000</b>
Step:	<b>NO</b>
Remarks:
