Manhole Inspection Report

Date:	05/04/2018	Weather:		Coding:	RZMACP
MH#:	M-705-023	Owner:	NA	Len. Surveyed:	11.5
P.O.#:		Surveyor:	Jen Costello	Rim to Invert:	13.1
Customer:		Cert. #:	U-907-5518	Wall Material:	Concrete (reinforced)

Street:	Main St. 189' North of 5th St.	Project:	Hobart, IN
City:	Hobart, IN	GPS Northing:	2906045.879
Location:		GPS Easting:	2906045.879
Drain Area:	South	GPS Accuracy:	Sub-Meter
Cover Shape:	Circular	Evidence of Surcharge:	No
Cover Size:	22.5	Potential for Runoff:	None
Comments:

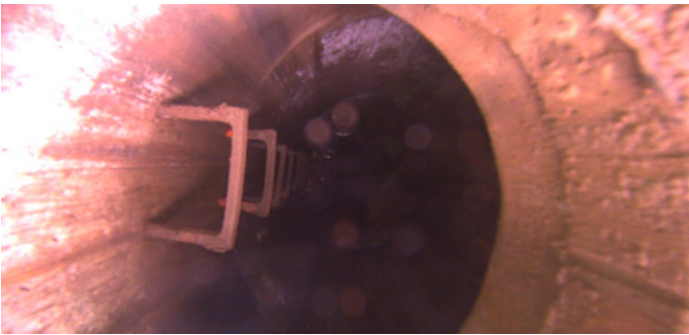
Code: **MGP**
Description: **General Photo**

Distance (ft): **.0**
Structural Grade: **0**
O&M Grade: **0**
Clock Start/From:
Clock To:
1st Value:
2nd Value:
Value Percent:
Step: **NO**
Remarks: **ACCESS MH**

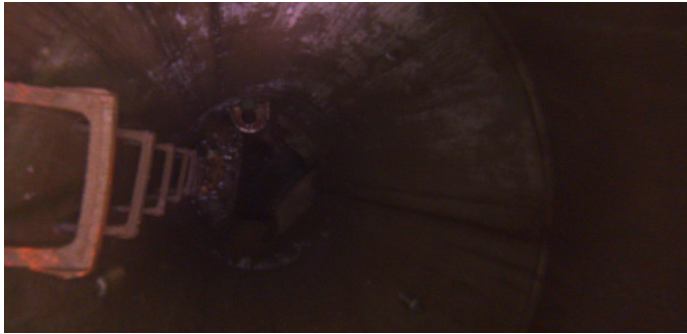
Code: **IS**
Description: **Infil Stain**

Distance (ft): **1.3**
Structural Grade: **0**
O&M Grade: **0**
Clock Start/From: **8**
Clock To: **4**
1st Value:
2nd Value:
Value Percent:
Step: **NO**
Remarks:

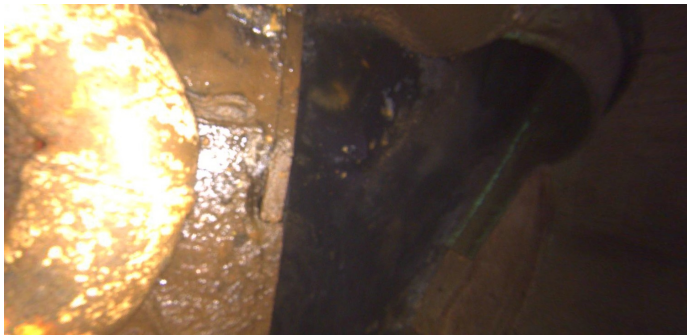
Code: **MGO**
Description: **General Observation**

Distance (ft): **11.5**
Structural Grade: **0**
O&M Grade: **0**
Clock Start/From:
Clock To:
1st Value:
2nd Value:
Value Percent:
Step: **NO**
Remarks: **END SURVEY**
