Manhole Inspection Report

Date:	05/03/2018	Weather:		Coding:	RZMACP
MH#:	M-705-025	Owner:	NA	Len. Surveyed:	12.6
P.O.#:		Surveyor:	Jen Costello	Rim to Invert:	13.1
Customer:		Cert. #:	U-907-5518	Wall Material:	Concrete (reinforced)

Street:	Intersection of Main St. and 3rd St.	Project:	Hobart, IN
City:	Hobart, IN	GPS Northing:	41.53209305
Location:		GPS Easting:	-87.25481415
Drain Area:	South	GPS Accuracy:	Nearest Meter
Cover Shape:	Circular	Evidence of Surcharge:	No
Cover Size:	22.5	Potential for Runoff:	None
Comments:

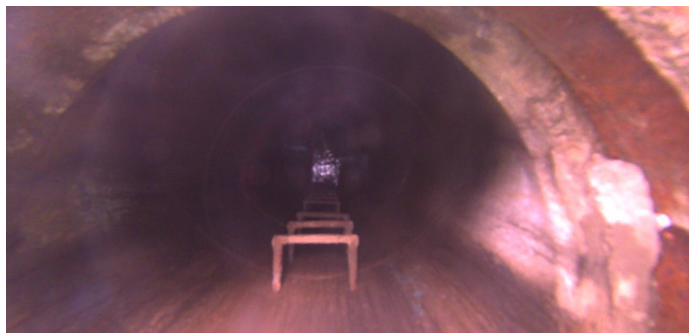
Code: **MGP**
Description: **General Photo**

Distance (ft): **.0**
Structural Grade: **0**
O&M Grade: **0**
Clock Start/From:
Clock To:
1st Value:
2nd Value:
Value Percent:
Step: **NO**
Remarks: **ACCESS MH**

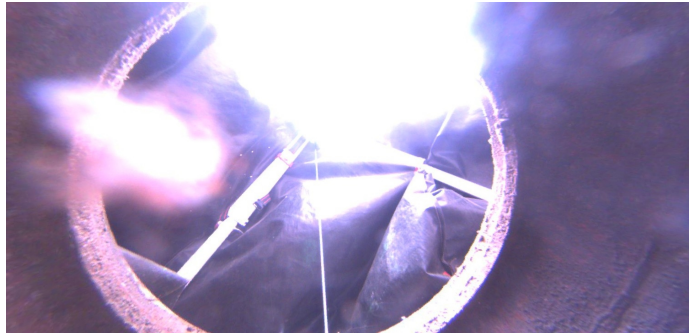
Code:	MGO
Description:	General Observation
Distance (ft):	1.3
Structural Grade:	0
O&M Grade:	0
Clock Start/From:	
Clock To:	
1st Value:	
2nd Value:	
Value Percent:	
Step:	NO
Remarks:	UNDERSIDE OF FRAME

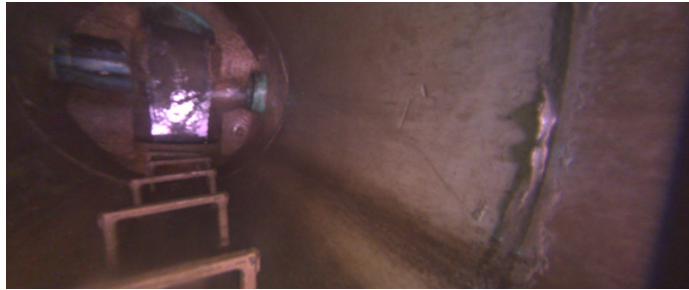
Code:	CM
Description:	Crack Multiple
Distance (ft):	5.7
Structural Grade:	3
O&M Grade:	0
Clock Start/From:	3
Clock To:	4
1st Value:	
2nd Value:	
Value Percent:	
Step:	NO
Remarks:

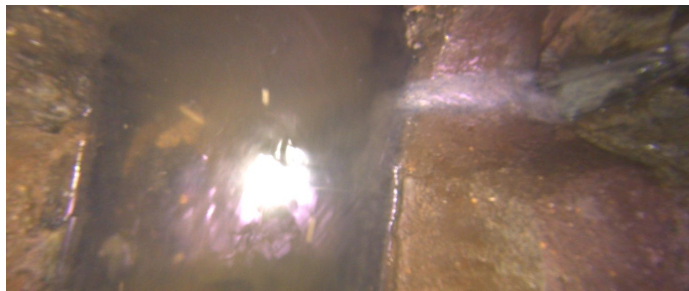
Code:	MGO
Description:	General Observation
Distance (ft):	12.6
Structural Grade:	0
O&M Grade:	0
Clock Start/From:	
Clock To:	
1st Value:	
2nd Value:	
Value Percent:	
Step:	NO
Remarks:	END SURVEY
