Manhole Inspection Report

Date:	05/03/2018	Weather:		Coding:	RZMACP
MH#:	M-705-026	Owner:	NA	Len. Surveyed:	12.4
P.O.#:		Surveyor:	Jen Costello	Rim to Invert:	12.7
Customer:		Cert. #:	U-907-5518	Wall Material:	Concrete (reinforced)

Street:	Intersection of Main St. and Second	Project:	Hobart, IN
City:	Hobart, IN	GPS Northing:	41.53307724
Location:		GPS Easting:	-87.25546265
Drain Area:	South	GPS Accuracy:	Nearest Meter
Cover Shape:	Circular	Evidence of Surcharge:	No
Cover Size:	22.5	Potential for Runoff:	None
Comments:

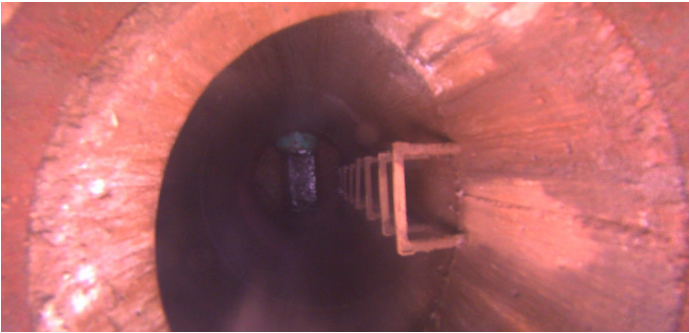
Code: **MGP**
 Description: **General Photo**

Distance (ft): **.0**
 Structural Grade: **0**
 O&M Grade: **0**
 Clock Start/From:
 Clock To:
 1st Value:
 2nd Value:
 Value Percent:
 Step: **NO**
 Remarks: **ACCESS MH**

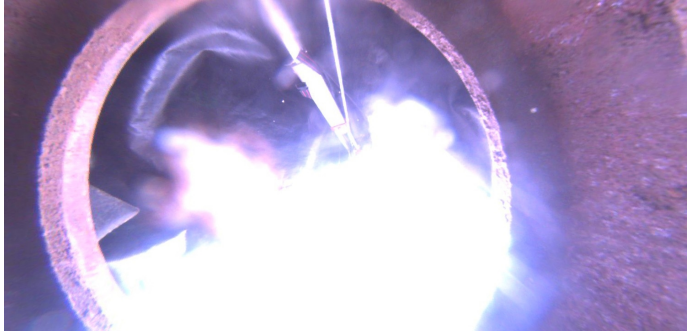
Code: **MGO**
Description: **General Observation**

Distance (ft): **1.2**
Structural Grade: **0**
O&M Grade: **0**
Clock Start/From:
Clock To:
1st Value:
2nd Value:
Value Percent:
Step: **NO**
Remarks: **END SURVEY**

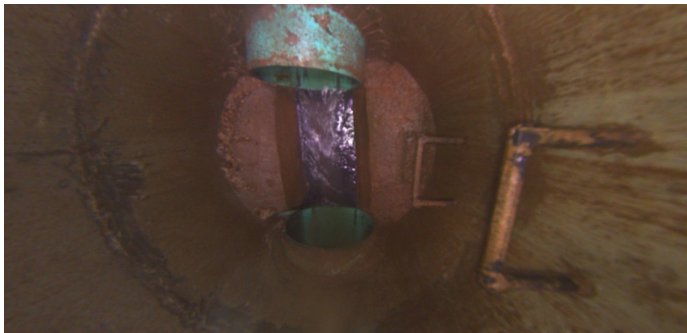
Code: **RFJ**
Description: **Roots Fine Joint**

Distance (ft): **8.9**
Structural Grade: **0**
O&M Grade: **1**
Clock Start/From: **6**
Clock To: **9**
1st Value:
2nd Value:
Value Percent:
Step: **NO**
Remarks:

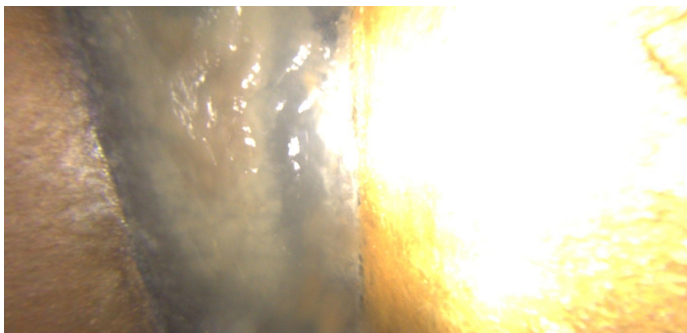
Code: **MGO**
Description: **General Observation**

Distance (ft): **12.4**
Structural Grade: **0**
O&M Grade: **0**
Clock Start/From:
Clock To:
1st Value:
2nd Value:
Value Percent:
Step: **NO**
Remarks: **END SURVEY**
