Manhole Inspection Report

Date:	05/04/2018	Weather:		Coding:	RZMACP
MH#:	M-705-027	Owner:	NA	Len. Surveyed:	11.5
P.O.#:		Surveyor:	Jen Costello	Rim to Invert:	11.8
Customer:		Cert. #:	U-907-5518	Wall Material:	Concrete (reinforced)

Street:	Intersection of Main St. and Front St	Project:	Hobart, IN
City:	Hobart, IN	GPS Northing:	2905472.381
Location:		GPS Easting:	2905472.381
Drain Area:	South	GPS Accuracy:	Sub-Meter
Cover Shape:	Circular	Evidence of Surcharge:	No
Cover Size:	22.5	Potential for Runoff:	None
Comments:

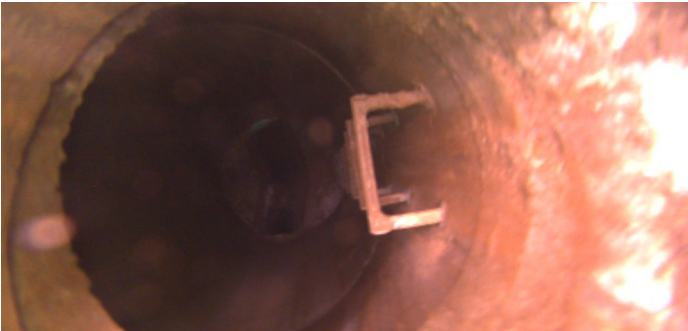
Code:

MGP

Description:

General Photo

Distance (ft):

.0

Remarks:

ACCESS MH

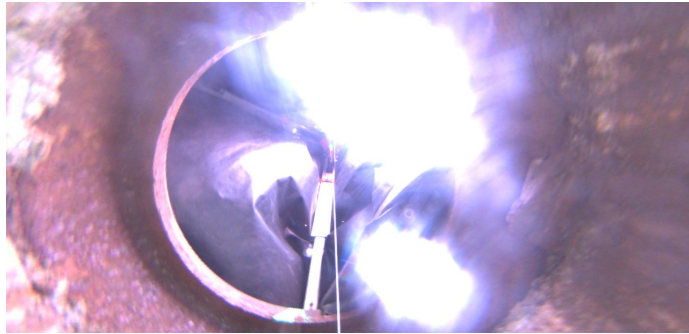
Code:	MGO
Description:	General Observation
Distance (ft):	1.3
Structural Grade:	0
O&M Grade:	0
Clock Start/From:	
Clock To:	
1st Value:	
2nd Value:	
Value Percent:	
Step:	NO
Remarks:	UNDERSIDE OF FRAME

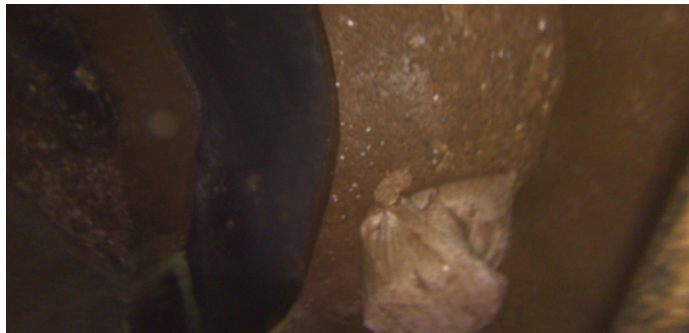
Code:	OBZ
Description:	Obstacle Other
Distance (ft):	9.5
Structural Grade:	0
O&M Grade:	2
Clock Start/From:	4
Clock To:	5
1st Value:	
2nd Value:	
Value Percent:	5.000
Step:	NO
Remarks:	SAND BAG

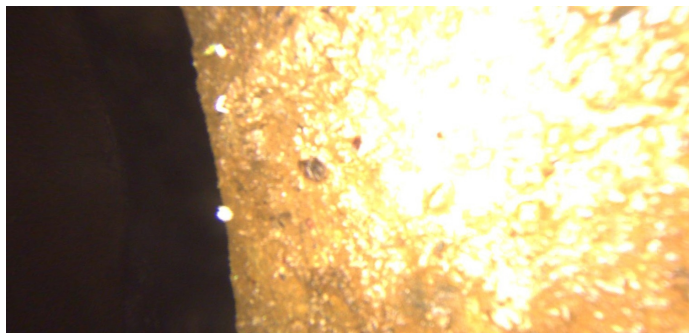
Code:	MGO
Description:	General Observation
Distance (ft):	11.5
Structural Grade:	0
O&M Grade:	0
Clock Start/From:	
Clock To:	
1st Value:	
2nd Value:	
Value Percent:	
Step:	NO
Remarks:	END SURVEY
