Manhole Inspection Report

Date:	05/06/2018	Weather:		Coding:	RZMACP
MH#:	M-705-028	Owner:	NA	Len. Surveyed:	12.0
P.O.#:		Surveyor:	Jen Costello	Rim to Invert:	12.6
Customer:		Cert. #:	U-907-5518	Wall Material:	Concrete (reinforced)

Street:	Intersection of Main St. and Front St	Project:	Hobart, IN
City:	Hobart, IN	GPS Northing:	2905484.198
Location:		GPS Easting:	2905484.198
Drain Area:	South	GPS Accuracy:	Sub-Meter
Cover Shape:	Circular	Evidence of Surcharge:	No
Cover Size:	22.5	Potential for Runoff:	None
Comments:

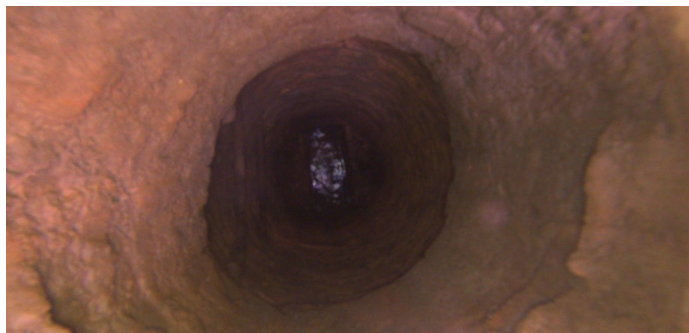
Code: **MGP**
Description: **General Photo**

Distance (ft): **.0**
Structural Grade: **0**
O&M Grade: **0**
Clock Start/From:
Clock To:
1st Value:
2nd Value:
Value Percent:
Step: **NO**
Remarks: **ACCESS MH**

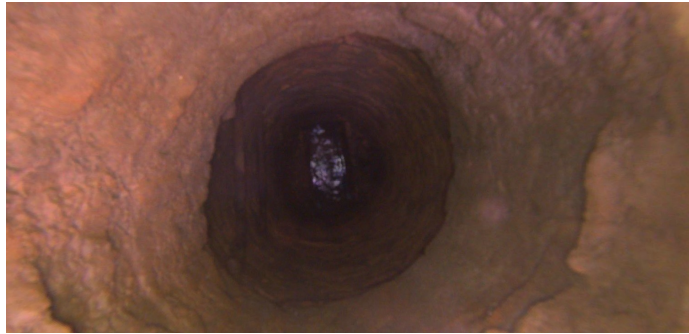
Code:	DAE
Description:	Deposits Attached Encrustation
Distance (ft):	.0
Structural Grade:	0
O&M Grade:	2
Clock Start/From:	12
Clock To:	12
1st Value:	
2nd Value:	
Value Percent:	10.000
Step:	NO
Remarks:

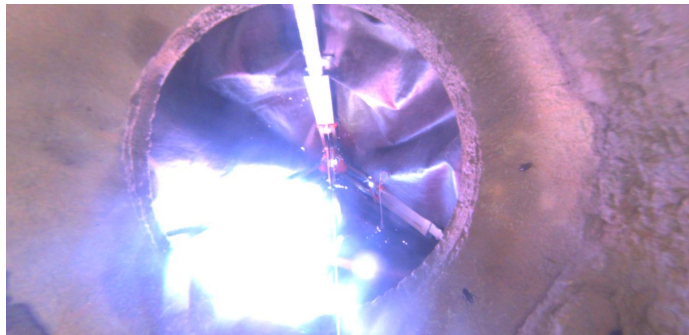
Code:	VC
Description:	Vermin Cockroach
Distance (ft):	1.8
Structural Grade:	0
O&M Grade:	1
Clock Start/From:	
Clock To:	
1st Value:	
2nd Value:	
Value Percent:	
Step:	NO
Remarks:

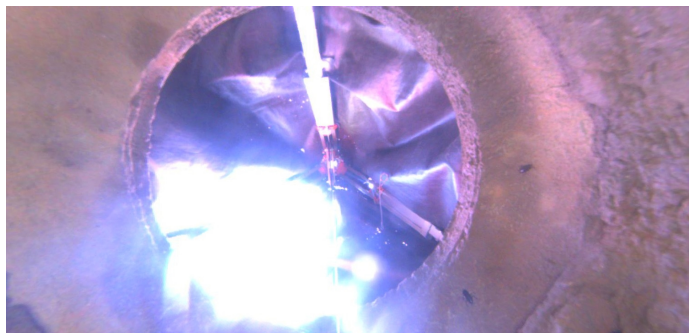
Code:	MGO
Description:	General Observation
Distance (ft):	1.8
Structural Grade:	0
O&M Grade:	0
Clock Start/From:	
Clock To:	
1st Value:	
2nd Value:	
Value Percent:	
Step:	NO
Remarks:	UNDERSIDE OF FRAME

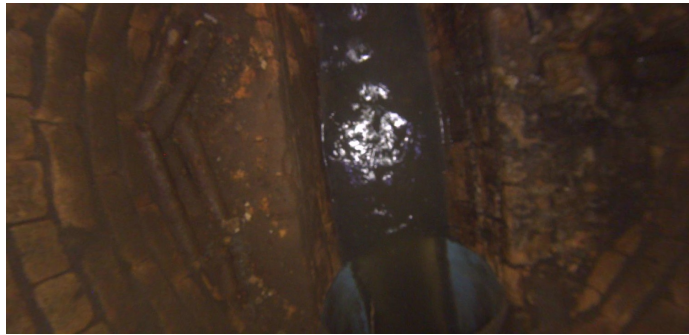
Code: **OBZ**
Description: **Obstacle Other**

Distance (ft): **9.0**
Structural Grade: **0**
O&M Grade: **2**
Clock Start/From: **8**
Clock To: **10**
1st Value:
2nd Value:
Value Percent: **5.000**
Step: **NO**
Remarks: **BROKEN STEPS**

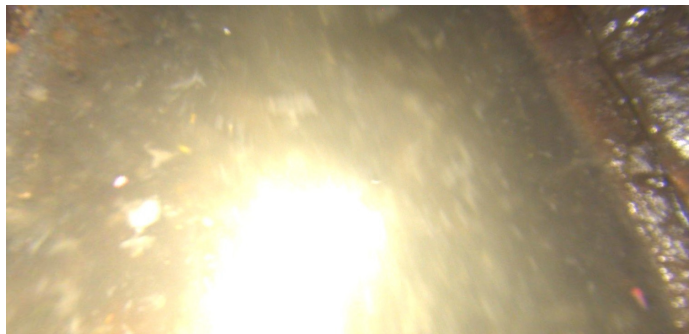
Code: **MGO**
Description: **General Observation**

Distance (ft): **12.0**
Structural Grade: **0**
O&M Grade: **0**
Clock Start/From:
Clock To:
1st Value:
2nd Value:
Value Percent:
Step: **NO**
Remarks: **END SURVEY**
