Manhole Inspection Report

Date:	05/03/2018	Weather:		Coding:	RZMACP
MH#:	M-705-029	Owner:	NA	Len. Surveyed:	7.3
P.O.#:		Surveyor:	Jen Costello	Rim to Invert:	7.8
Customer:		Cert. #:	U-907-5518	Wall Material:	Concrete (reinforced)

Street:	Center St. 258' North of 5th St.	Project:	Hobart, IN
City:	Hobart, IN	GPS Northing:	2906447.667
Location:		GPS Easting:	2906447.667
Drain Area:	South	GPS Accuracy:	Sub-Meter
Cover Shape:	Circular	Evidence of Surcharge:	No
Cover Size:	22.5	Potential for Runoff:	None
Comments:

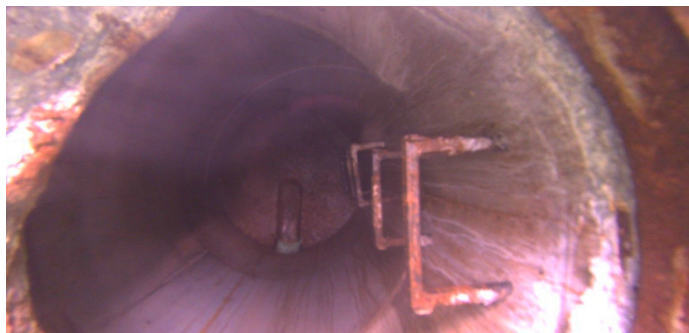
Code: **MGP**
Description: **General Photo**

Distance (ft): **.0**
Structural Grade: **0**
O&M Grade: **0**
Clock Start/From:
Clock To:
1st Value:
2nd Value:
Value Percent:
Step: **NO**
Remarks: **ACCESS MH**

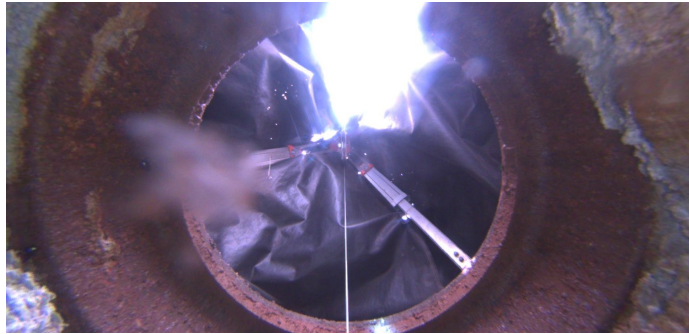
Code:	MGO
Description:	General Observation
Distance (ft):	1.6
Structural Grade:	0
O&M Grade:	0
Clock Start/From:	
Clock To:	
1st Value:	
2nd Value:	
Value Percent:	
Step:	NO
Remarks:	UNDERSIDE OF FRAME

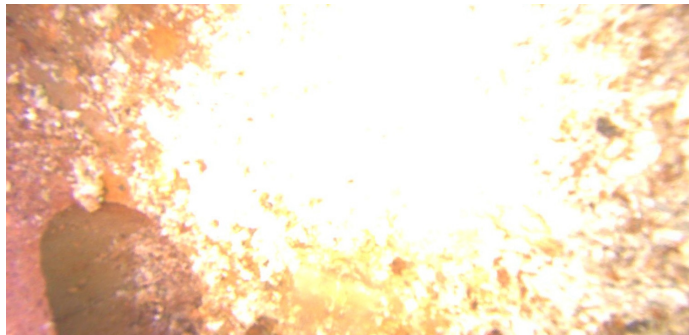
Code:	DSF
Description:	Deposits Settled Fine
Distance (ft):	7.3
Structural Grade:	0
O&M Grade:	2
Clock Start/From:	12
Clock To:	6
1st Value:	
2nd Value:	
Value Percent:	5.000
Step:	NO
Remarks:

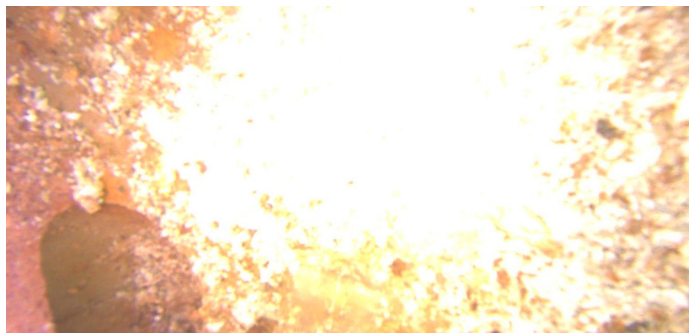
Code:	MGO
Description:	General Observation
Distance (ft):	7.3
Structural Grade:	0
O&M Grade:	0
Clock Start/From:	
Clock To:	
1st Value:	
2nd Value:	
Value Percent:	
Step:	NO
Remarks:	END SURVEY
