Manhole Inspection Report

Date:	05/03/2018	Weather:		Coding:	RZMACP
MH#:	M-705-030	Owner:	NA	Len. Surveyed:	7.5
P.O.#:		Surveyor:	Jen Costello	Rim to Invert:	9.0
Customer:		Cert. #:	U-907-5518	Wall Material:	Concrete (reinforced)

Street:	Center St. 228' South of 4th St.	Project:	Hobart, IN
City:	Hobart, IN	GPS Northing:	2906359.037
Location:		GPS Easting:	2906359.037
Drain Area:	South	GPS Accuracy:	Sub-Meter
Cover Shape:	Circular	Evidence of Surcharge:	No
Cover Size:	22.5	Potential for Runoff:	None
Comments:

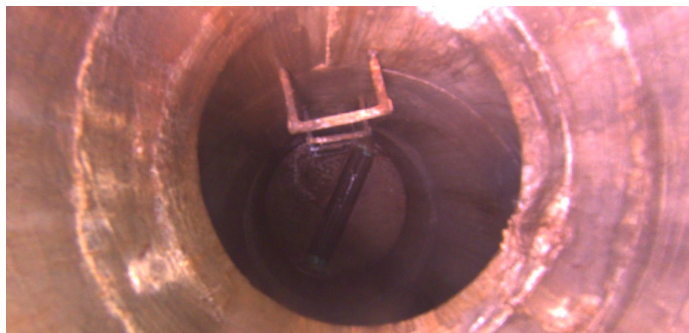
Code: **MGP**
Description: **General Photo**

Distance (ft): **.0**
Structural Grade: **0**
O&M Grade: **0**
Clock Start/From:
Clock To:
1st Value:
2nd Value:
Value Percent:
Step: **NO**
Remarks: **ACCESS MH**

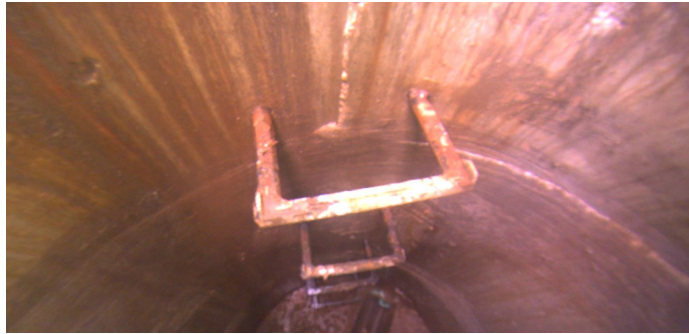
Code: **CL**
Description: **Crack Longitudinal**

Distance (ft): **1.4**
Structural Grade: **2**
O&M Grade: **0**
Clock Start/From: **12**
Clock To:
1st Value:
2nd Value:
Value Percent:
Step: **NO**
Remarks:

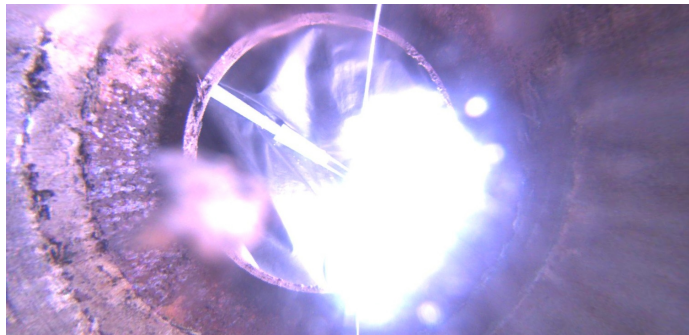
Code: **MGO**
Description: **General Observation**

Distance (ft): **1.4**
Structural Grade: **0**
O&M Grade: **0**
Clock Start/From:
Clock To:
1st Value:
2nd Value:
Value Percent:
Step: **NO**
Remarks: **UNDERSIDE OF FRAME**

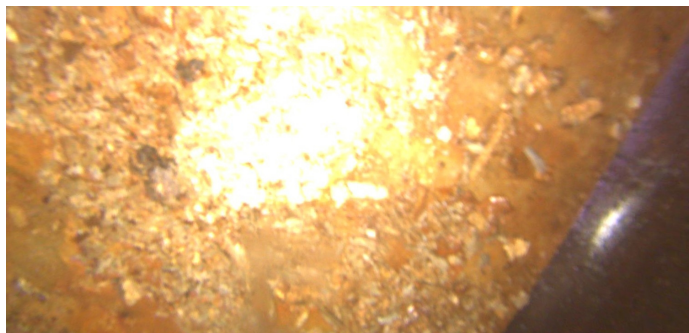
Code: **MGO**
Description: **General Observation**

Distance (ft): **7.5**
Structural Grade: **0**
O&M Grade: **0**
Clock Start/From:
Clock To:
1st Value:
2nd Value:
Value Percent:
Step: **NO**
Remarks: **END SURVEY**
