Manhole Inspection Report

Date:	05/03/2018	Weather:		Coding:	RZMACP
MH#:	M-705-031	Owner:	NA	Len. Surveyed:	8.0
P.O.#:		Surveyor:	Jen Costello	Rim to Invert:	8.7
Customer:		Cert. #:	U-907-5518	Wall Material:	Concrete (reinforced)

Street:	Intersection of Center St. and 4th St.	Project:	Hobart, IN
City:	Hobart, IN	GPS Northing:	41.53146744
Location:		GPS Easting:	-87.25309753
Drain Area:	South	GPS Accuracy:	Nearest Meter
Cover Shape:	Circular	Evidence of Surcharge:	No
Cover Size:	22.5	Potential for Runoff:	None
Comments:

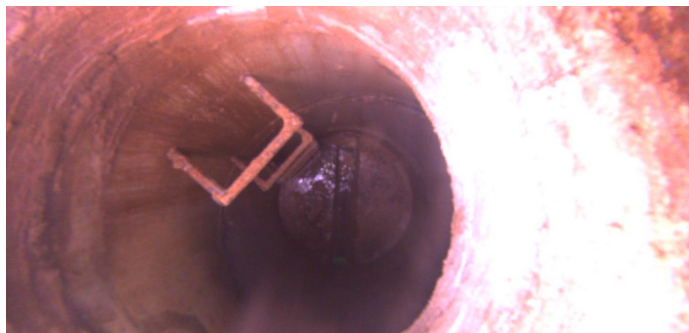
Code: **MGO**
Description: **General Observation**

Distance (ft): **.0**
Structural Grade: **0**
O&M Grade: **0**
Clock Start/From:
Clock To:
1st Value:
2nd Value:
Value Percent:
Step: **NO**
Remarks: **ACCESS MH**

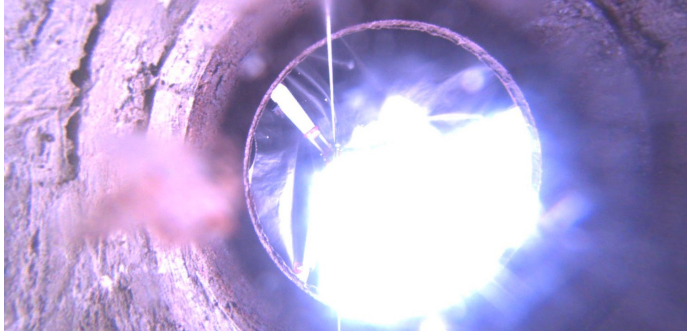
Code: **MGO**
Description: **General Observation**

Distance (ft): **1.6**
Structural Grade: **0**
O&M Grade: **0**
Clock Start/From:
Clock To:
1st Value:
2nd Value:
Value Percent:
Step: **NO**
Remarks: **UNDERSIDE OF FRAME**

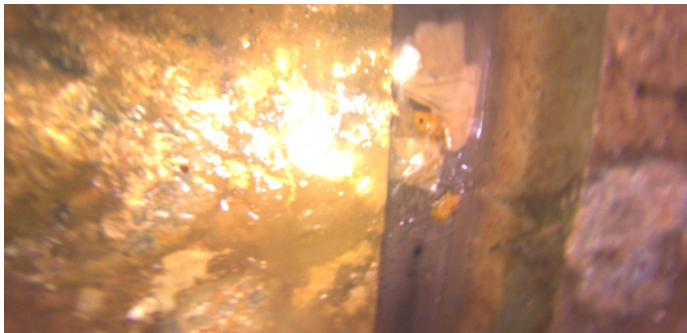
Code: **MGO**
Description: **General Observation**

Distance (ft): **8.0**
Structural Grade: **0**
O&M Grade: **0**
Clock Start/From:
Clock To:
1st Value:
2nd Value:
Value Percent:
Step: **NO**
Remarks: **END SURVEY**
