Manhole Inspection Report

Date:	05/03/2018	Weather:		Coding:	RZMACP
MH#:	M-705-034	Owner:	NA	Len. Surveyed:	9.6
P.O.#:		Surveyor:	Jen Costello	Rim to Invert:	9.8
Customer:		Cert. #:	U-907-5518	Wall Material:	Concrete (reinforced)

Street:	Center St. 195' South of Second St.	Project:	Hobart, IN
City:	Hobart, IN	GPS Northing:	41.53271866
Location:		GPS Easting:	-87.2538681
Drain Area:	South	GPS Accuracy:	Nearest Meter
Cover Shape:	Circular	Evidence of Surcharge:	No
Cover Size:	22.5	Potential for Runoff:	None
Comments:

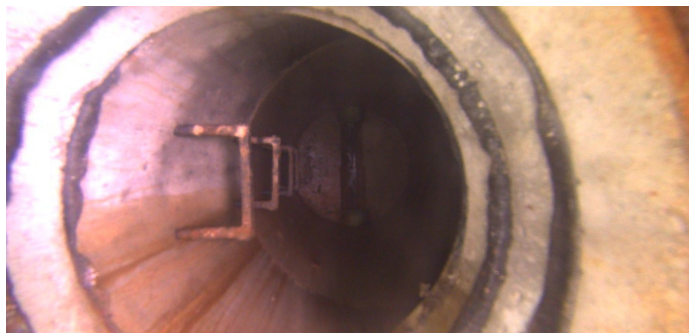
Code: **MGP**
Description: **General Photo**

Distance (ft): **.0**
Structural Grade: **0**
O&M Grade: **0**
Clock Start/From:
Clock To:
1st Value:
2nd Value:
Value Percent:
Step: **NO**
Remarks: **ACCESS MH**

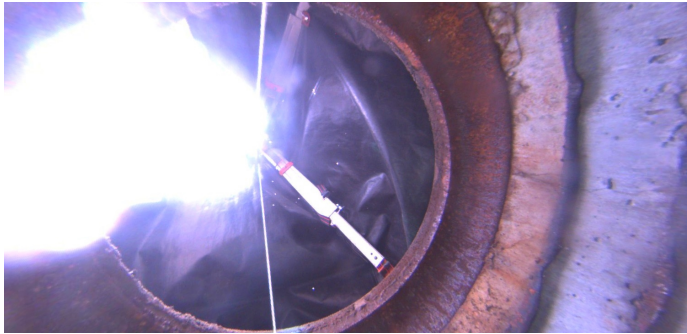
Code: **MGO**
Description: **General Observation**

Distance (ft): **1.3**
Structural Grade: **0**
O&M Grade: **0**
Clock Start/From:
Clock To:
1st Value:
2nd Value:
Value Percent:
Step: **NO**
Remarks: **UNDERSIDE OF FRAME**

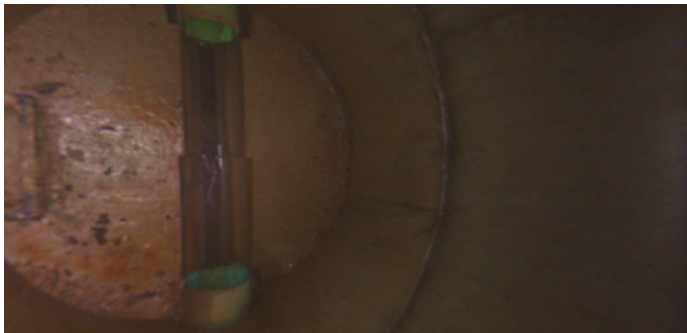
Code: **RFJ**
Description: **Roots Fine Joint**

Distance (ft): **5.9**
Structural Grade: **0**
O&M Grade: **1**
Clock Start/From: **4**
Clock To:
1st Value:
2nd Value:
Value Percent:
Step: **NO**
Remarks:

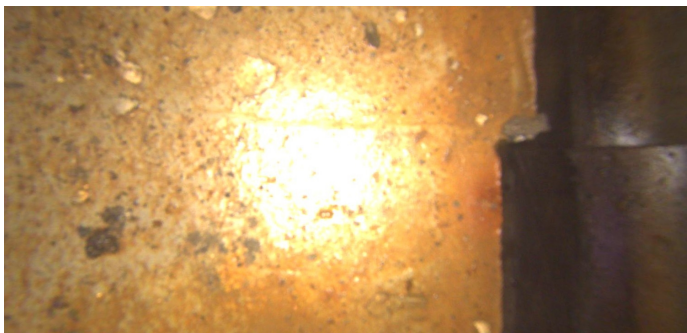
Code: **MGO**
Description: **General Observation**

Distance (ft): **9.3**
Structural Grade: **0**
O&M Grade: **0**
Clock Start/From:
Clock To:
1st Value:
2nd Value:
Value Percent:
Step: **NO**
Remarks: **END SURVEY**
