Manhole Inspection Report

Date:	05/06/2018	Weather:		Coding:	RZMACP
MH#:	M-705-036	Owner:	NA	Len. Surveyed:	11.1
P.O.#:		Surveyor:	Jen Costello	Rim to Invert:	12.1
Customer:		Cert. #:	U-907-5518	Wall Material:	Concrete (reinforced)

Street:	Intersection of Front St. and Center	Project:	Hobart, IN
City:	Hobart, IN	GPS Northing:	2905751.285
Location:		GPS Easting:	2905751.285
Drain Area:	South	GPS Accuracy:	Sub-Meter
Cover Shape:	Circular	Evidence of Surcharge:	No
Cover Size:	22.5	Potential for Runoff:	None
Comments:

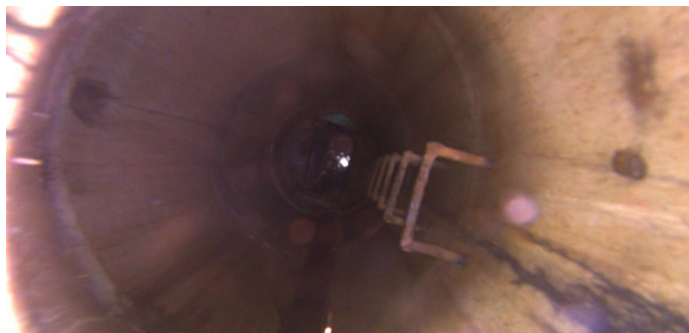
Code: **MGP**
Description: **General Photo**

Distance (ft): **.0**
Structural Grade: **0**
O&M Grade: **0**
Clock Start/From:
Clock To:
1st Value:
2nd Value:
Value Percent:
Step: **NO**
Remarks: **ACCESS MH**

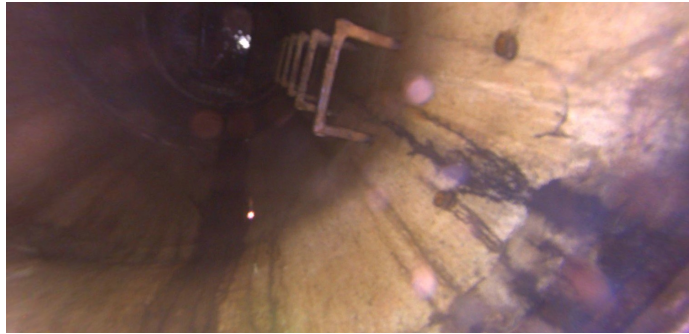
Code: **RFJ**
Description: **Roots Fine Joint**

Distance (ft): **.0**
Structural Grade: **0**
O&M Grade: **1**
Clock Start/From: **4**
Clock To: **5**
1st Value:
2nd Value:
Value Percent:
Step: **NO**
Remarks:

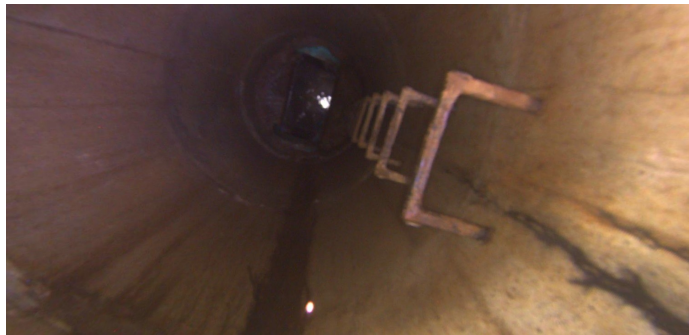
Code: **IS**
Description: **Infil Stain**

Distance (ft): **.8**
Structural Grade: **0**
O&M Grade: **0**
Clock Start/From: **6**
Clock To:
1st Value:
2nd Value:
Value Percent:
Step: **NO**
Remarks:

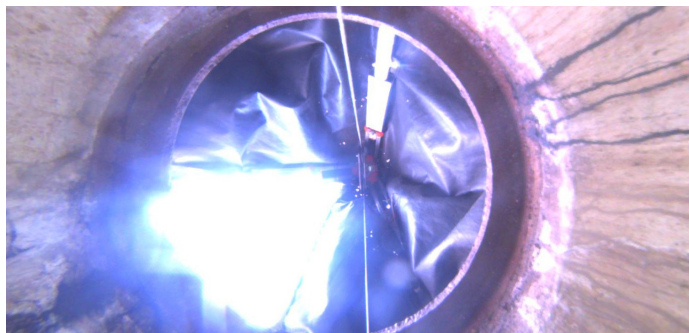
Code: **MGO**
Description: **General Observation**

Distance (ft): **1.9**
Structural Grade: **0**
O&M Grade: **0**
Clock Start/From:
Clock To:
1st Value:
2nd Value:
Value Percent:
Step: **NO**
Remarks: **UNDERSIDE OF FRAME**

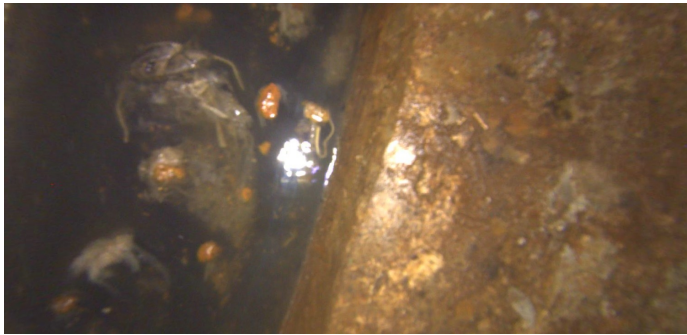
Code: **MGO**
Description: **General Observation**

Distance (ft): **11.1**
Structural Grade: **0**
O&M Grade: **0**
Clock Start/From:
Clock To:
1st Value:
2nd Value:
Value Percent:
Step: **NO**
Remarks: **END SURVEY**
