Manhole Inspection Report

Date:	05/04/2018	Weather:		Coding:	RZMACP
MH#:	M-705-046	Owner:	NA	Len. Surveyed:	12.4
P.O.#:		Surveyor:	Jen Costello	Rim to Invert:	14.2
Customer:		Cert. #:	U-907-5518	Wall Material:	Concrete (reinforced)

Street:	Intersection of East St. and 3rd St.	Project:	Hobart, IN
City:	Hobart, IN	GPS Northing:	2906410.265
Location:		GPS Easting:	2906410.265
Drain Area:	South	GPS Accuracy:	Sub-Meter
Cover Shape:	Circular	Evidence of Surcharge:	No
Cover Size:	22.5	Potential for Runoff:	None
Comments:

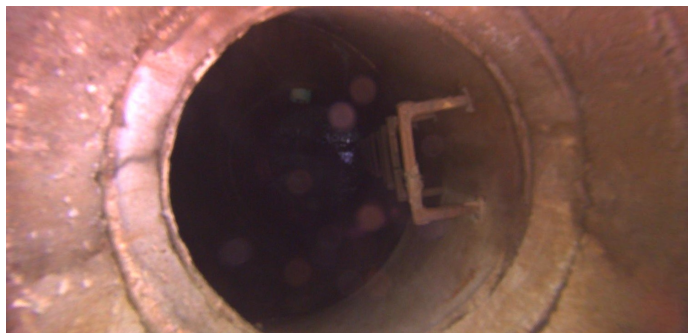
Code: **MGO**
Description: **General Observation**

Distance (ft): **.0**
Structural Grade: **0**
O&M Grade: **0**
Clock Start/From:
Clock To:
1st Value:
2nd Value:
Value Percent:
Step: **NO**
Remarks: **ACCESS MH**

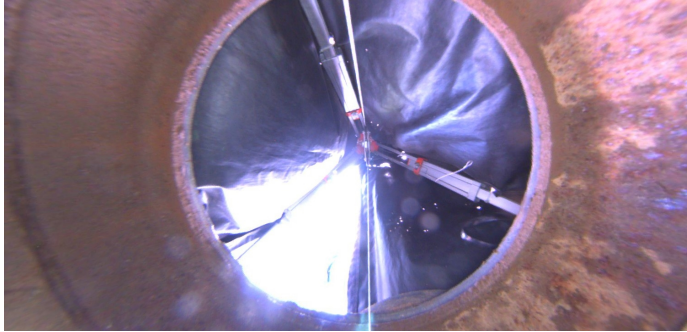
Code:	MGO
Description:	General Observation
Distance (ft):	1.4
Structural Grade:	0
O&M Grade:	0
Clock Start/From:	
Clock To:	
1st Value:	
2nd Value:	
Value Percent:	
Step:	NO
Remarks:	UNDERSIDE OF FRAME

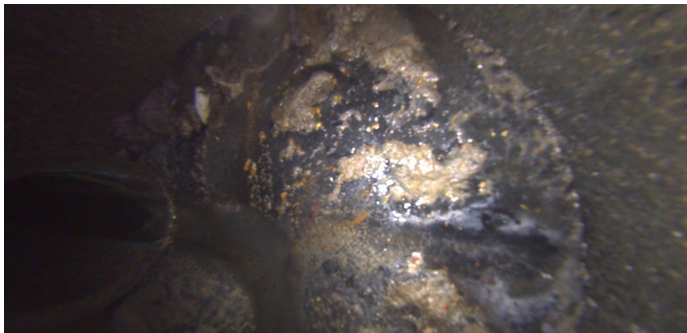
Code:	MGO
Description:	General Observation
Distance (ft):	12.4
Structural Grade:	0
O&M Grade:	0
Clock Start/From:	
Clock To:	
1st Value:	
2nd Value:	
Value Percent:	
Step:	NO
Remarks:	END SURVEY
