Manhole Inspection Report

Date:	05/04/2018	Weather:		Coding:	RZMACP
MH#:	M-705-047	Owner:	NA	Len. Surveyed:	8.7
P.O.#:		Surveyor:	Jen Costello	Rim to Invert:	9.8
Customer:		Cert. #:	U-907-5518	Wall Material:	Brick

Street:	Intersection of Second St. and East S	Project:	Hobart, IN
City:	Hobart, IN	GPS Northing:	2906252.95
Location:		GPS Easting:	2906252.95
Drain Area:	South	GPS Accuracy:	Sub-Meter
Cover Shape:	Circular	Evidence of Surcharge:	No
Cover Size:	22.5	Potential for Runoff:	None
Comments:

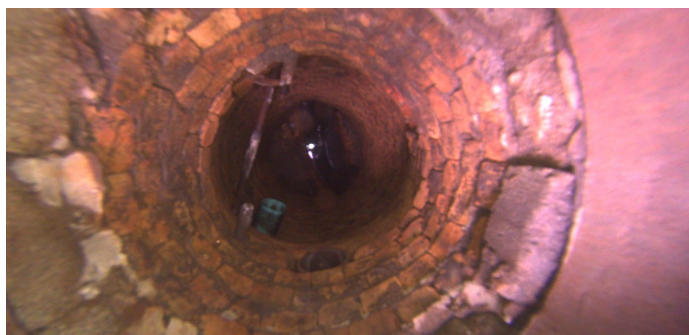
Code: **MGP**
Description: **General Photo**

Distance (ft): **.0**
Structural Grade: **0**
O&M Grade: **0**
Clock Start/From:
Clock To:
1st Value:
2nd Value:
Value Percent:
Step: **NO**
Remarks: **ACCESS MH**

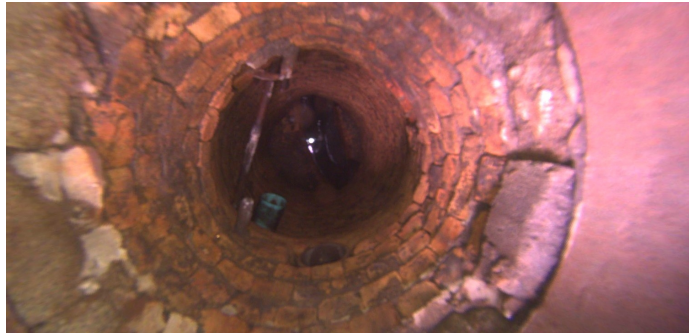
Code: **DB**
Description: **Displaced Brick**

Distance (ft): **.0**
Structural Grade: **3**
O&M Grade: **0**
Clock Start/From: **3**
Clock To: **9**
1st Value:
2nd Value:
Value Percent:
Step: **NO**
Remarks:

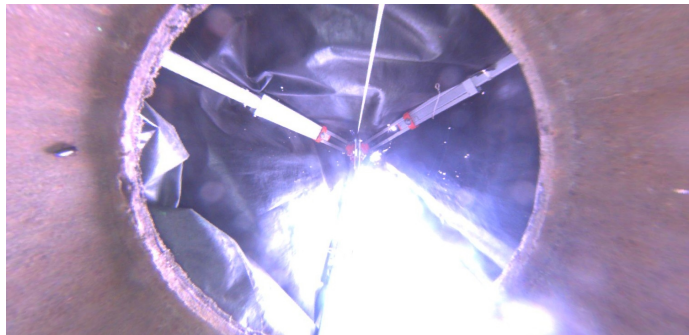
Code: **VC**
Description: **Vermin Cockroach**

Distance (ft): **1.1**
Structural Grade: **0**
O&M Grade: **1**
Clock Start/From:
Clock To:
1st Value:
2nd Value:
Value Percent:
Step: **NO**
Remarks:

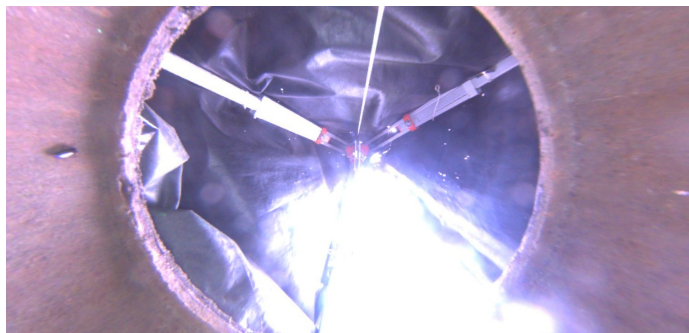
Code: **MGO**
Description: **General Observation**

Distance (ft): **1.1**
Structural Grade: **0**
O&M Grade: **0**
Clock Start/From:
Clock To:
1st Value:
2nd Value:
Value Percent:
Step: **NO**
Remarks: **UNDERSIDE OF FRAME**

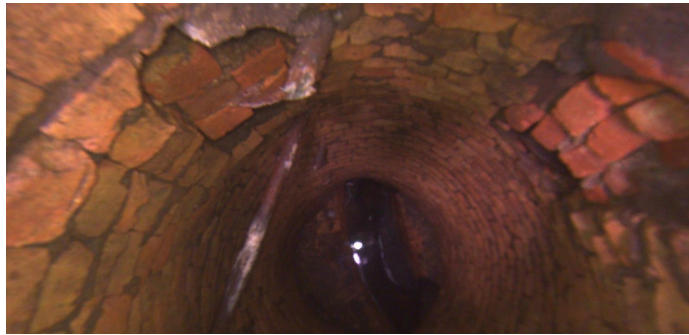
Code:	MGO
Description:	General Observation
Distance (ft):	1.3
Structural Grade:	0
O&M Grade:	0
Clock Start/From:	
Clock To:	
1st Value:	
2nd Value:	
Value Percent:	
Step:	NO
Remarks:	MISSING AND BROKEN STEPS

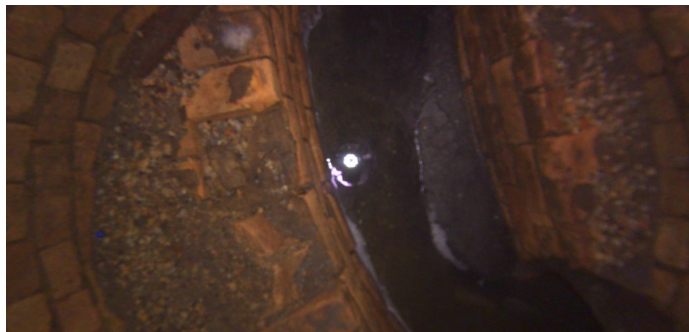
Code:	MB
Description:	Missing Brick
Distance (ft):	7.4
Structural Grade:	4
O&M Grade:	0
Clock Start/From:	8
Clock To:	10
1st Value:	
2nd Value:	
Value Percent:	
Step:	NO
Remarks:

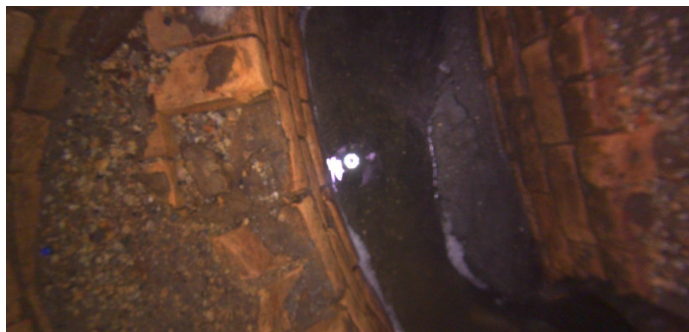
Code:	DSGV
Description:	Deposits Settled Gravel
Distance (ft):	7.9
Structural Grade:	0
O&M Grade:	2
Clock Start/From:	12
Clock To:	12
1st Value:	
2nd Value:	
Value Percent:	5.000
Step:	NO
Remarks:

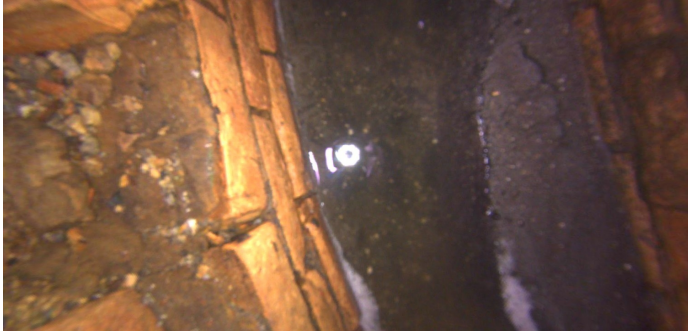
Code:	MGO
Description:	General Observation
Distance (ft):	8.7
Structural Grade:	0
O&M Grade:	0
Clock Start/From:	
Clock To:	
1st Value:	
2nd Value:	
Value Percent:	
Step:	NO
Remarks:	END SURVEY
