Manhole Inspection Report

Date:	05/04/2018	Weather:		Coding:	RZMACP
MH#:	M-705-049	Owner:	NA	Len. Surveyed:	8.6
P.O.#:		Surveyor:	Jen Costello	Rim to Invert:	9.4
Customer:		Cert. #:	U-907-5518	Wall Material:	Concrete (reinforced)

Street:	4th St. 45' West of New St.	Project:	Hobart, IN
City:	Hobart, IN	GPS Northing:	2906739.059
Location:		GPS Easting:	2906739.059
Drain Area:	South	GPS Accuracy:	Sub-Meter
Cover Shape:	Circular	Evidence of Surcharge:	No
Cover Size:	22.5	Potential for Runoff:	None
Comments:

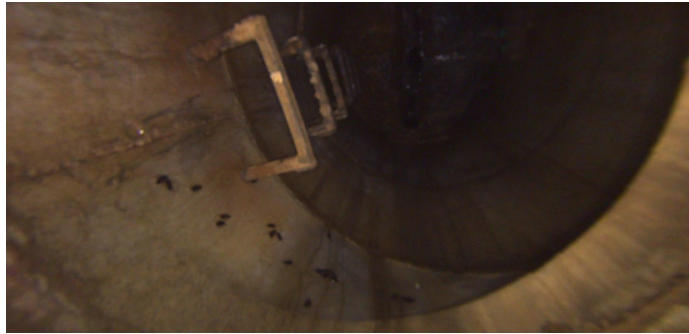
Code: **VC**
Description: **Vermin Cockroach**

Distance (ft): **1.6**
Structural Grade: **0**
O&M Grade: **1**
Clock Start/From:
Clock To:
1st Value:
2nd Value:
Value Percent:
Step: **NO**
Remarks:

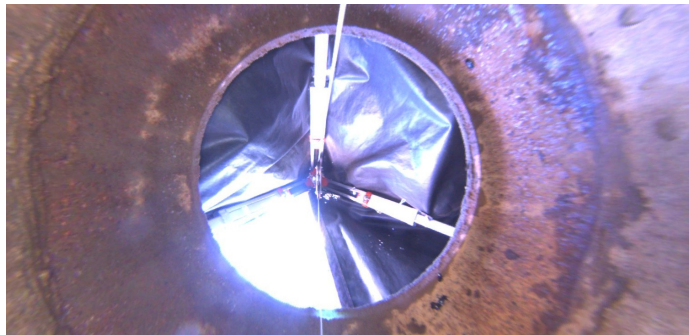
Code: **MGO**
Description: **General Observation**

Distance (ft): **1.6**
Structural Grade: **0**
O&M Grade: **0**
Clock Start/From:
Clock To:
1st Value:
2nd Value:
Value Percent:
Step: **NO**
Remarks: **underside of frame**

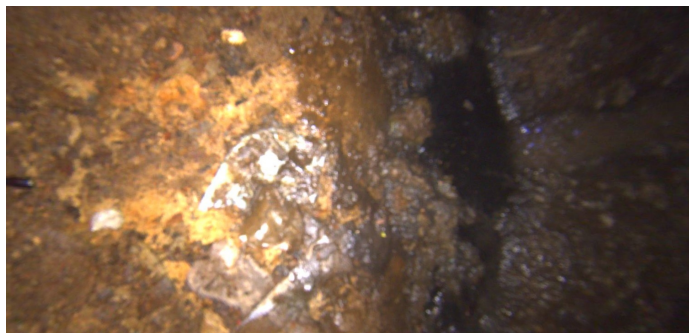
Code: **MGO**
Description: **General Observation**

Distance (ft): **8.6**
Structural Grade: **0**
O&M Grade: **0**
Clock Start/From:
Clock To:
1st Value:
2nd Value:
Value Percent:
Step: **NO**
Remarks: **end survey**
