Manhole Inspection Report

Date:	05/04/2018	Weather:		Coding:	RZMACP
MH#:	M-705-052.1	Owner:	NA	Len. Surveyed:	6.2
P.O.#:		Surveyor:	Jen Costello	Rim to Invert:	6.6
Customer:		Cert. #:	U-907-5518	Wall Material:	Concrete (reinforced)

Street:	3rd St. 187' West of Linda St.	Project:	Hobart, IN
City:	Hobart, IN	GPS Northing:	2906909.262
Location:		GPS Easting:	2906909.262
Drain Area:	South	GPS Accuracy:	Sub-Meter
Cover Shape:	Circular	Evidence of Surcharge:	No
Cover Size:	22.5	Potential for Runoff:	None
Comments:

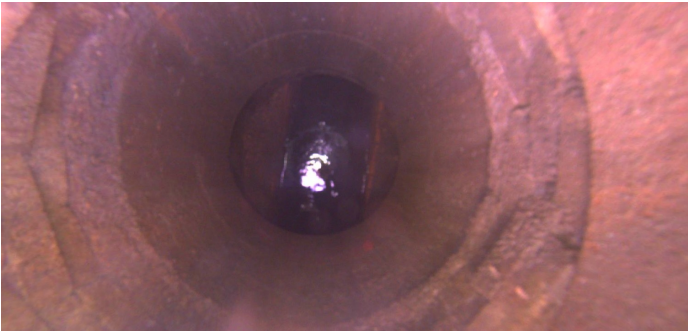
Code:	MGP
Description:	General Photo
Distance (ft):	.0
Structural Grade:	0
O&M Grade:	0
Clock Start/From:	
Clock To:	
1st Value:	
2nd Value:	
Value Percent:	
Step:	NO
Remarks:	access MH

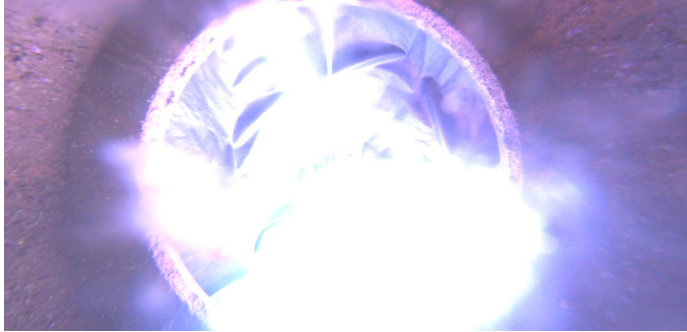
Code:	MGO
Description:	General Observation
Distance (ft):	1.5
Structural Grade:	0
O&M Grade:	0
Clock Start/From:	
Clock To:	
1st Value:	
2nd Value:	
Value Percent:	
Step:	NO
Remarks:	UNDERSIDE OF FRAME
