Manhole Inspection Report

Date:	05/03/2018	Weather:		Coding:	RZMACP
MH#:	M-705-053	Owner:	NA	Len. Surveyed:	4.8
P.O.#:		Surveyor:	Jen Costello	Rim to Invert:	4.9
Customer:		Cert. #:	U-907-5518	Wall Material:	Brick

Street:	3rd St. 143' East of Park St.	Project:	Hobart, IN
City:	Hobart, IN	GPS Northing:	41.53120804
Location:		GPS Easting:	-87.25725555
Drain Area:	West	GPS Accuracy:	Nearest Meter
Cover Shape:	Circular	Evidence of Surcharge:	No
Cover Size:	22.5	Potential for Runoff:	None
Comments:

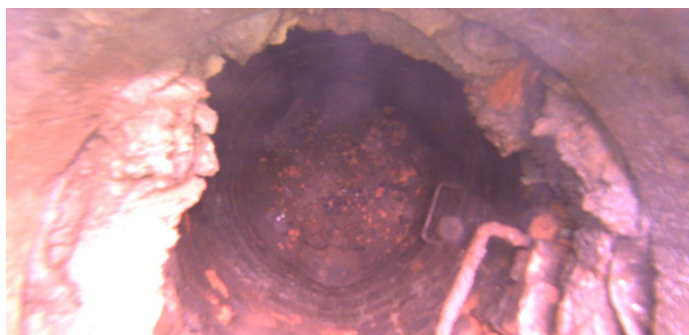
Code: **MGP**
Description: **General Photo**

Distance (ft): **.0**
Structural Grade: **0**
O&M Grade: **0**
Clock Start/From:
Clock To:
1st Value:
2nd Value:
Value Percent:
Step: **NO**
Remarks: **ACCESS MH**

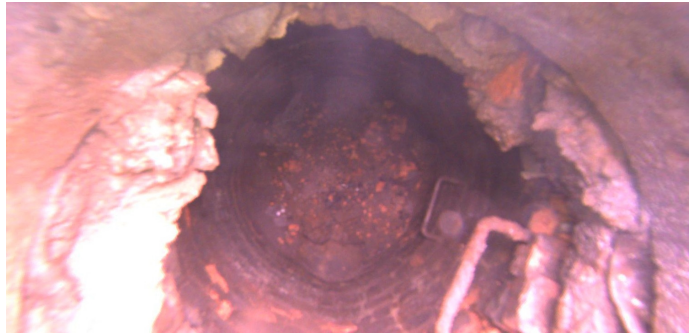
Code:	DAE
Description:	Deposits Attached Encrustation
Distance (ft):	.0
Structural Grade:	0
O&M Grade:	2
Clock Start/From:	12
Clock To:	12
1st Value:	
2nd Value:	
Value Percent:	10.000
Step:	NO
Remarks:

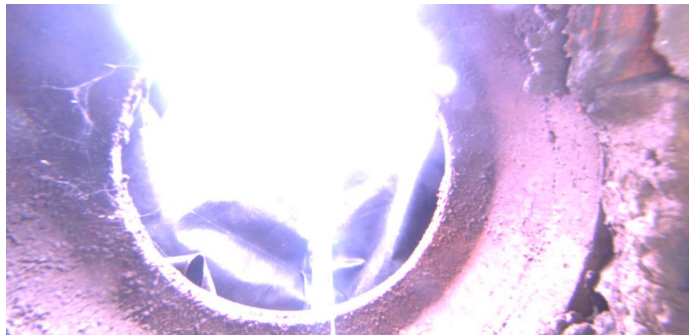
Code:	MGO
Description:	General Observation
Distance (ft):	1.8
Structural Grade:	0
O&M Grade:	0
Clock Start/From:	
Clock To:	
1st Value:	
2nd Value:	
Value Percent:	
Step:	NO
Remarks:	UNDERSIDE OF FRAME
