Manhole Inspection Report

Date:	05/04/2018	Weather:		Coding:	RZMACP
MH#:	M-705-059	Owner:	NA	Len. Surveyed:	19.0
P.O.#:		Surveyor:	Jen Costello	Rim to Invert:	24.3
Customer:		Cert. #:	U-907-5518	Wall Material:	Concrete (reinforced)

Street:	171' East of Ridge Road. North of M	Project:	Hobart, IN
City:	Hobart, IN	GPS Northing:	2905607.022
Location:		GPS Easting:	2905607.022
Drain Area:	South	GPS Accuracy:	Sub-Meter
Cover Shape:	Circular	Evidence of Surcharge:	No
Cover Size:	22.5	Potential for Runoff:	None
Comments:

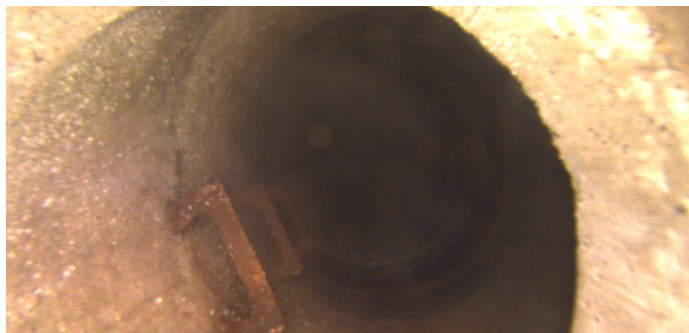
Code: **MGP**
Description: **General Photo**

Distance (ft): **.0**
Structural Grade: **0**
O&M Grade: **0**
Clock Start/From:
Clock To:
1st Value:
2nd Value:
Value Percent:
Step: **NO**
Remarks: **ACCESS MH**

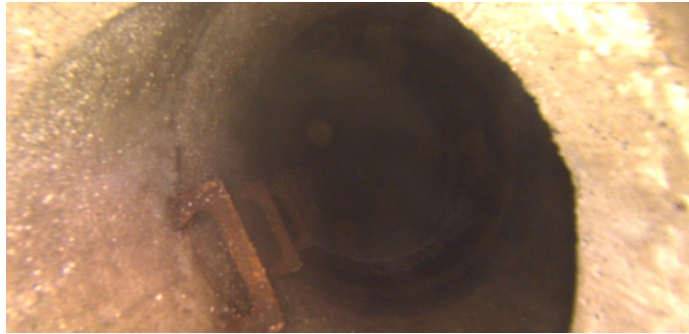
Code:	SAV
Description:	Surface Aggregate Visible
Distance (ft):	.0
Structural Grade:	3
O&M Grade:	0
Clock Start/From:	12
Clock To:	12
1st Value:	
2nd Value:	
Value Percent:	
Step:	NO
Remarks:

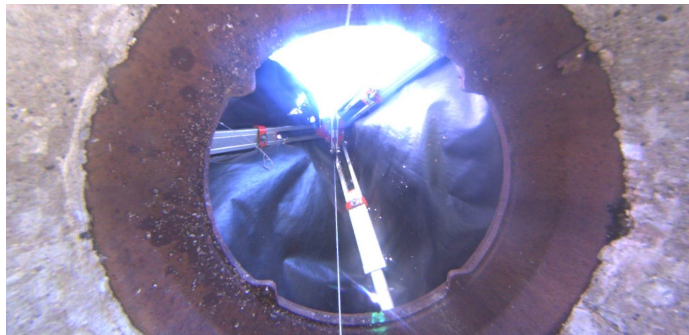
Code:	MGO
Description:	General Observation
Distance (ft):	1.4
Structural Grade:	0
O&M Grade:	0
Clock Start/From:	
Clock To:	
1st Value:	
2nd Value:	
Value Percent:	
Step:	NO
Remarks:	UNDERSIDE OF FRAME

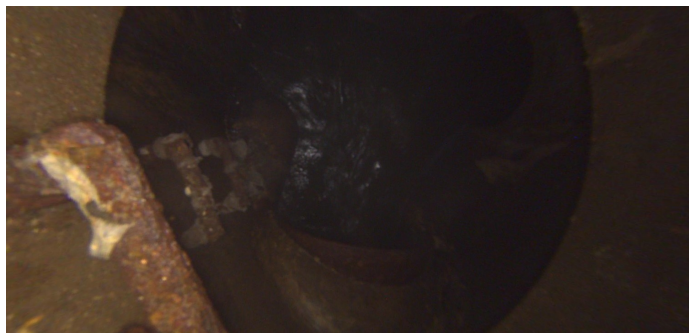
Code:	MGO
Description:	General Observation
Distance (ft):	19.0
Structural Grade:	0
O&M Grade:	0
Clock Start/From:	
Clock To:	
1st Value:	
2nd Value:	
Value Percent:	
Step:	NO
Remarks:	END SURVEY
