Manhole Inspection Report

Date:	05/04/2018	Weather:		Coding:	RZMACP
MH#:	M-705-061	Owner:	NA	Len. Surveyed:	8.6
P.O.#:		Surveyor:	Jen Costello	Rim to Invert:	10.3
Customer:		Cert. #:	U-907-5518	Wall Material:	Concrete (reinforced)

Street:	38' East of Ridge Rd. North of Clevel	Project:	Hobart, IN
City:	Hobart, IN	GPS Northing:	2905548.817
Location:		GPS Easting:	2905548.817
Drain Area:	South	GPS Accuracy:	Sub-Meter
Cover Shape:	Circular	Evidence of Surcharge:	No
Cover Size:	22.5	Potential for Runoff:	None
Comments:

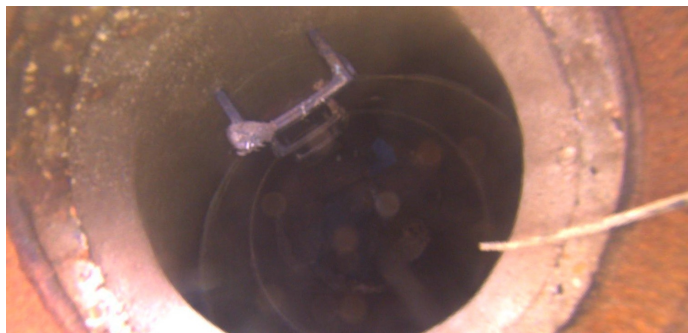
Code: **MGO**
Description: **General Observation**

Distance (ft): **.0**
Structural Grade: **0**
O&M Grade: **0**
Clock Start/From:
Clock To:
1st Value:
2nd Value:
Value Percent:
Step: **NO**
Remarks: **access mh**

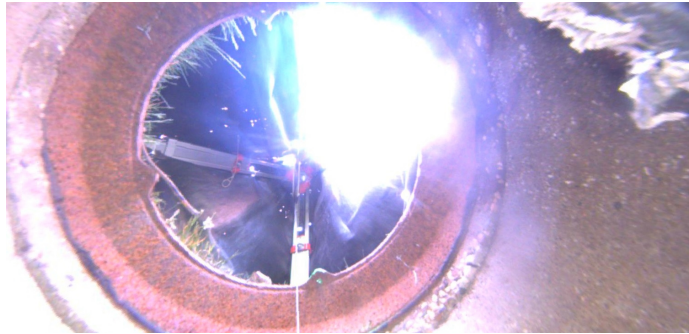
Code: **MGO**
Description: **General Observation**

Distance (ft): **2.4**
Structural Grade: **0**
O&M Grade: **0**
Clock Start/From:
Clock To:
1st Value:
2nd Value:
Value Percent:
Step: **NO**
Remarks: **underside of frame**

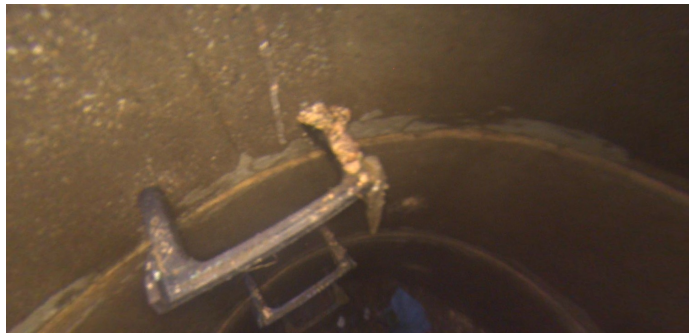
Code: **SAV**
Description: **Surface Aggregate Visible**

Distance (ft): **2.4**
Structural Grade: **3**
O&M Grade: **0**
Clock Start/From: **10**
Clock To: **12**
1st Value:
2nd Value:
Value Percent:
Step: **NO**
Remarks:

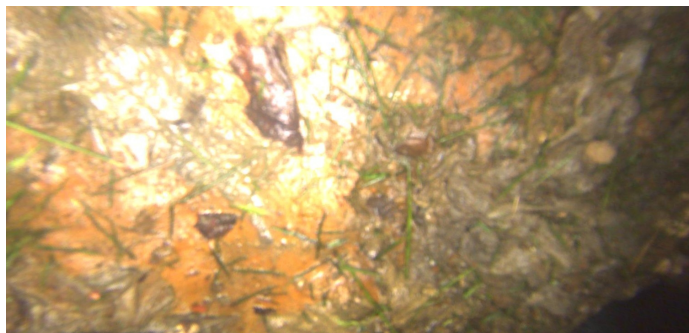
Code: **MGO**
Description: **General Observation**

Distance (ft): **8.6**
Structural Grade: **0**
O&M Grade: **0**
Clock Start/From:
Clock To:
1st Value:
2nd Value:
Value Percent:
Step: **NO**
Remarks: **end survey**
