Manhole Inspection Report

Date:	05/06/2018	Weather:		Coding:	RZMACP
MH#:	M-705-066	Owner:	NA	Len. Surveyed:	13.3
P.O.#:		Surveyor:	Jen Costello	Rim to Invert:	14.5
Customer:		Cert. #:	U-907-5518	Wall Material:	Concrete (reinforced)

Street:	In Park. 255' Southeast of Cleveland	Project:	Hobart, IN
City:	Hobart, IN	GPS Northing:	2905053.598
Location:		GPS Easting:	2905053.598
Drain Area:	West	GPS Accuracy:	Sub-Meter
Cover Shape:	Circular	Evidence of Surcharge:	No
Cover Size:	22.5	Potential for Runoff:	None
Comments:

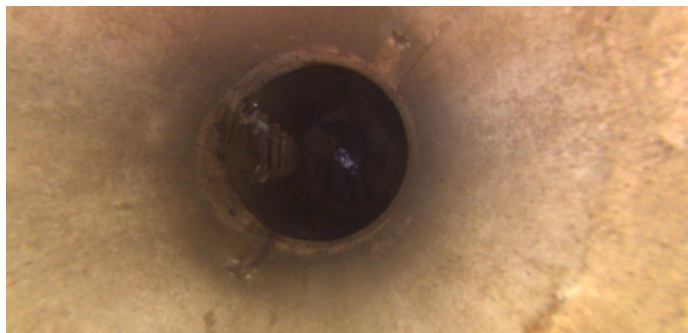
Code: **MGP**
Description: **General Photo**

Distance (ft): **.0**
Structural Grade: **0**
O&M Grade: **0**
Clock Start/From:
Clock To:
1st Value:
2nd Value:
Value Percent:
Step: **NO**
Remarks: **access MH**

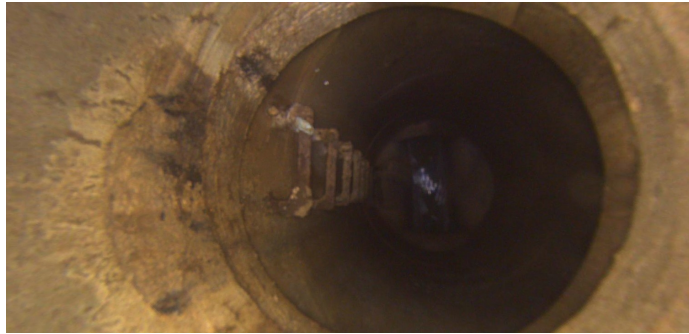
Code: **FC**
Description: **Fracture Circumferential**

Distance (ft): **1.8**
Structural Grade: **2**
O&M Grade: **0**
Clock Start/From: **8**
Clock To: **10**
1st Value:
2nd Value:
Value Percent:
Step: **NO**
Remarks:

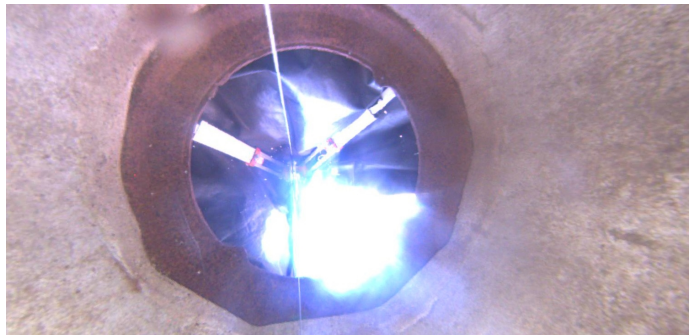
Code: **MGO**
Description: **General Observation**

Distance (ft): **2.5**
Structural Grade: **0**
O&M Grade: **0**
Clock Start/From:
Clock To:
1st Value:
2nd Value:
Value Percent:
Step: **NO**
Remarks: **END SURVEY**

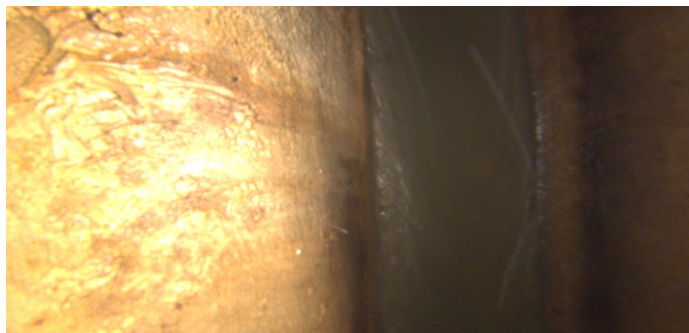
Code: **MGO**
Description: **General Observation**

Distance (ft): **13.3**
Structural Grade: **0**
O&M Grade: **0**
Clock Start/From:
Clock To:
1st Value:
2nd Value:
Value Percent:
Step: **NO**
Remarks: **END SURVEY**
