Manhole Inspection Report

O&M Index:	0.00	O&M Quick:	0000	O&M Rating:	0.00
Structural Index:	0.00	Structural Quick:	0000	Structural Rating:	0.00
Overall Index:	0.00	Overall Quick:	0000	Overall Rating:	0.00

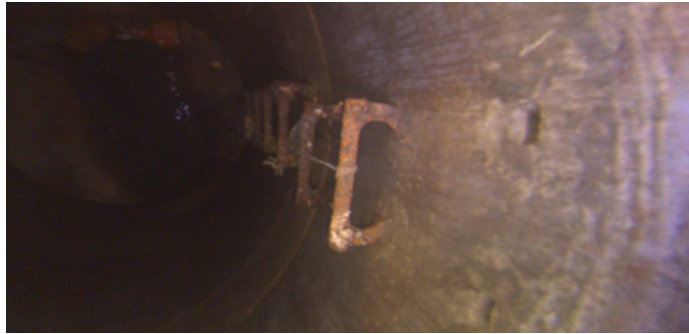
Code: **MGO**
Description: **General Observation**

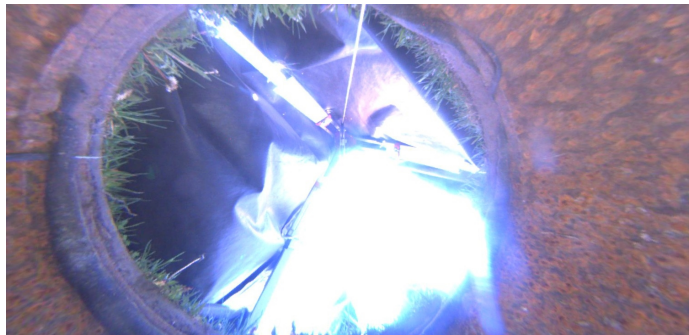
Code: **MGO**
Description: **General Observation**
