Manhole Inspection Report

Date:	05/04/2018	Weather:		Coding:	RZMACP
MH#:	M-705-071	Owner:	NA	Len. Surveyed:	5.8
P.O.#:		Surveyor:	Jen Costello	Rim to Invert:	6.5
Customer:		Cert. #:	U-907-5518	Wall Material:	Concrete (reinforced)

Street:	Cleveland Ave. and Old Ridge Road.	Project:	Hobart, IN
City:	Hobart, IN	GPS Northing:	2905540.234
Location:		GPS Easting:	2905540.234
Drain Area:	South	GPS Accuracy:	Sub-Meter
Cover Shape:	Circular	Evidence of Surcharge:	No
Cover Size:	22.5	Potential for Runoff:	None
Comments:

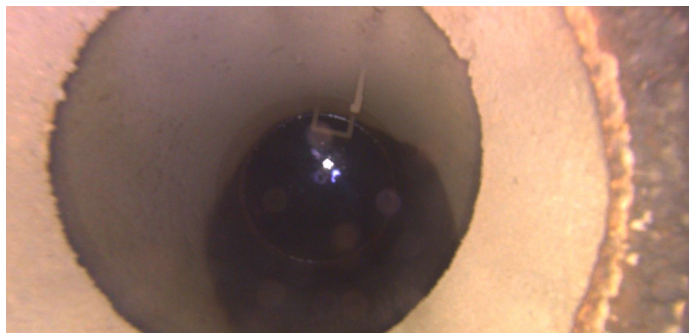
Code: **MGP**
Description: **General Photo**

Distance (ft): **.0**
Structural Grade: **0**
O&M Grade: **0**
Clock Start/From:
Clock To:
1st Value:
2nd Value:
Value Percent:
Step: **NO**
Remarks: **ACCESS MH**

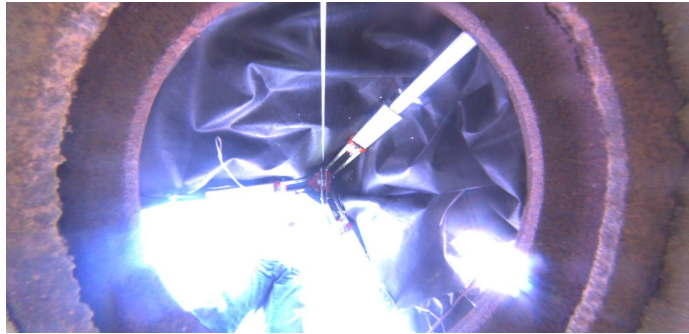
Code: **MGO**
Description: **General Observation**

Distance (ft): **1.4**
Structural Grade: **0**
O&M Grade: **0**
Clock Start/From:
Clock To:
1st Value:
2nd Value:
Value Percent:
Step: **NO**
Remarks: **UNDERSIDE OF FRAME**

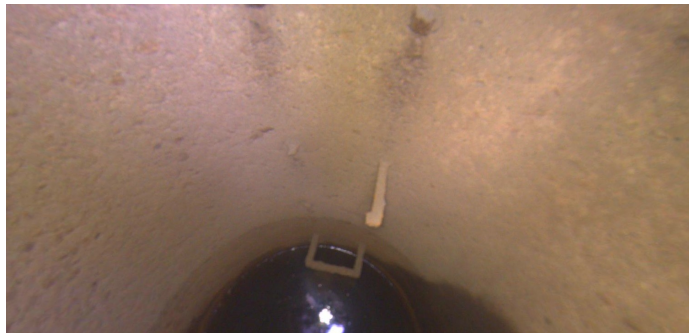
Code: **MGO**
Description: **General Observation**

Distance (ft): **1.4**
Structural Grade: **0**
O&M Grade: **0**
Clock Start/From:
Clock To:
1st Value:
2nd Value:
Value Percent:
Step: **NO**
Remarks: **MISSING AND BROKEN STEPS**

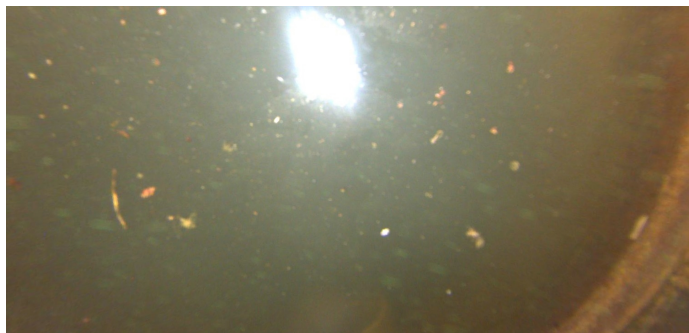
Code: **MSA**
Description: **Abandoned Survey**

Distance (ft): **5.8**
Structural Grade: **0**
O&M Grade: **0**
Clock Start/From:
Clock To:
1st Value:
2nd Value:
Value Percent:
Step: **NO**
Remarks: **BENCH IS SUBMERGED**
