# Manhole Inspection Report

Date:	05/04/2018	Weather:		Coding:	RZMACP
MH#:	M-705-075	Owner:	NA	Len. Surveyed:	8.5
P.O.#:		Surveyor:	Jen Costello	Rim to Invert:	9.2
Customer:		Cert. #:	U-907-5518	Wall Material:	Concrete (reinforced)

Street:	Old Ridge Road. West of Main L/S.	Project:	Hobart, IN
City:	Hobart, IN	GPS Northing:	2905370.654
Location:		GPS Easting:	2905370.654
Drain Area:	West	GPS Accuracy:	Sub-Meter
Cover Shape:	Circular	Evidence of Surcharge:	No
Cover Size:	22.5	Potential for Runoff:	None
Comments:

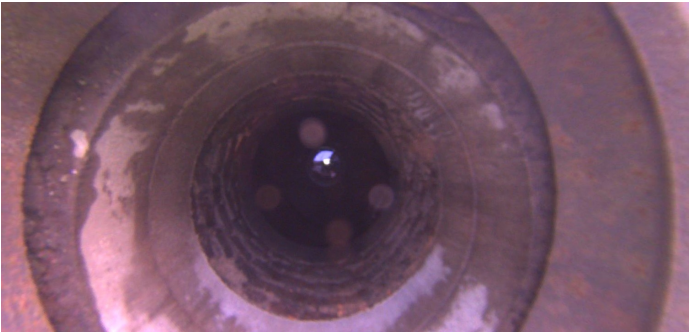
Code: **MGP**  
 Description: **General Photo**

Distance (ft): **.0**  
 Structural Grade: **0**  
 O&M Grade: **0**  
 Clock Start/From:  
 Clock To:  
 1st Value:  
 2nd Value:  
 Value Percent:  
 Step: **NO**  
 Remarks: **ACCESS MH**

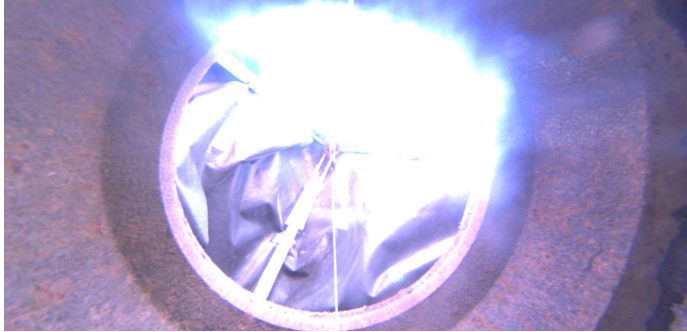
Code:	<b>MGO</b>
Description:	<b>General Observation</b>
Distance (ft):	<b>1.8</b>
Structural Grade:	<b>0</b>
O&M Grade:	<b>0</b>
Clock Start/From:	
Clock To:	
1st Value:	
2nd Value:	
Value Percent:	
Step:	<b>NO</b>
Remarks:	<b>UNDERSIDE OF FRAME</b>

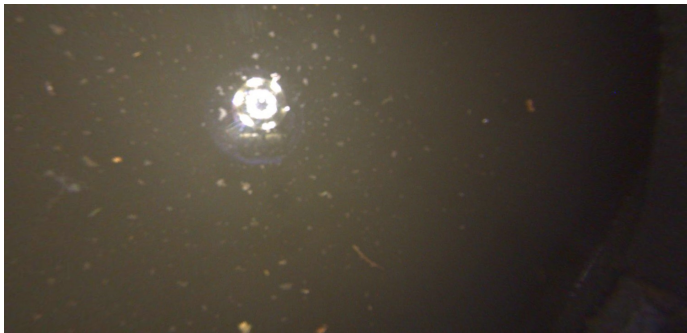
Code:	<b>MSA</b>
Description:	<b>Abandoned Survey</b>
Distance (ft):	<b>8.5</b>
Structural Grade:	<b>0</b>
O&M Grade:	<b>0</b>
Clock Start/From:	
Clock To:	
1st Value:	
2nd Value:	
Value Percent:	
Step:	<b>NO</b>
Remarks:	<b>BENCH SI SUBMERGED</b>
