Manhole Inspection Report

Date:	05/04/2018	Weather:		Coding:	RZMACP
MH#:	M-705-076	Owner:	NA	Len. Surveyed:	6.7
P.O.#:		Surveyor:	Jen Costello	Rim to Invert:	7.8
Customer:		Cert. #:	U-907-5518	Wall Material:	Concrete (reinforced)

Street:	Old Ridge Road. West of Main L/S.	Project:	Hobart, IN
City:	Hobart, IN	GPS Northing:	41.53582001
Location:		GPS Easting:	-87.25637817
Drain Area:	West	GPS Accuracy:	Nearest Meter
Cover Shape:	Circular	Evidence of Surcharge:	No
Cover Size:	22.5	Potential for Runoff:	None
Comments:

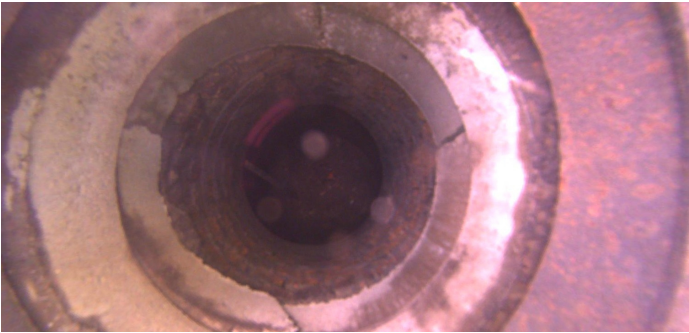
Code: **MGP**
 Description: **General Photo**

Distance (ft): **.0**
 Structural Grade: **0**
 O&M Grade: **0**
 Clock Start/From:
 Clock To:
 1st Value:
 2nd Value:
 Value Percent:
 Step: **NO**
 Remarks: **ACCESS MH**

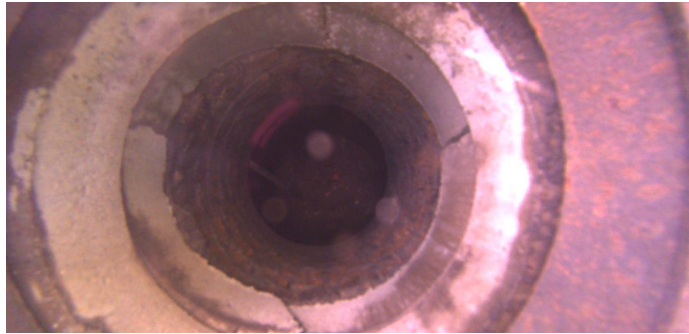
Code: **FM**
Description: **Fracture Multiple**

Distance (ft): **.0**
Structural Grade: **4**
O&M Grade: **0**
Clock Start/From: **12**
Clock To: **12**
1st Value:
2nd Value:
Value Percent:
Step: **NO**
Remarks:

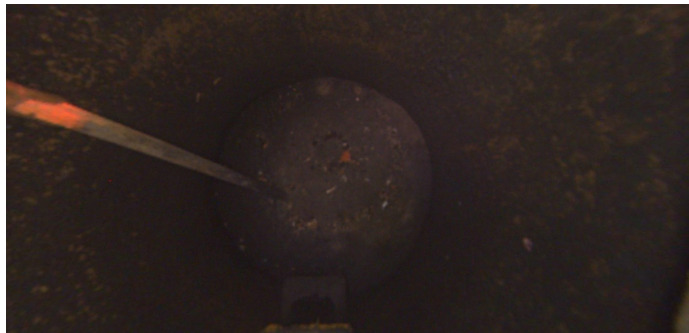
Code: **OBZ**
Description: **Obstacle Other**

Distance (ft): **3.6**
Structural Grade: **0**
O&M Grade: **2**
Clock Start/From: **9**
Clock To:
1st Value:
2nd Value:
Value Percent: **5.000**
Step: **NO**
Remarks: **STICK**

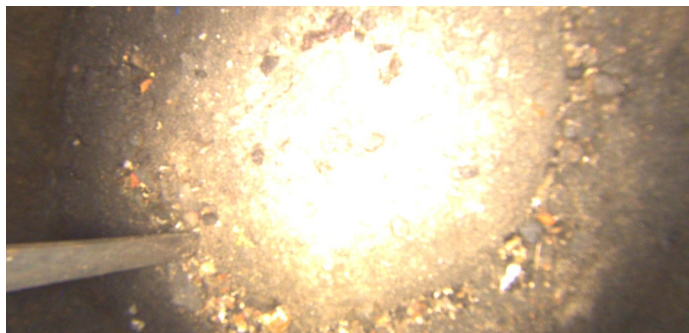
Code: **MGO**
Description: **General Observation**

Distance (ft): **6.7**
Structural Grade: **0**
O&M Grade: **0**
Clock Start/From:
Clock To:
1st Value:
2nd Value:
Value Percent:
Step: **NO**
Remarks: **END SURVEY**
