Manhole Inspection Report

Date:	05/06/2018	Weather:		Coding:	RZMACP
MH#:	M-705-077	Owner:	NA	Len. Surveyed:	.5
P.O.#:		Surveyor:	Jen Costello	Rim to Invert:	.0
Customer:		Cert. #:	U-907-5518	Wall Material:	Concrete (reinforced)

Street:	Northeast of Dam in Park.	Project:	Hobart, IN
City:	Hobart, IN	GPS Northing:	2905299.583
Location:		GPS Easting:	2905299.583
Drain Area:	West	GPS Accuracy:	Sub-Meter
Cover Shape:	Circular	Evidence of Surcharge:	No
Cover Size:	24.0	Potential for Runoff:	None
Comments:

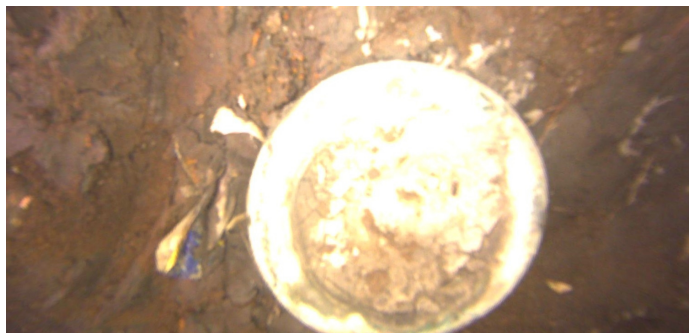
Code: **MGO**
Description: **General Observation**

Distance (ft): **.0**
Structural Grade: **0**
O&M Grade: **0**
Clock Start/From:
Clock To:
1st Value:
2nd Value:
Value Percent:
Step: **NO**
Remarks: **ACCESS MH**

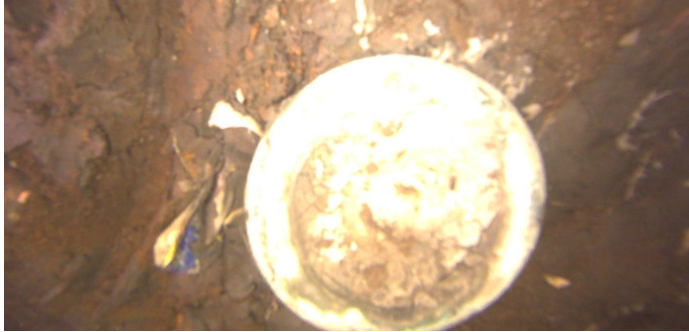
Code:	DSZ
Description:	Deposits Settled Other
Distance (ft):	.0
Structural Grade:	0
O&M Grade:	2
Clock Start/From:	12
Clock To:	12
1st Value:	
2nd Value:	
Value Percent:	10.000
Step:	NO
Remarks:	MISC

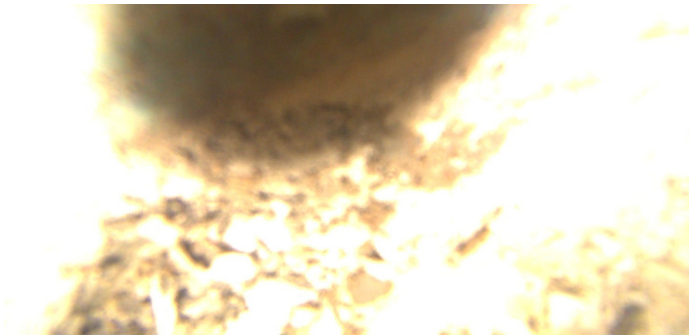
Code:	MSA
Description:	Abandoned Survey
Distance (ft):	.5
Structural Grade:	0
O&M Grade:	0
Clock Start/From:	
Clock To:	
1st Value:	
2nd Value:	
Value Percent:	
Step:	NO
Remarks:	DSZ
