Manhole Inspection Report

Date:	05/04/2018	Weather:		Coding:	RZMACP
MH#:	M-705-078	Owner:	NA	Len. Surveyed:	1.0
P.O.#:		Surveyor:	Jen Costello	Rim to Invert:	17.7
Customer:		Cert. #:	U-907-5518	Wall Material:	Concrete (reinforced)

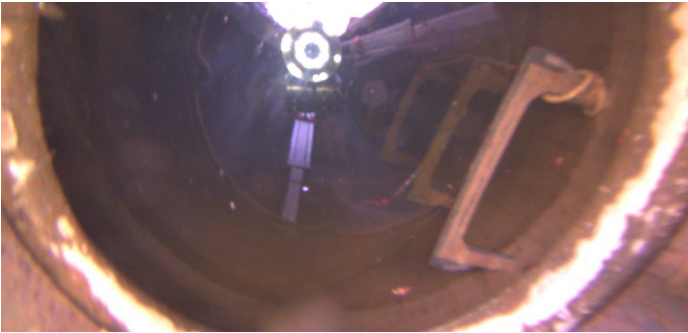
General Observation

access MH

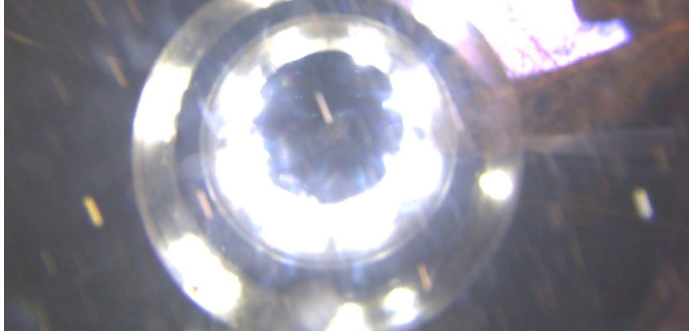
Code:	MSA
Description:	Abandoned Survey
Distance (ft):	1.0
Structural Grade:	0
O&M Grade:	0
Clock Start/From:	
Clock To:	
1st Value:	
2nd Value:	
Value Percent:	
Step:	NO
Remarks:	SUBMERGED
