Manhole Inspection Report

Date:	05/04/2018	Weather:		Coding:	RZMACP
MH#:	M-705-079	Owner:	NA	Len. Surveyed:	7.7
P.O.#:		Surveyor:	Jen Costello	Rim to Invert:	8.5
Customer:		Cert. #:	U-907-5518	Wall Material:	Concrete (reinforced)

Street:	On East St. South of 3rd St.	Project:	Hobart, IN
City:	Hobart, IN	GPS Northing:	2906490.609
Location:		GPS Easting:	2906490.609
Drain Area:	South	GPS Accuracy:	Sub-Meter
Cover Shape:	Circular	Evidence of Surcharge:	No
Cover Size:	22.5	Potential for Runoff:	None
Comments:

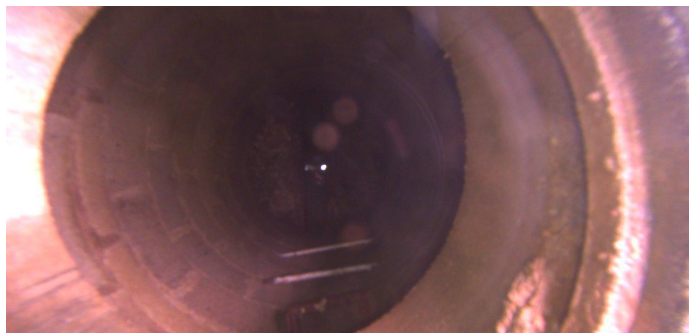
Code: **MGO**
Description: **General Observation**

Distance (ft): **.0**
Structural Grade: **0**
O&M Grade: **0**
Clock Start/From:
Clock To:
1st Value:
2nd Value:
Value Percent:
Step: **NO**
Remarks: **access mh**

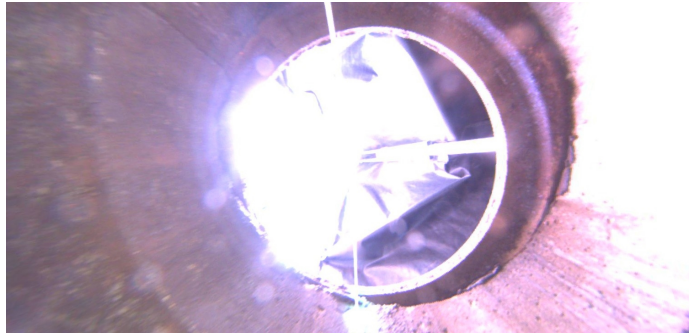
Code: **MGO**
Description: **General Observation**

Distance (ft): **2.0**
Structural Grade: **0**
O&M Grade: **0**
Clock Start/From:
Clock To:
1st Value:
2nd Value:
Value Percent:
Step: **NO**
Remarks: **underside of frame**

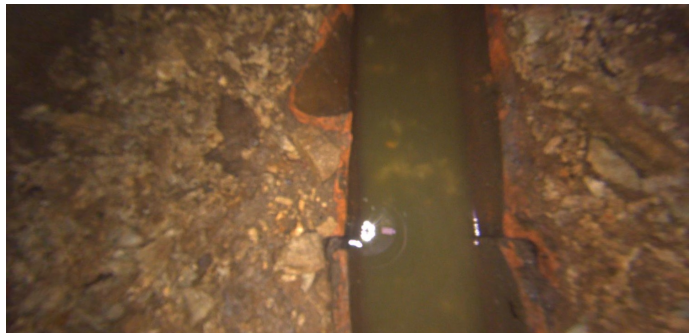
Code: **OBR**
Description: **Obstacle Rocks**

Distance (ft): **7.3**
Structural Grade: **0**
O&M Grade: **2**
Clock Start/From: **12**
Clock To: **12**
1st Value:
2nd Value:
Value Percent: **10.000**
Step: **NO**
Remarks:

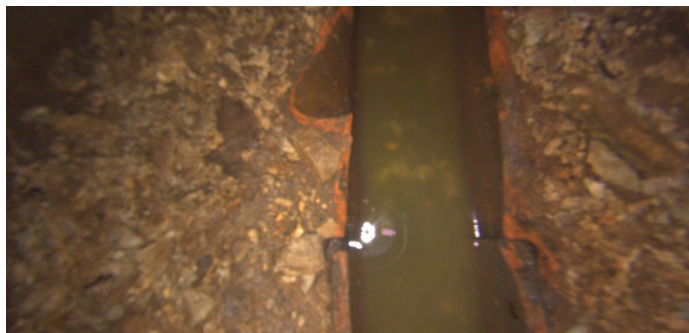
Code: **MGO**
Description: **General Observation**

Distance (ft): **7.3**
Structural Grade: **0**
O&M Grade: **0**
Clock Start/From:
Clock To:
1st Value:
2nd Value:
Value Percent:
Step: **NO**
Remarks: **end survey**
