Manhole Inspection Report

Date:	05/01/2018	Weather:		Coding:	RZMACP
MH#:	M-705-080	Owner:	NA	Len. Surveyed:	4.5
P.O.#:		Surveyor:	Jen Costello	Rim to Invert:	4.7
Customer:		Cert. #:	U-907-5518	Wall Material:	Concrete (reinforced)

Street:	Lake Park Ave. and Cleveland Ave. T	Project:	Hobart, IN
City:	Hobart, IN	GPS Northing:	41.53588104
Location:		GPS Easting:	-87.25900269
Drain Area:	West	GPS Accuracy:	Nearest Meter
Cover Shape:	Circular	Evidence of Surcharge:	No
Cover Size:	22.5	Potential for Runoff:	None
Comments:

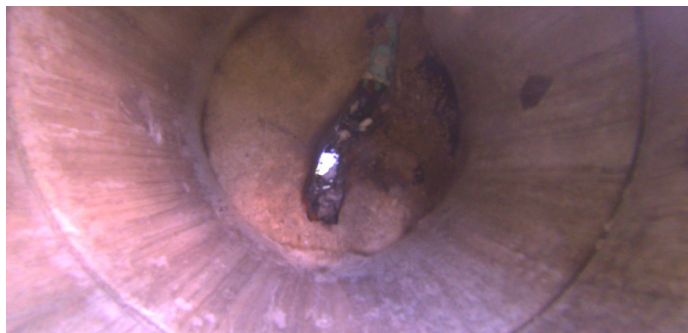
Code: **MGP**
Description: **General Photo**

Distance (ft): **.0**
Structural Grade: **0**
O&M Grade: **0**
Clock Start/From:
Clock To:
1st Value:
2nd Value:
Value Percent:
Step: **NO**
Remarks: **ACCESS MH**

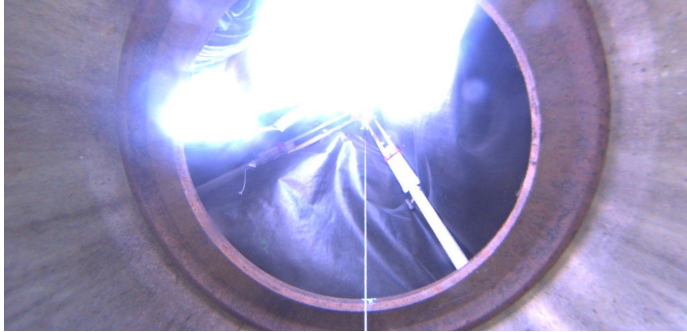
Code:	MGO
Description:	General Observation
Distance (ft):	1.5
Structural Grade:	0
O&M Grade:	0
Clock Start/From:	
Clock To:	
1st Value:	
2nd Value:	
Value Percent:	
Step:	NO
Remarks:	UNDERSIDE OF FRAME

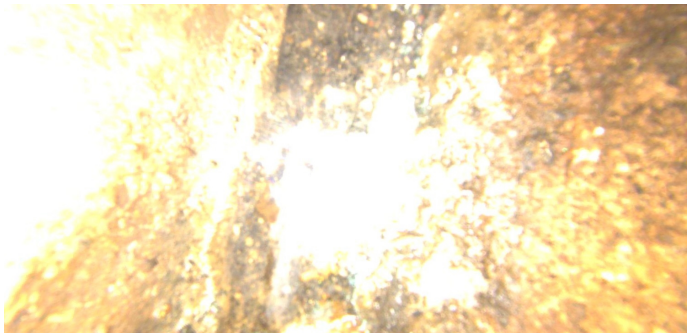
Code:	MGO
Description:	General Observation
Distance (ft):	4.5
Structural Grade:	0
O&M Grade:	0
Clock Start/From:	
Clock To:	
1st Value:	
2nd Value:	
Value Percent:	
Step:	NO
Remarks:	END SURVEY
