Manhole Inspection Report

Date:	05/03/2018	Weather:		Coding:	RZMACP
MH#:	M-705-086	Owner:	NA	Len. Surveyed:	4.3
P.O.#:		Surveyor:	Jen Costello	Rim to Invert:	4.8
Customer:		Cert. #:	U-907-5518	Wall Material:	Concrete (reinforced)

Street:	South Side of 3rd St. 246' West of M	Project:	Hobart, IN
City:	Hobart, IN	GPS Northing:	41.53172684
Location:		GPS Easting:	-87.25563049
Drain Area:	South	GPS Accuracy:	Nearest Meter
Cover Shape:	Circular	Evidence of Surcharge:	No
Cover Size:	22.5	Potential for Runoff:	None
Comments:

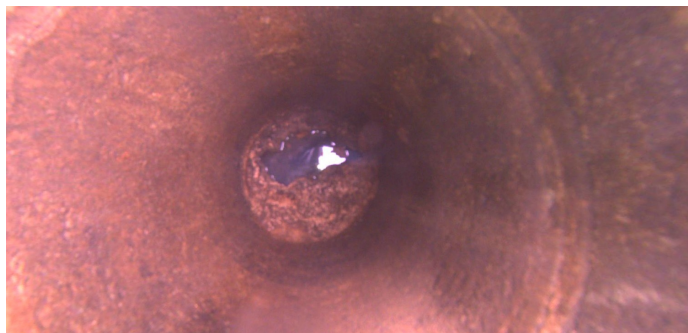
Code: **MGO**
Description: **General Observation**

Distance (ft): **.0**
Structural Grade: **0**
O&M Grade: **0**
Clock Start/From:
Clock To:
1st Value:
2nd Value:
Value Percent:
Step: **NO**
Remarks: **access MH**

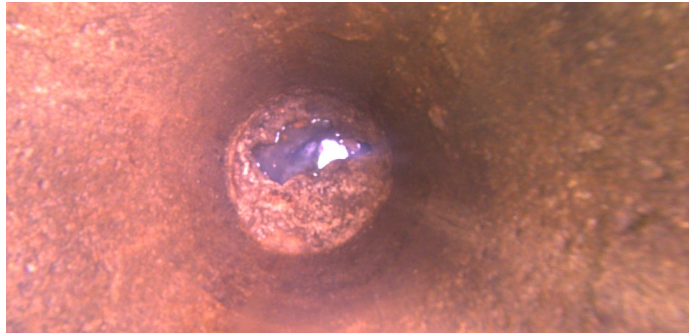
Code: **SAV**
Description: **Surface Aggregate Visible**

Distance (ft): **.7**
Structural Grade: **3**
O&M Grade: **0**
Clock Start/From: **12**
Clock To: **12**
1st Value:
2nd Value:
Value Percent:
Step: **NO**
Remarks:

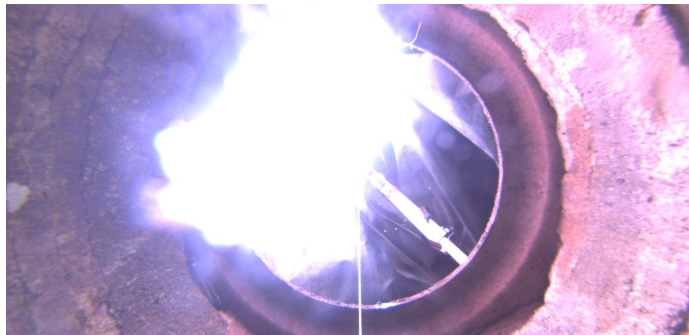
Code: **MGO**
Description: **General Observation**

Distance (ft): **1.5**
Structural Grade: **0**
O&M Grade: **0**
Clock Start/From:
Clock To:
1st Value:
2nd Value:
Value Percent:
Step: **NO**
Remarks: **UNDERSIDE OF FRAME**

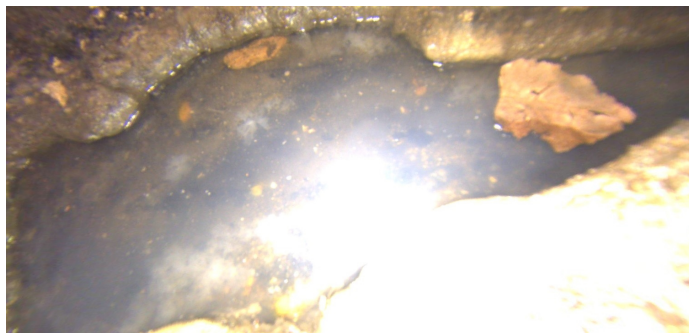
Code: **MGO**
Description: **General Observation**

Distance (ft): **4.3**
Structural Grade: **0**
O&M Grade: **0**
Clock Start/From:
Clock To:
1st Value:
2nd Value:
Value Percent:
Step: **NO**
Remarks: **END SURVEY**
