Manhole Inspection Report

Date:	04/24/2018	Weather:		Coding:	RZMACP
MH#:	M-706-007.2	Owner:	NA	Len. Surveyed:	9.0
P.O.#:		Surveyor:	Jen Costello	Rim to Invert:	9.0
Customer:	8.7	Cert. #:	U-907-5518	Wall Material:	Brick

Street:	Intersection of 9th St. and Linda St.	Project:	Hobart, IN
City:	Hobart, IN	GPS Northing:	0.0
Location:		GPS Easting:	0.0
Drain Area:	Southeast	GPS Accuracy:	Nearest Meter
Cover Shape:	Circular	Evidence of Surcharge:	No
Cover Size:	22.5	Potential for Runoff:	None
Comments:

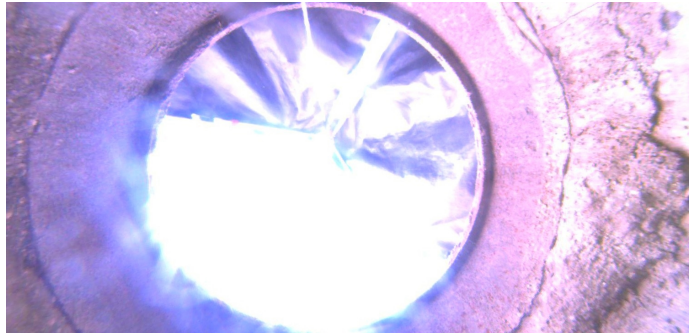
Code:	MGP
Description:	General Photo
Distance (ft):	2.2
Structural Grade:	0
O&M Grade:	0
Clock Start/From:	
Clock To:	
1st Value:	
2nd Value:	
Value Percent:	
Step:	NO
Remarks:	underside of frame

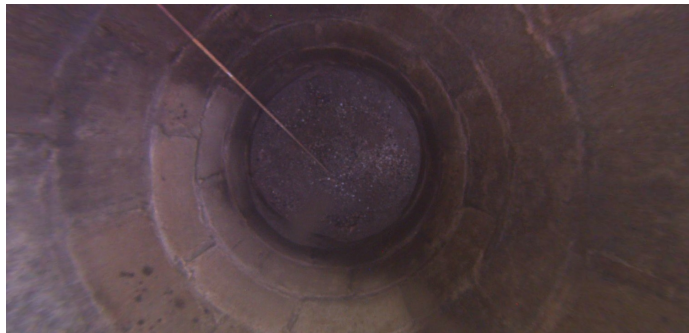
Code:	OBZ
Description:	Obstacle Other
Distance (ft):	5.0
Structural Grade:	0
O&M Grade:	2
Clock Start/From:	9
Clock To:	11
1st Value:	
2nd Value:	
Value Percent:	5.000
Step:	NO
Remarks:	stick

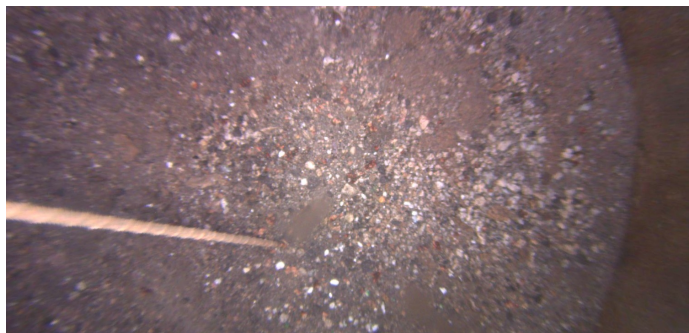
Code:	DSGV
Description:	Deposits Settled Gravel
Distance (ft):	8.7
Structural Grade:	0
O&M Grade:	2
Clock Start/From:	12
Clock To:	12
1st Value:	
2nd Value:	
Value Percent:	10.000
Step:	NO
Remarks:
