Manhole Inspection Report

Date:	04/23/2018	Weather:		Coding:	RZMACP
MH#:	M-706-008.3	Owner:	NA	Len. Surveyed:	8.3
P.O.#:		Surveyor:	Jen Costello	Rim to Invert:	8.1
Customer:	8.7	Cert. #:	U-907-5518	Wall Material:	Brick

Street:	Intersection of 9th St. and Garfield S	Project:	Hobart, IN
City:	Hobart, IN	GPS Northing:	0.0
Location:		GPS Easting:	0.0
Drain Area:	Southeast	GPS Accuracy:	Nearest Meter
Cover Shape:	Circular	Evidence of Surcharge:	No
Cover Size:	22.5	Potential for Runoff:	None
Comments:

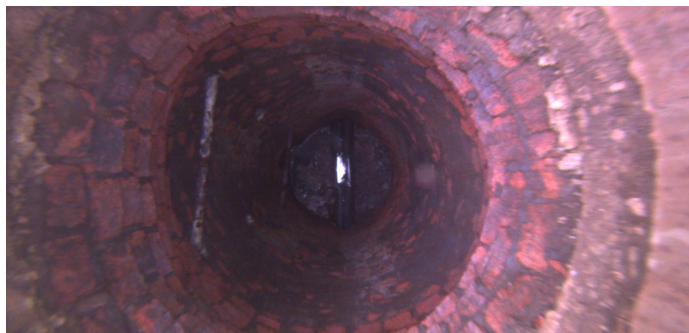
Code: **MGO**
Description: **General Observation**

Distance (ft): **.0**
Structural Grade: **0**
O&M Grade: **0**
Clock Start/From:
Clock To:
1st Value:
2nd Value:
Value Percent:
Step: **NO**
Remarks: **access mh**

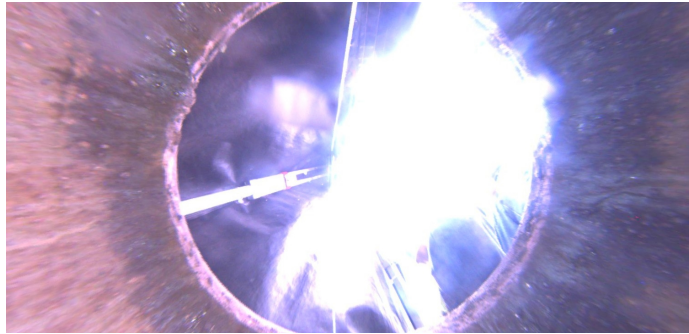
Code:	MGP
Description:	General Photo
Distance (ft):	1.5
Structural Grade:	0
O&M Grade:	0
Clock Start/From:	
Clock To:	
1st Value:	
2nd Value:	
Value Percent:	
Step:	NO
Remarks:	underside of frame

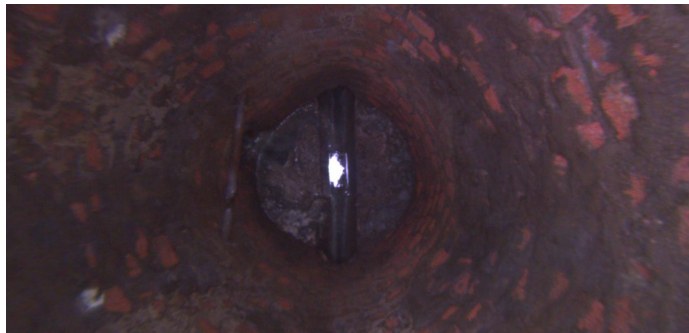
Code:	MGO
Description:	General Observation
Distance (ft):	2.9
Structural Grade:	0
O&M Grade:	0
Clock Start/From:	
Clock To:	
1st Value:	
2nd Value:	
Value Percent:	
Step:	NO
Remarks:	missing step

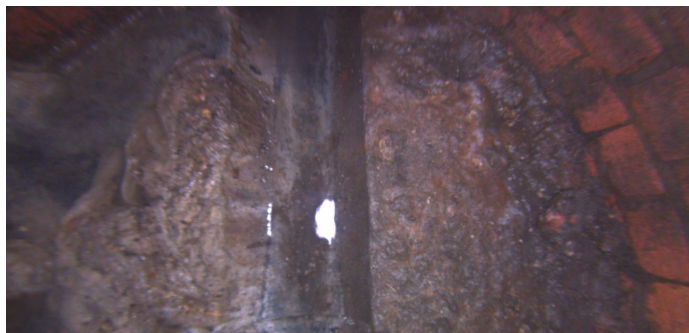
Code:	DSF
Description:	Deposits Settled Fine
Distance (ft):	7.0
Structural Grade:	0
O&M Grade:	2
Clock Start/From:	12
Clock To:	12
1st Value:	
2nd Value:	
Value Percent:	5.000
Step:	NO
Remarks:

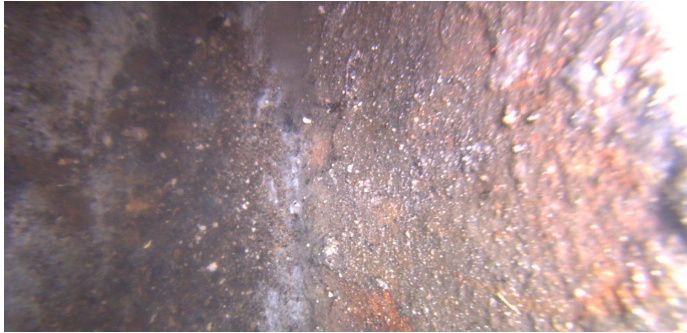
Code:	MGO
Description:	General Observation
Distance (ft):	8.3
Structural Grade:	0
O&M Grade:	0
Clock Start/From:	
Clock To:	
1st Value:	
2nd Value:	
Value Percent:	
Step:	NO
Remarks:	end survey
