Manhole Inspection Report

Date:	04/24/2018	Weather:		Coding:	RZMACP
MH#:	M-706-008.9	Owner:	NA	Len. Surveyed:	5.0
P.O.#:		Surveyor:	Jen Costello	Rim to Invert:	4.8
Customer:	8.7	Cert. #:	U-907-5518	Wall Material:	Brick

Street:	10th St. 132' West of Linda St.	Project:	Hobart, IN
City:	Hobart, IN	GPS Northing:	0.0
Location:		GPS Easting:	0.0
Drain Area:	Southeast	GPS Accuracy:	Nearest Meter
Cover Shape:	Circular	Evidence of Surcharge:	No
Cover Size:	22.5	Potential for Runoff:	None
Comments:

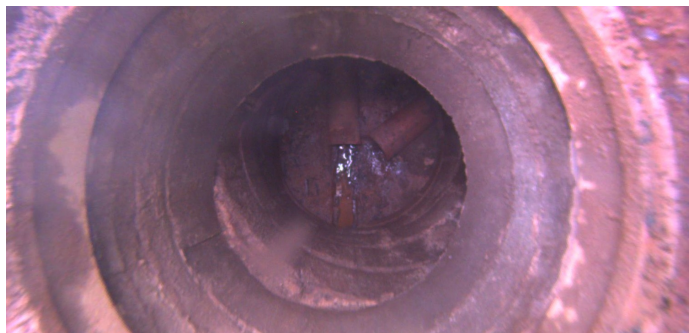
Code: **MGO**
Description: **General Observation**

Distance (ft): **.0**
Structural Grade: **0**
O&M Grade: **0**
Clock Start/From:
Clock To:
1st Value:
2nd Value:
Value Percent:
Step: **NO**
Remarks: **ACCESS MH**

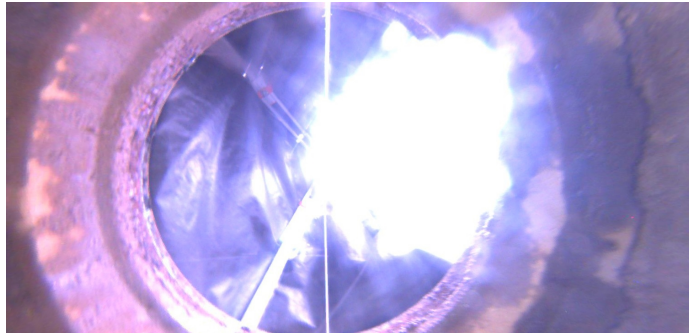
Code:	MGP
Description:	General Photo
Distance (ft):	2.0
Structural Grade:	0
O&M Grade:	0
Clock Start/From:	
Clock To:	
1st Value:	
2nd Value:	
Value Percent:	
Step:	NO
Remarks:	UNDERSIDE OF FRAME

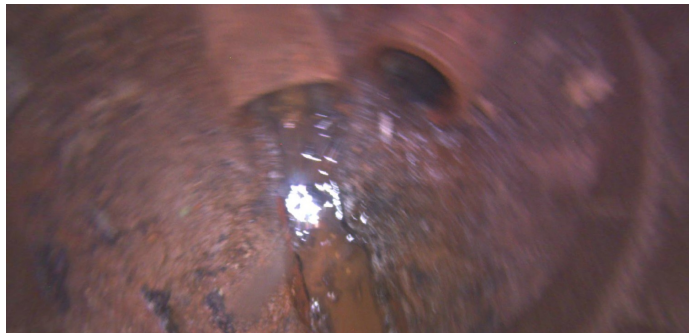
Code:	DSF
Description:	Deposits Settled Fine
Distance (ft):	4.2
Structural Grade:	0
O&M Grade:	2
Clock Start/From:	12
Clock To:	12
1st Value:	
2nd Value:	
Value Percent:	5.000
Step:	NO
Remarks:

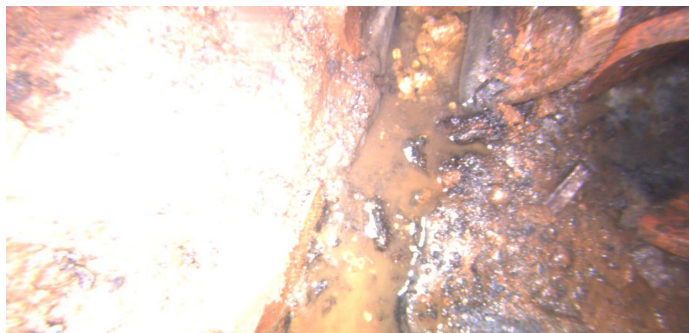
Code:	MGO
Description:	General Observation
Distance (ft):	5.0
Structural Grade:	0
O&M Grade:	0
Clock Start/From:	
Clock To:	
1st Value:	
2nd Value:	
Value Percent:	
Step:	NO
Remarks:	END SURVEY
