# Manhole Inspection Report

Date:	<b>04/28/2018</b>	Weather:		Coding:	<b>RZMACP</b>
MH#:	<b>M-706-009.1</b>	Owner:	<b>NA</b>	Len. Surveyed:	<b>7.0</b>
P.O.#:		Surveyor:	<b>Jen Costello</b>	Rim to Invert:	<b>7.1</b>
Customer:		Cert. #:	<b>U-907-5518</b>	Wall Material:	<b>Concrete (reinforced)</b>

Street:	<b>Intersection of 8th Pl. and Hwy 51.</b>	Project:	<b>Hobart, IN</b>
City:	<b>Hobart, IN</b>	GPS Northing:	<b>41.52361298</b>
Location:		GPS Easting:	<b>-87.25217438</b>
Drain Area:	<b>Southeast</b>	GPS Accuracy:	<b>Nearest Meter</b>
Cover Shape:	<b>Circular</b>	Evidence of Surcharge:	<b>No</b>
Cover Size:	<b>22.5</b>	Potential for Runoff:	<b>None</b>
Comments:

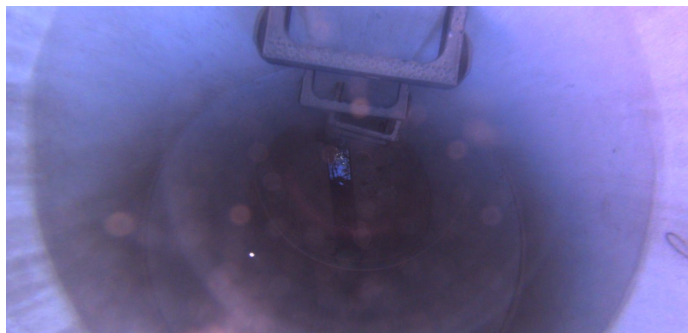
Code: **MGO**  
Description: **General Observation**

Distance (ft): **.0**  
Structural Grade: **0**  
O&M Grade: **0**  
Clock Start/From:  
Clock To:  
1st Value:  
2nd Value:  
Value Percent:  
Step: **NO**  
Remarks: **ACCESS MH**

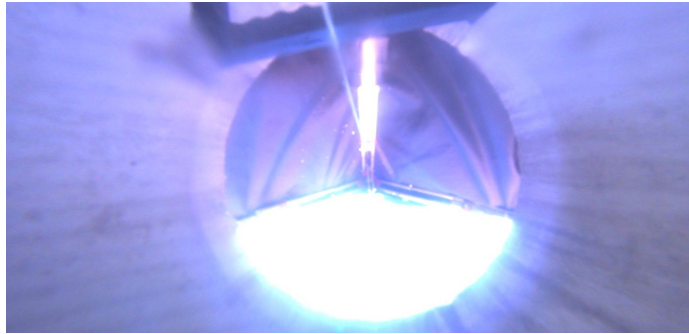
Code:	<b>MGO</b>
Description:	<b>General Observation</b>
Distance (ft):	<b>2.0</b>
Structural Grade:	<b>0</b>
O&M Grade:	<b>0</b>
Clock Start/From:	
Clock To:	
1st Value:	
2nd Value:	
Value Percent:	
Step:	<b>NO</b>
Remarks:	<b>UNDERSIDE OF FRAME</b>

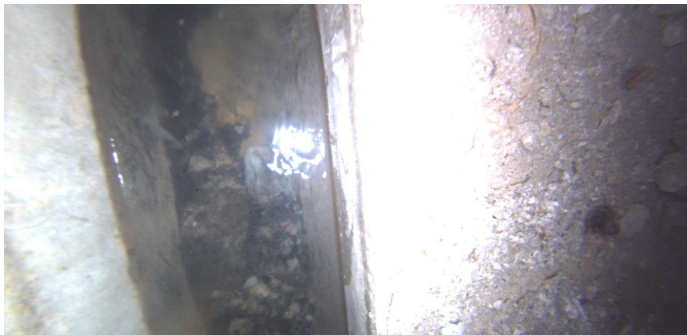
Code:	<b>MGO</b>
Description:	<b>General Observation</b>
Distance (ft):	<b>7.0</b>
Structural Grade:	<b>0</b>
O&M Grade:	<b>0</b>
Clock Start/From:	
Clock To:	
1st Value:	
2nd Value:	
Value Percent:	
Step:	<b>NO</b>
Remarks:	<b>END SURVEY</b>
