Manhole Inspection Report

Date:	04/28/2018	Weather:		Coding:	RZMACP
MH#:	M-706-009.1	Owner:	NA	Len. Surveyed:	6.6
P.O.#:		Surveyor:	Jen Costello	Rim to Invert:	7.4
Customer:		Cert. #:	U-907-5518	Wall Material:	Concrete (reinforced)

Street:	Intersection of 8th Pl. and Hwy 51.	Project:	Hobart, IN
City:	Hobart, IN	GPS Northing:	41.52456665
Location:		GPS Easting:	-87.25217438
Drain Area:	Southeast	GPS Accuracy:	Nearest Meter
Cover Shape:	Circular	Evidence of Surcharge:	No
Cover Size:	22.5	Potential for Runoff:	None
Comments:

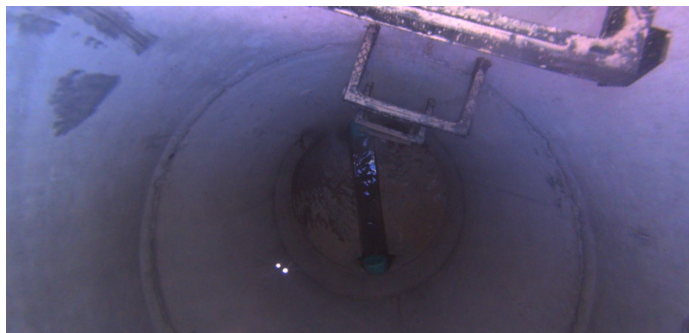
Code: **MGO**
Description: **General Observation**

Distance (ft): **.0**
Structural Grade: **0**
O&M Grade: **0**
Clock Start/From:
Clock To:
1st Value:
2nd Value:
Value Percent:
Step: **NO**
Remarks: **END SURVEY**

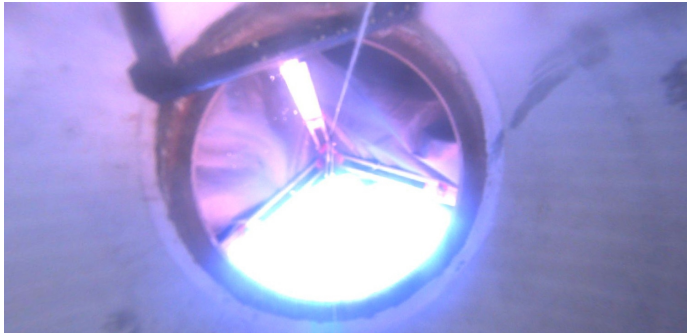
Code:	MGO
Description:	General Observation
Distance (ft):	1.7
Structural Grade:	0
O&M Grade:	0
Clock Start/From:	
Clock To:	
1st Value:	
2nd Value:	
Value Percent:	
Step:	NO
Remarks:	UNDERSIDE OF FRAME

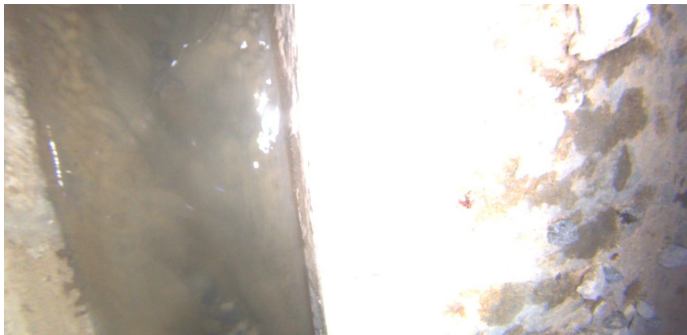
Code:	MGO
Description:	General Observation
Distance (ft):	6.6
Structural Grade:	0
O&M Grade:	0
Clock Start/From:	
Clock To:	
1st Value:	
2nd Value:	
Value Percent:	
Step:	NO
Remarks:	END SURVEY
