Manhole Inspection Report

Date:	04/27/2018	Weather:		Coding:	RZMACP
MH#:	M-706-010.1	Owner:	NA	Len. Surveyed:	8.2
P.O.#:		Surveyor:	Jen Costello	Rim to Invert:	8.2
Customer:		Cert. #:	U-907-5518	Wall Material:	Concrete (reinforced)

Street:	State St. 223' South of 8th St.	Project:	Hobart, IN
City:	Hobart, IN	GPS Northing:	41.52482224
Location:		GPS Easting:	-87.25336456
Drain Area:	Southeast	GPS Accuracy:	Nearest Meter
Cover Shape:	Circular	Evidence of Surcharge:	No
Cover Size:	22.5	Potential for Runoff:	None
Comments:

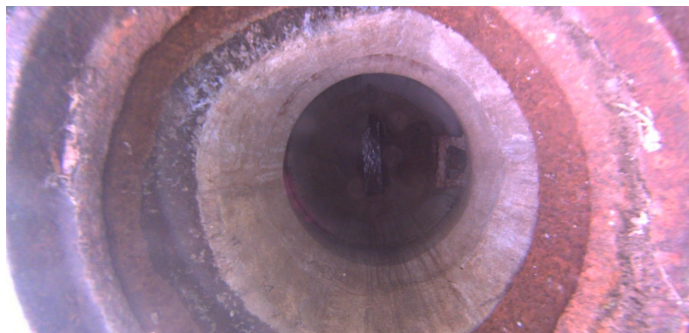
Code: **MGO**
Description: **General Observation**

Distance (ft): **.0**
Structural Grade: **0**
O&M Grade: **0**
Clock Start/From:
Clock To:
1st Value:
2nd Value:
Value Percent:
Step: **NO**
Remarks: **ACCESS MH**

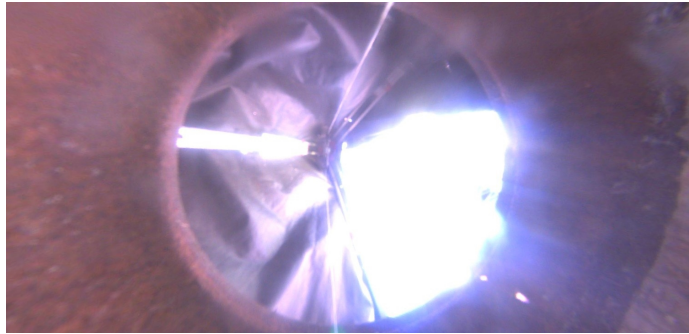
Code:	MGP
Description:	General Photo
Distance (ft):	1.8
Structural Grade:	0
O&M Grade:	0
Clock Start/From:	
Clock To:	
1st Value:	
2nd Value:	
Value Percent:	
Step:	NO
Remarks:	UNDERSIDE OF FRAME

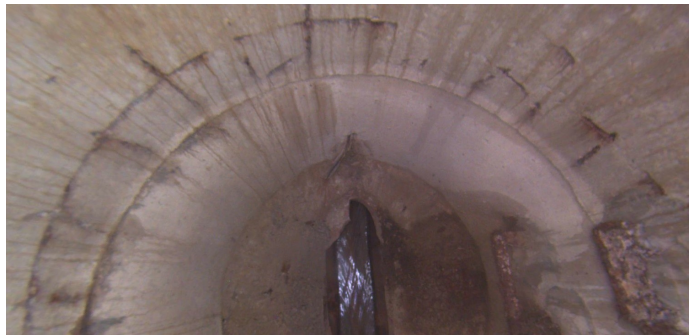
Code:	FM
Description:	Fracture Multiple
Distance (ft):	3.8
Structural Grade:	4
O&M Grade:	0
Clock Start/From:	9
Clock To:	3
1st Value:	
2nd Value:	
Value Percent:	
Step:	NO
Remarks:

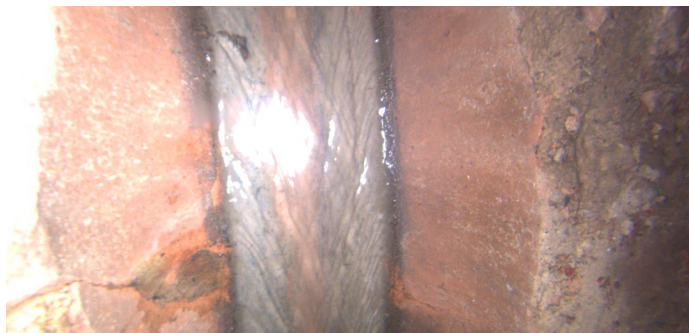
Code:	MGO
Description:	General Observation
Distance (ft):	8.2
Structural Grade:	0
O&M Grade:	0
Clock Start/From:	
Clock To:	
1st Value:	
2nd Value:	
Value Percent:	
Step:	NO
Remarks:	END SURVEY
