Manhole Inspection Report

Date:	04/24/2018	Weather:		Coding:	RZMACP
MH#:	M-706-010.3	Owner:	NA	Len. Surveyed:	8.6
P.O.#:		Surveyor:	Jen Costello	Rim to Invert:	8.1
Customer:	8.7	Cert. #:	U-907-5518	Wall Material:	Concrete (reinforced)

Street:	Intersection of State St. and 9th St.	Project:	Hobart, IN
City:	Hobart, IN	GPS Northing:	0.0
Location:		GPS Easting:	0.0
Drain Area:	Southeast	GPS Accuracy:	Nearest Meter
Cover Shape:	Circular	Evidence of Surcharge:	No
Cover Size:	22.5	Potential for Runoff:	None
Comments:

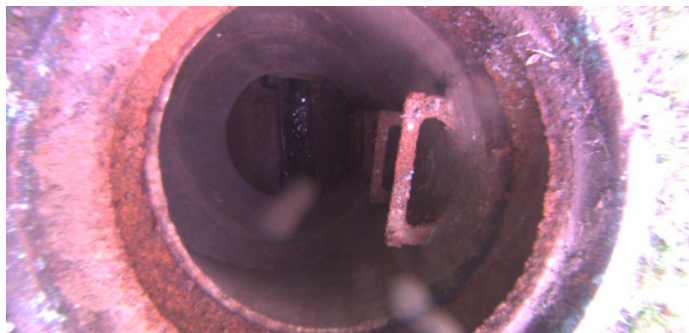
Code: **MGO**
Description: **General Observation**

Distance (ft): **.0**
Structural Grade: **0**
O&M Grade: **0**
Clock Start/From:
Clock To:
1st Value:
2nd Value:
Value Percent:
Step: **NO**
Remarks: **ACCESS MH**

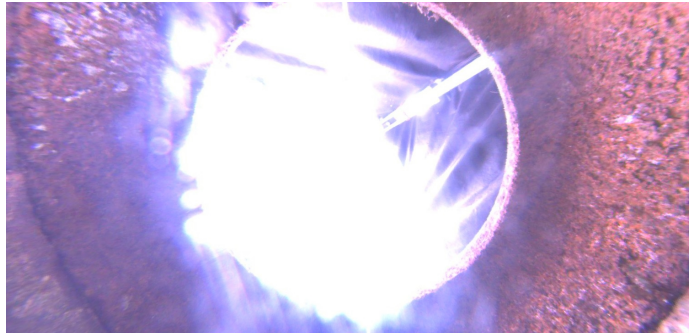
Code:	MGP
Description:	General Photo
Distance (ft):	2.3
Structural Grade:	0
O&M Grade:	0
Clock Start/From:	
Clock To:	
1st Value:	
2nd Value:	
Value Percent:	
Step:	NO
Remarks:	UNDERSIDE OF FRAME

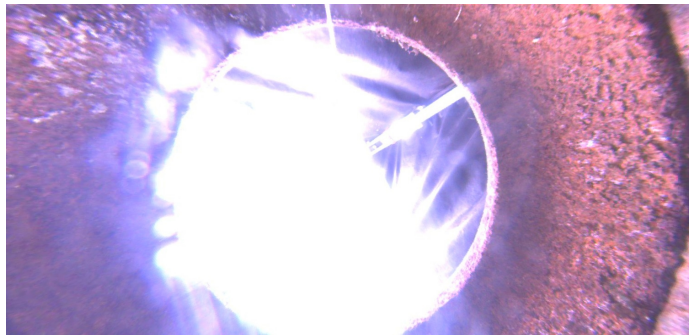
Code:	SRI
Description:	Surface Roughness Increased
Distance (ft):	2.3
Structural Grade:	1
O&M Grade:	0
Clock Start/From:	12
Clock To:	12
1st Value:	
2nd Value:	
Value Percent:	
Step:	NO
Remarks:

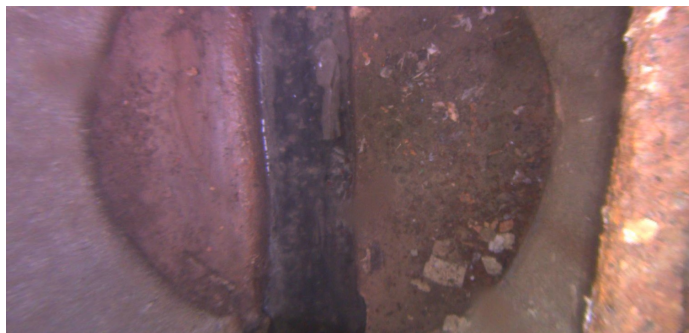
Code:	OBR
Description:	Obstacle Rocks
Distance (ft):	6.9
Structural Grade:	0
O&M Grade:	2
Clock Start/From:	4
Clock To:	6
1st Value:	
2nd Value:	
Value Percent:	5.000
Step:	NO
Remarks:

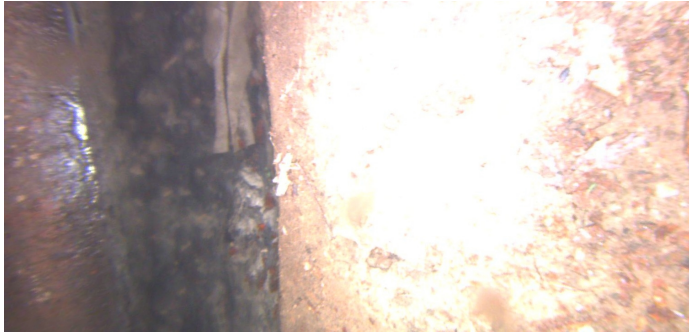
Code:	MGO
Description:	General Observation
Distance (ft):	8.6
Structural Grade:	0
O&M Grade:	0
Clock Start/From:	
Clock To:	
1st Value:	
2nd Value:	
Value Percent:	
Step:	NO
Remarks:	END SURVEY
