Manhole Inspection Report

Date:	04/24/2018	Weather:		Coding:	RZMACP
MH#:	M-706-010.6	Owner:	NA	Len. Surveyed:	8.8
P.O.#:		Surveyor:	John Kuglmaier	Rim to Invert:	8.6
Customer:	8.7	Cert. #:	U-1215-07002349	Wall Material:	Concrete (reinforced)

Street:	Intersection of State St. and 10th St.	Project:	Hobart, IN
City:	Hobart, IN	GPS Northing:	0.0
Location:		GPS Easting:	0.0
Drain Area:	Southeast	GPS Accuracy:	Nearest Meter
Cover Shape:	Circular	Evidence of Surcharge:	No
Cover Size:	22.5	Potential for Runoff:	None
Comments:

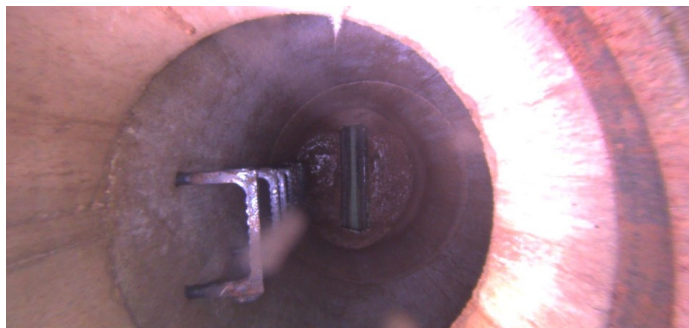
Code: **MGP**
Description: **General Photo**

Distance (ft): **.0**
Structural Grade: **0**
O&M Grade: **0**
Clock Start/From:
Clock To:
1st Value:
2nd Value:
Value Percent:
Step: **NO**
Remarks:

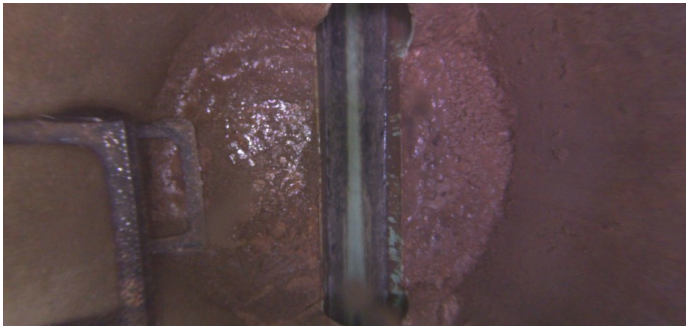
Code: **DSF**
Description: **Deposits Settled Fine**

Distance (ft): **6.2**
Structural Grade: **0**
O&M Grade: **2**
Clock Start/From: **12**
Clock To: **12**
1st Value:
2nd Value:
Value Percent: **10.000**
Step: **NO**
Remarks:

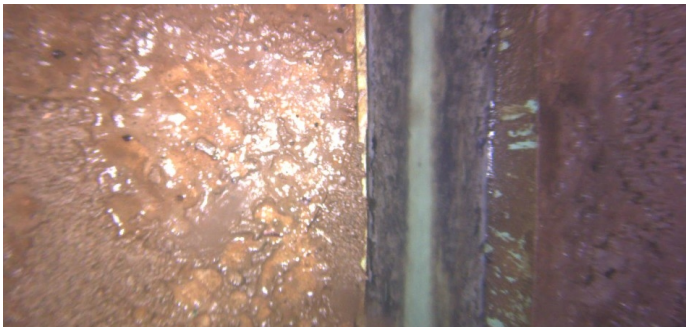
Code: **MGO**
Description: **General Observation**

Distance (ft): **8.1**
Structural Grade: **0**
O&M Grade: **0**
Clock Start/From:
Clock To:
1st Value:
2nd Value:
Value Percent:
Step: **NO**
Remarks: **Ins. Comp.**
