Manhole Inspection Report

Date:	04/27/2018	Weather:		Coding:	RZMACP
MH#:	M-706-011.1	Owner:	NA	Len. Surveyed:	4.3
P.O.#:		Surveyor:	Jen Costello	Rim to Invert:	4.8
Customer:		Cert. #:	U-907-5518	Wall Material:	Concrete (reinforced)

Street:	Lake St. 215' South of 8th St.	Project:	Hobart, IN
City:	Hobart, IN	GPS Northing:	41.52479172
Location:		GPS Easting:	-87.25460052
Drain Area:	Southeast	GPS Accuracy:	Nearest Meter
Cover Shape:	Circular	Evidence of Surcharge:	No
Cover Size:	22.5	Potential for Runoff:	None
Comments:

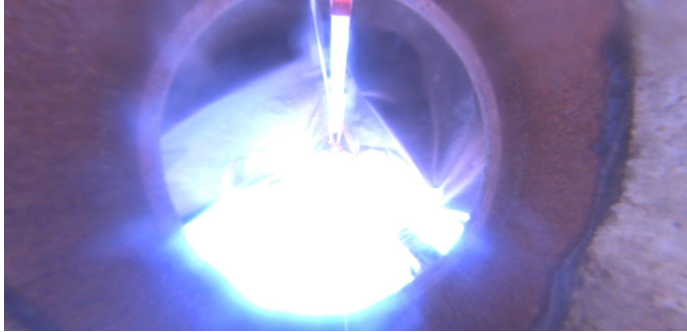
Code:	MGO
Description:	General Observation
Distance (ft):	2.0
Structural Grade:	0
O&M Grade:	0
Clock Start/From:	
Clock To:	
1st Value:	
2nd Value:	
Value Percent:	
Step:	NO
Remarks:	UNDERSIDE OF FRAME

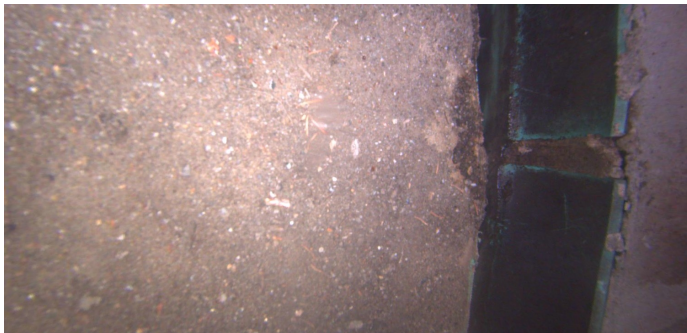
Code:	MGO
Description:	General Observation
Distance (ft):	4.3
Structural Grade:	0
O&M Grade:	0
Clock Start/From:	
Clock To:	
1st Value:	
2nd Value:	
Value Percent:	
Step:	NO
Remarks:	END SURVEY
