Manhole Inspection Report

Date:	04/24/2018	Weather:		Coding:	RZMACP
MH#:	M-706-011.2	Owner:	NA	Len. Surveyed:	3.6
P.O.#:		Surveyor:	Jen Costello	Rim to Invert:	3.8
Customer:	8.7	Cert. #:	U-907-5518	Wall Material:	Concrete (reinforced)

Street:	Lake St. 409' South of 8th St.	Project:	Hobart, IN
City:	Hobart, IN	GPS Northing:	0.0
Location:		GPS Easting:	0.0
Drain Area:	Southeast	GPS Accuracy:	Nearest Meter
Cover Shape:	Circular	Evidence of Surcharge:	No
Cover Size:	22.5	Potential for Runoff:	None
Comments:

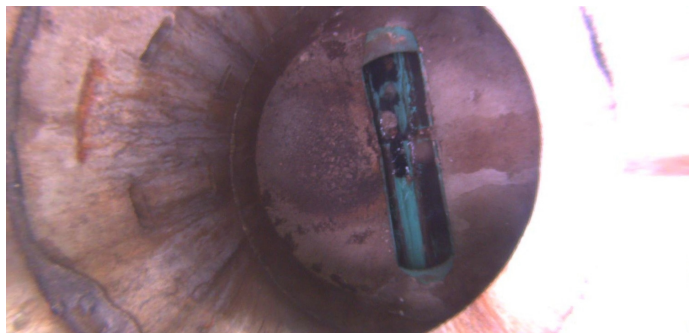
Code: **MGO**
Description: **General Observation**

Distance (ft): **.0**
Structural Grade: **0**
O&M Grade: **0**
Clock Start/From:
Clock To:
1st Value:
2nd Value:
Value Percent:
Step: **NO**
Remarks: **MISSING STEPS**

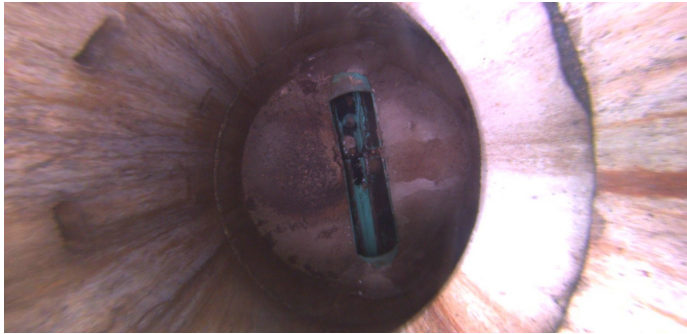
Code: **MGO**
Description: **General Observation**

Distance (ft): **.6**
Structural Grade: **0**
O&M Grade: **0**
Clock Start/From:
Clock To:
1st Value:
2nd Value:
Value Percent:
Step: **NO**
Remarks: **MISSING STEPS**

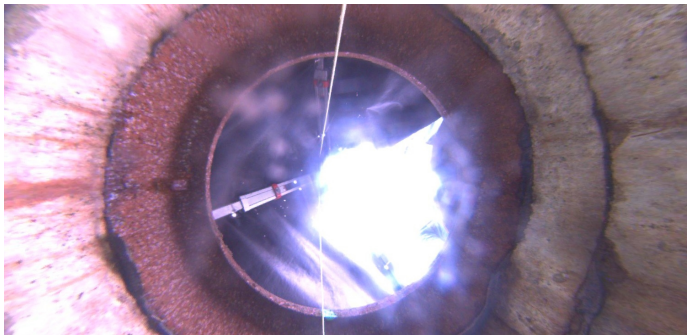
Code: **MGP**
Description: **General Photo**

Distance (ft): **1.8**
Structural Grade: **0**
O&M Grade: **0**
Clock Start/From:
Clock To:
1st Value:
2nd Value:
Value Percent:
Step: **NO**
Remarks: **UNDERSIDE OF FRAME**

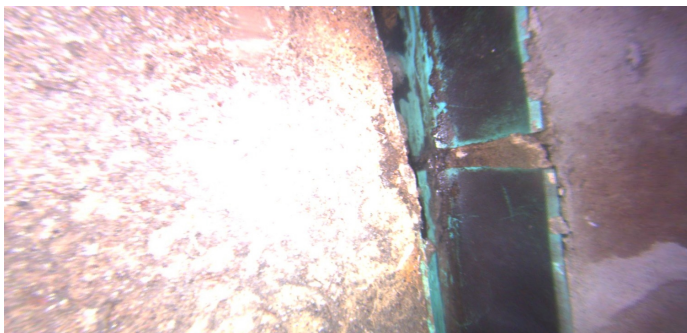
Code: **MGO**
Description: **General Observation**

Distance (ft): **3.6**
Structural Grade: **0**
O&M Grade: **0**
Clock Start/From:
Clock To:
1st Value:
2nd Value:
Value Percent:
Step: **NO**
Remarks: **END SURVEY**
