Manhole Inspection Report

Date:	04/23/2018	Weather:		Coding:	RZMACP
MH#:	M-706-011.4	Owner:	NA	Len. Surveyed:	5.7
P.O.#:		Surveyor:	John Kuglmaier	Rim to Invert:	5.7
Customer:	8.7	Cert. #:	U-1215-07002349	Wall Material:	Brick

Street:	Lake St. 628' North of 10th St.	Project:	Hobart, IN
City:	Hobart, IN	GPS Northing:	0.0
Location:		GPS Easting:	0.0
Drain Area:	Southeast	GPS Accuracy:	Nearest Meter
Cover Shape:	Circular	Evidence of Surcharge:	No
Cover Size:	22.5	Potential for Runoff:	None
Comments:

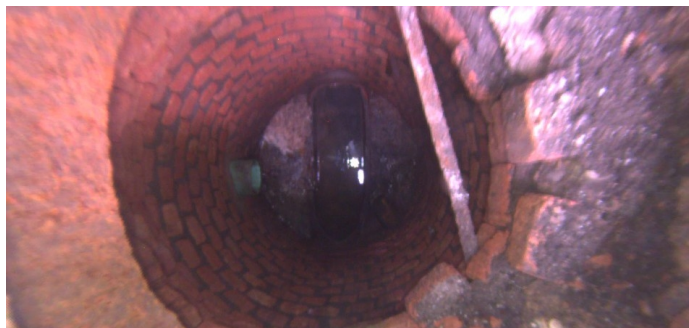
Code: **MGP**
Description: **General Photo**

Distance (ft): **.0**
Structural Grade: **0**
O&M Grade: **0**
Clock Start/From:
Clock To:
1st Value:
2nd Value:
Value Percent:
Step: **NO**
Remarks:

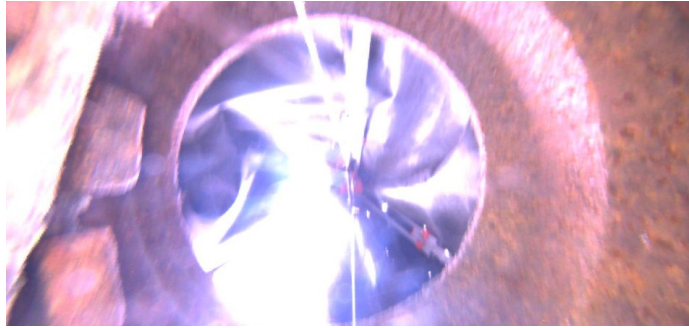
Code:	MGP
Description:	General Photo
Distance (ft):	2.3
Structural Grade:	0
O&M Grade:	0
Clock Start/From:	
Clock To:	
1st Value:	
2nd Value:	
Value Percent:	
Step:	NO
Remarks:

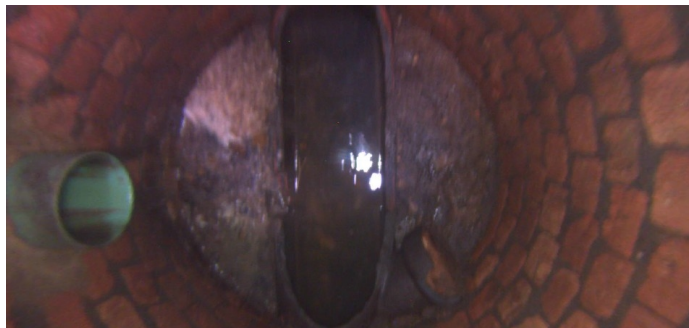
Code:	DAZ
Description:	Deposits Attached Other
Distance (ft):	3.1
Structural Grade:	0
O&M Grade:	2
Clock Start/From:	12
Clock To:	12
1st Value:	
2nd Value:	
Value Percent:	10.000
Step:	NO
Remarks:	Mixed materials

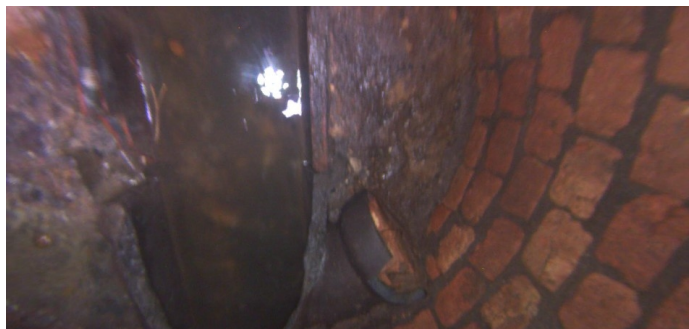
Code:	OBZ
Description:	Obstacle Other
Distance (ft):	4.0
Structural Grade:	0
O&M Grade:	2
Clock Start/From:	5
Clock To:	
1st Value:	
2nd Value:	
Value Percent:	5.000
Step:	NO
Remarks:	VCP pipe

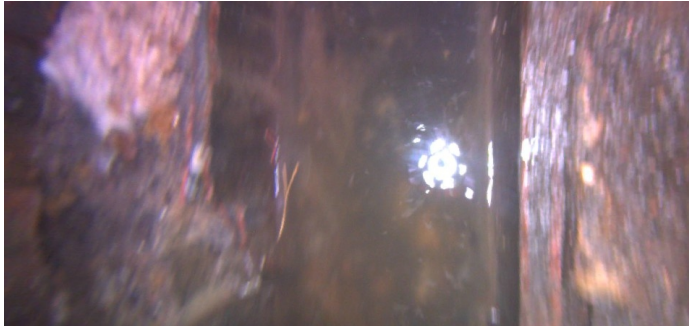
Code:	MGO
Description:	General Observation
Distance (ft):	4.9
Structural Grade:	0
O&M Grade:	0
Clock Start/From:	
Clock To:	
1st Value:	
2nd Value:	
Value Percent:	
Step:	NO
Remarks:	Ins. Comp.
