Manhole Inspection Report

Date:	04/23/2018	Weather:		Coding:	RZMACP
MH#:	M-706-011.7	Owner:	NA	Len. Surveyed:	6.3
P.O.#:		Surveyor:	Jen Costello	Rim to Invert:	6.0
Customer:	8.7	Cert. #:	U-907-5518	Wall Material:	Brick

Street:	Lake St. 224' North of 10th St.	Project:	Hobart, IN
City:	Hobart, IN	GPS Northing:	0.0
Location:		GPS Easting:	0.0
Drain Area:	Southeast	GPS Accuracy:	Nearest Meter
Cover Shape:	Circular	Evidence of Surcharge:	No
Cover Size:	22.5	Potential for Runoff:	None
Comments:

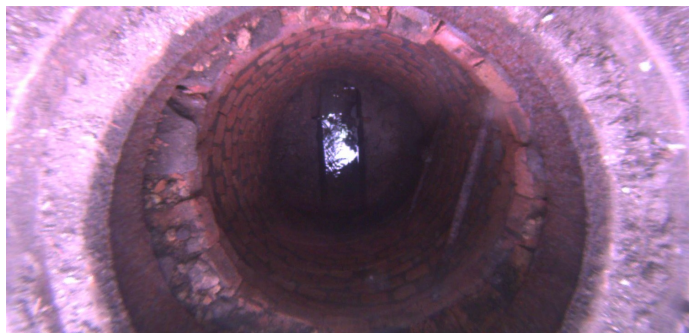
Code: **MGO**
Description: **General Observation**

Distance (ft): **.0**
Structural Grade: **0**
O&M Grade: **0**
Clock Start/From:
Clock To:
1st Value:
2nd Value:
Value Percent:
Step: **NO**
Remarks: **ACCESS MH**

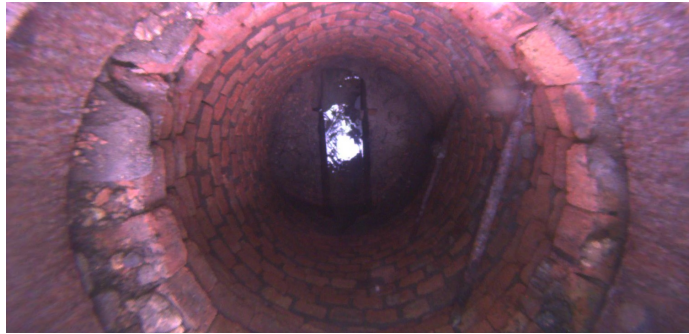
Code: **DB**
Description: **Displaced Brick**

Distance (ft): **.4**
Structural Grade: **3**
O&M Grade: **0**
Clock Start/From: **6**
Clock To: **11**
1st Value:
2nd Value:
Value Percent:
Step: **NO**
Remarks:

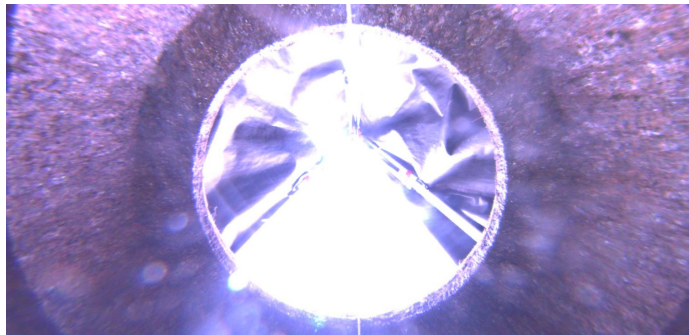
Code: **MGP**
Description: **General Photo**

Distance (ft): **2.3**
Structural Grade: **0**
O&M Grade: **0**
Clock Start/From:
Clock To:
1st Value:
2nd Value:
Value Percent:
Step: **NO**
Remarks: **UNDERSIDE OF FRAME**

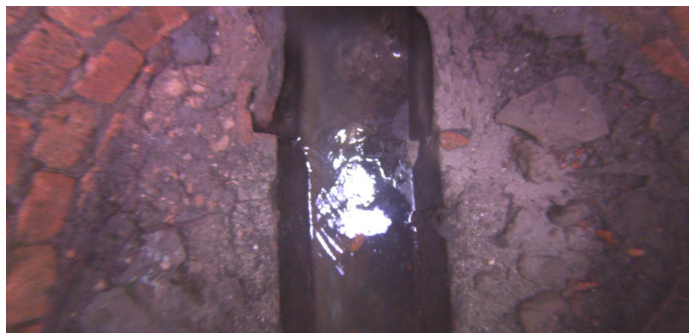
Code: **OBR**
Description: **Obstacle Rocks**

Distance (ft): **4.7**
Structural Grade: **0**
O&M Grade: **2**
Clock Start/From: **12**
Clock To: **12**
1st Value:
2nd Value:
Value Percent: **10.000**
Step: **NO**
Remarks:

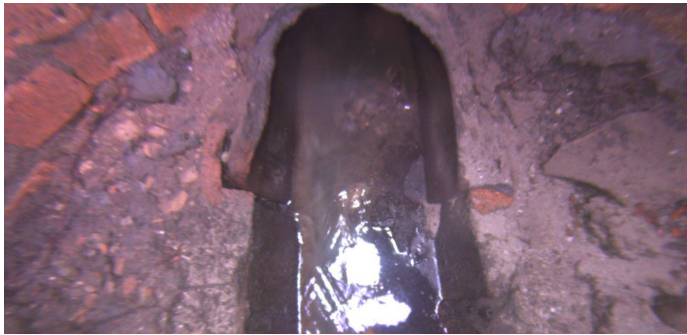
Code: **B**
Description: **Broken**

Distance (ft): **5.2**
Structural Grade: **3**
O&M Grade: **0**
Clock Start/From: **9**
Clock To:
1st Value:
2nd Value:
Value Percent:
Step: **NO**
Remarks:

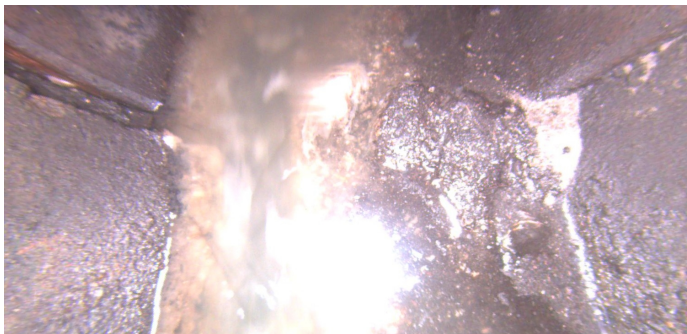
Code: **MGO**
Description: **General Observation**

Distance (ft): **6.3**
Structural Grade: **0**
O&M Grade: **0**
Clock Start/From:
Clock To:
1st Value:
2nd Value:
Value Percent:
Step: **NO**
Remarks: **END SURVEY**
