Manhole Inspection Report

| MH#: | M-706-012 | Owner: | NA | Len. Surveyed: | 12.0 |

| Street: | 8th St. 104' East of Water St. | Project: | Hobart, IN |

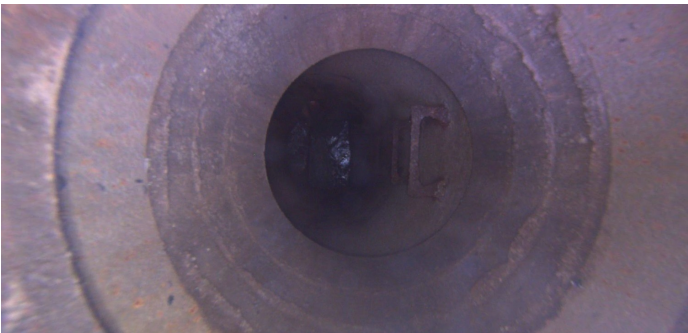
MGO

General Observation

1.0

ACCESS MH

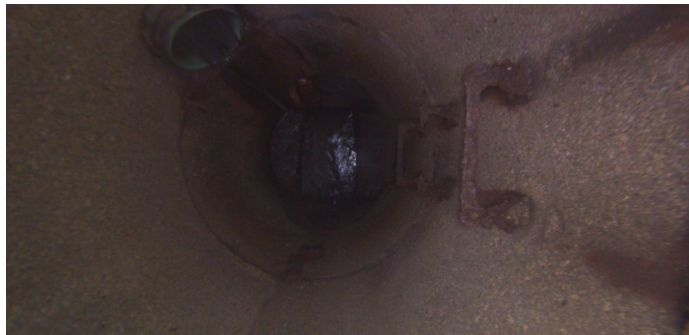
| Code: | MGO |
| Description: | General Observation |
| Distance (ft): | 2.9 |
| Remarks: | UNDERSIDE OF FRAME |

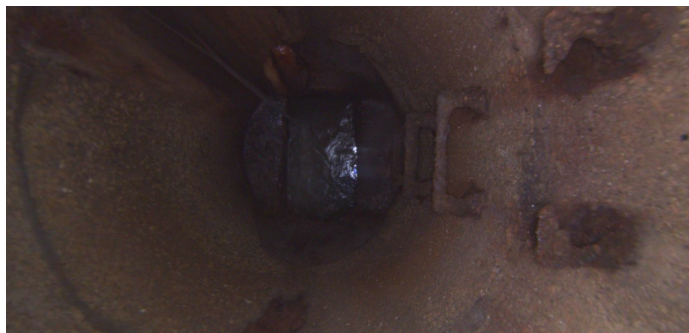
| | Position | Code | Observation | Video (sec) | Grade |
|---|---|---|---|---|---|
| | 3.9 | SAV | Surface Aggregate Visible | 45 | S 3 |

| Code: | SAV |
| Description: | Surface Aggregate Visible |
| Distance (ft): | 3.9 |
| Structural Grade: | 3 |

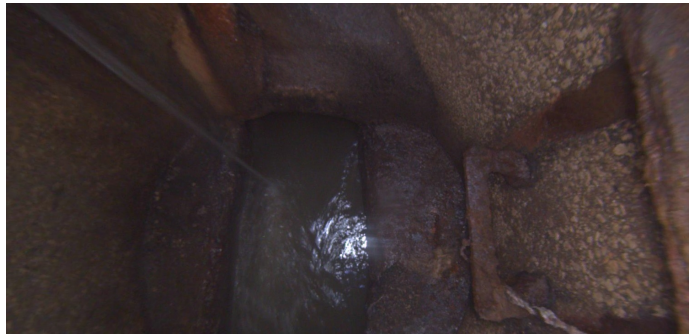
| Code: | MGO |
| Description: | General Observation |
| Distance (ft): | 6.0 |
| Remarks: | BROKEN STEP |

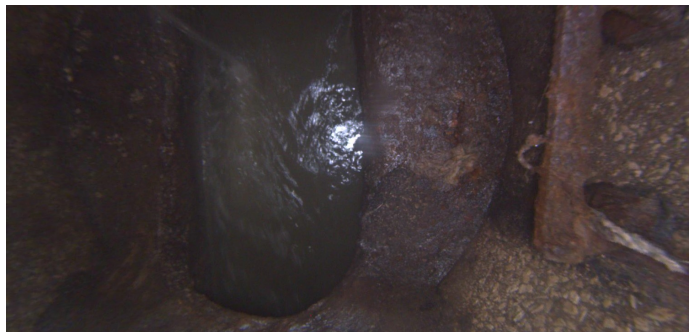
| | Position | Code | Observation | Video (sec) | Grade |
|---|---|---|---|---|---|
| | 9.2 | IW | Infil Weeper | 78 | M 2 |

Code: **IW**
Description: **Infil Weeper**

Distance (ft): **9.2**
Structural Grade: **0**
O&M Grade: **2**
Clock Start/From: **12**
Clock To:
1st Value:
2nd Value:
Value Percent:
Step: **NO**
Remarks:

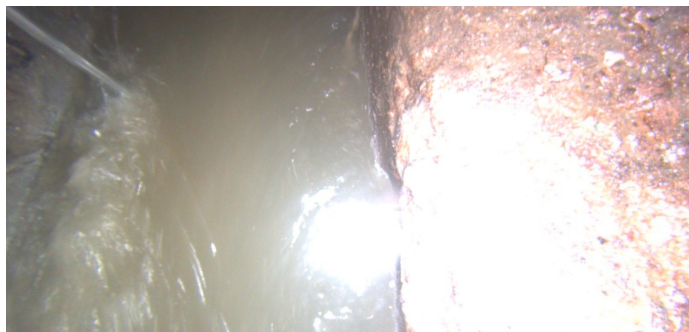
| | Position | Code | Observation | Video (sec) | Grade |
|---|---|---|---|---|---|
| | 10.2 | SAP | Surface Aggregate Projecting | 92 | S 3 |

Code: **SAP**
Description: **Surface Aggregate Projecting**

Distance (ft): **10.2**
Structural Grade: **3**
O&M Grade: **0**
Clock Start/From: **12**
Clock To: **12**
1st Value:
2nd Value:
Value Percent:
Step: **NO**
Remarks:
