Manhole Inspection Report

O&M Index:	3.00	O&M Quick:	3100	O&M Rating:	3.00
Structural Index:	0.00	Structural Quick:	0000	Structural Rating:	0.00
Overall Index:	3.00	Overall Quick:	3100	Overall Rating:	3.00

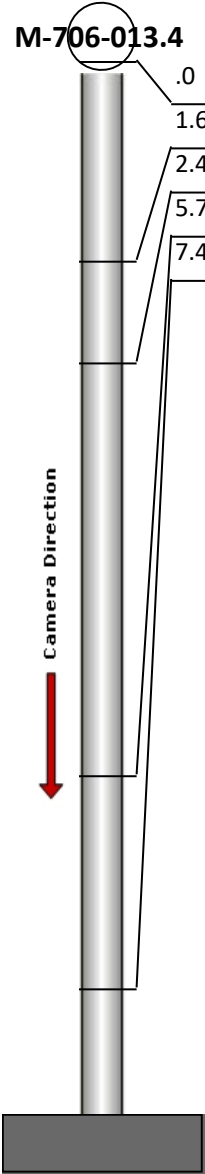
.0	MGP	General Photo	10	NA
	1.6	IS	Infil Stain	25	NA
	2.4	MGP	General Photo	40	NA
	5.7	DAZ	Deposits Attached Other	60	M 3
	7.4	MGO	General Observation	75	NA

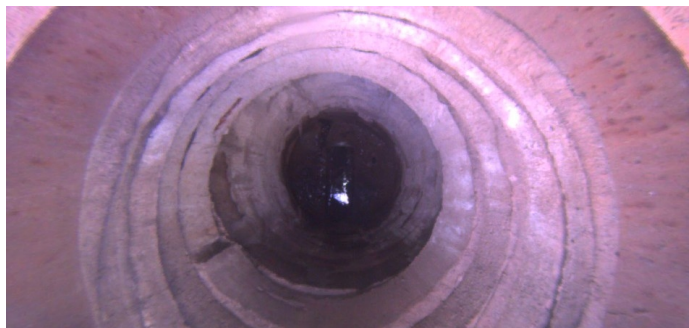
Code: **MGP**
Description: **General Photo**

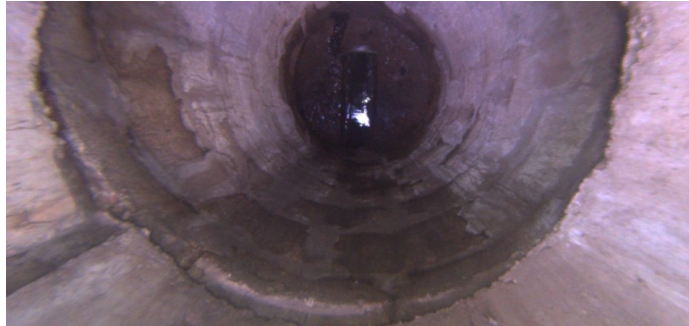
Code: **IS**
Description: **Infil Stain**

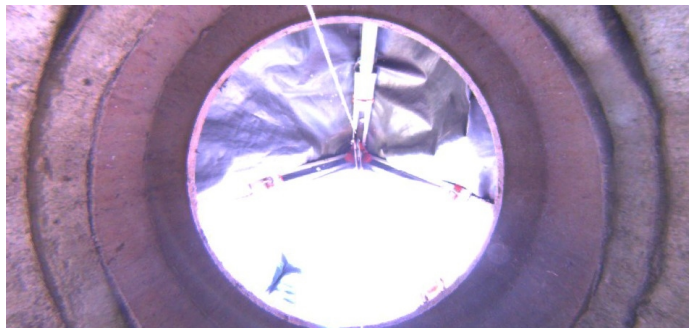
Code: **MGP**
Description: **General Photo**
