Manhole Inspection Report

Date:	04/23/2018	Weather:		Coding:	RZMACP
MH#:	M-706-013.5	Owner:	NA	Len. Surveyed:	8.5
P.O.#:		Surveyor:	Jen Costello	Rim to Invert:	8.6
Customer:	8.7	Cert. #:	U-907-5518	Wall Material:	Concrete (reinforced)

Street:	Water St. 211' North of 10th St.	Project:	Hobart, IN
City:	Hobart, IN	GPS Northing:	0.0
Location:		GPS Easting:	0.0
Drain Area:	Southeast	GPS Accuracy:	Nearest Meter
Cover Shape:	Circular	Evidence of Surcharge:	No
Cover Size:	22.5	Potential for Runoff:	None
Comments:

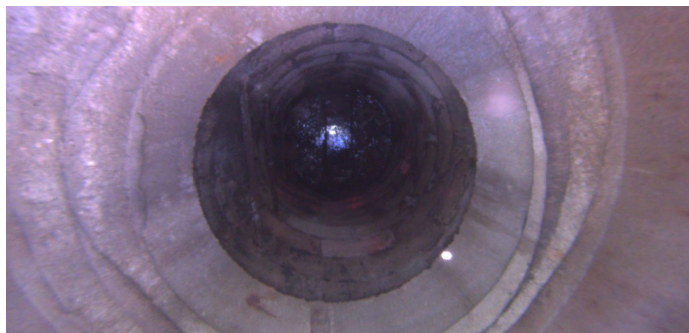
Code: **MGO**
Description: **General Observation**

Distance (ft): **.0**
Structural Grade: **0**
O&M Grade: **0**
Clock Start/From:
Clock To:
1st Value:
2nd Value:
Value Percent:
Step: **NO**
Remarks: **ACCESS MH**

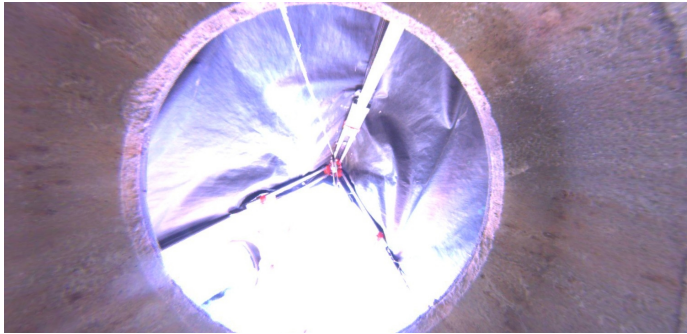
Code:	MGO
Description:	General Observation
Distance (ft):	1.6
Structural Grade:	0
O&M Grade:	0
Clock Start/From:	
Clock To:	
1st Value:	
2nd Value:	
Value Percent:	
Step:	NO
Remarks:	UNDERSIDE OF FRAME

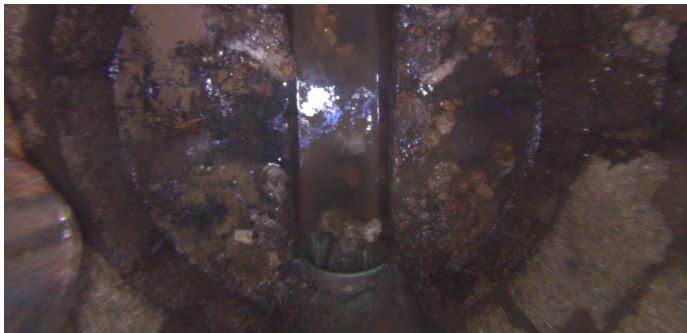
Code:	IW
Description:	Infil Weeper
Distance (ft):	6.5
Structural Grade:	0
O&M Grade:	2
Clock Start/From:	12
Clock To:	12
1st Value:	
2nd Value:	
Value Percent:	
Step:	NO
Remarks:

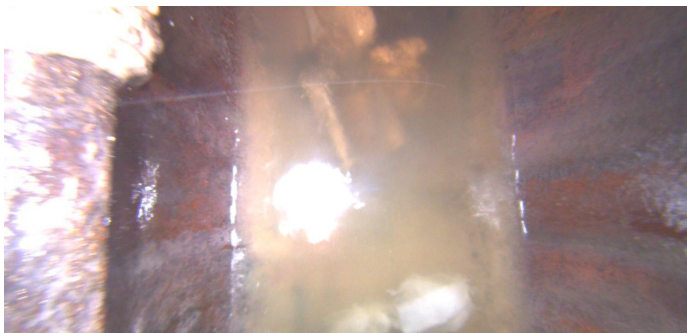
Code:	MGO
Description:	General Observation
Distance (ft):	8.5
Structural Grade:	0
O&M Grade:	0
Clock Start/From:	
Clock To:	
1st Value:	
2nd Value:	
Value Percent:	
Step:	NO
Remarks:	END SURVEY
