Manhole Inspection Report

Date:	04/27/2018	Weather:		Coding:	RZMACP
MH#:	M-706-013	Owner:	NA	Len. Surveyed:	5.4
P.O.#:		Surveyor:	Jen Costello	Rim to Invert:	5.5
Customer:		Cert. #:	U-907-5518	Wall Material:	Brick

Street:	Water St. 83' South of 8th St.	Project:	Hobart, IN
City:	Hobart, IN	GPS Northing:	41.52516937
Location:		GPS Easting:	-87.25583649
Drain Area:	Southeast	GPS Accuracy:	Nearest Meter
Cover Shape:	Circular	Evidence of Surcharge:	No
Cover Size:	22.5	Potential for Runoff:	None
Comments:

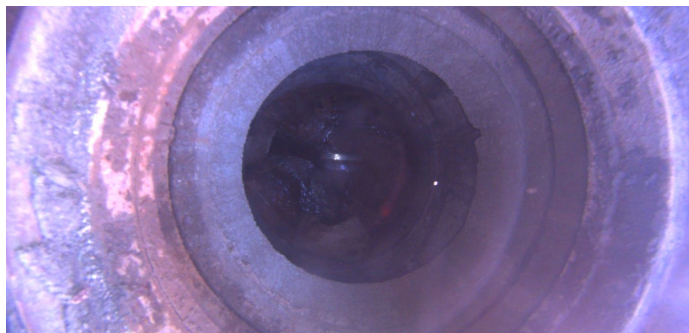
Code: **MGO**
Description: **General Observation**

Distance (ft): **.0**
Structural Grade: **0**
O&M Grade: **0**
Clock Start/From:
Clock To:
1st Value:
2nd Value:
Value Percent:
Step: **NO**
Remarks: **access MH**

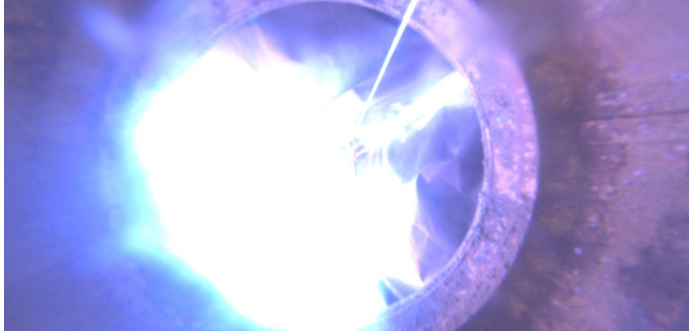
Code:	MGP
Description:	General Photo
Distance (ft):	1.8
Structural Grade:	0
O&M Grade:	0
Clock Start/From:	
Clock To:	
1st Value:	
2nd Value:	
Value Percent:	
Step:	NO
Remarks:	UNDERSIDE OF FRAME

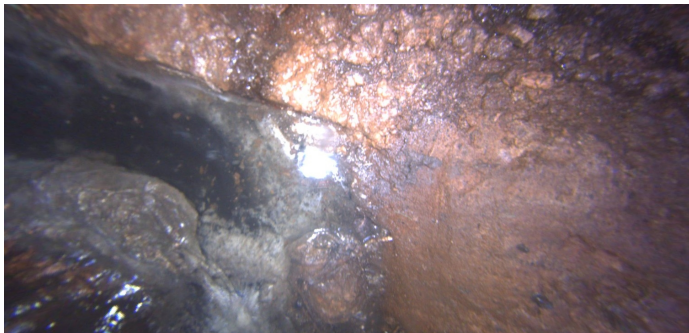
Code:	MGO
Description:	General Observation
Distance (ft):	5.4
Structural Grade:	0
O&M Grade:	0
Clock Start/From:	
Clock To:	
1st Value:	
2nd Value:	
Value Percent:	
Step:	NO
Remarks:	END SURVEY
