# Manhole Inspection Report

| MH#: | <b>M-706-020</b> | Owner: | <b>NA</b> | Len. Surveyed: | <b>8.7</b> |

| Street: | <b>On Main St. 140' North of 7th St.</b> | Project: | <b>Hobart, IN</b> |

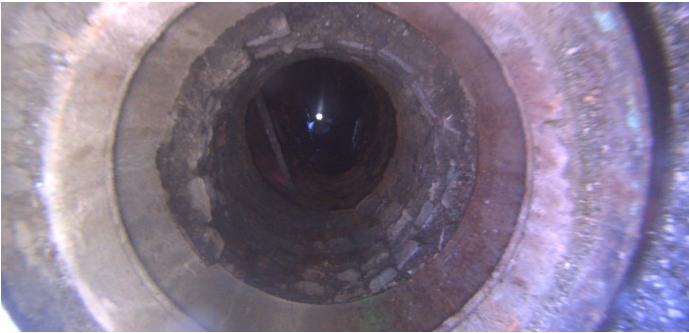
Code: **MGO**  
Description: **General Observation**

Distance (ft): **.0**  
Structural Grade: **0**  
O&M Grade: **0**  
Clock Start/From:  
Clock To:  
1st Value:  
2nd Value:  
Value Percent:  
Step: **NO**  
Remarks: **access mh**

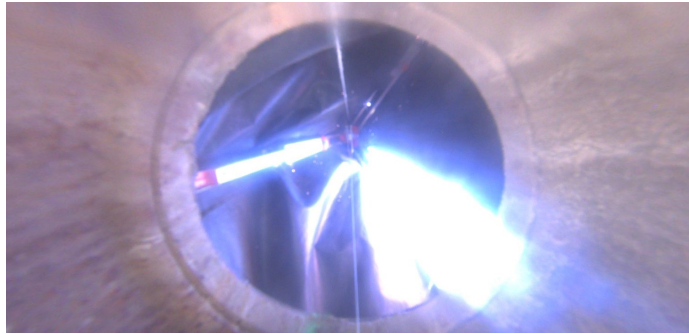
Code: **MGO**  
Description: **General Observation**

Distance (ft): **2.0**  
Structural Grade: **0**  
O&M Grade: **0**  
Clock Start/From:  
Clock To:  
1st Value:  
2nd Value:  
Value Percent:  
Step: **NO**  
Remarks: **underside of frame**

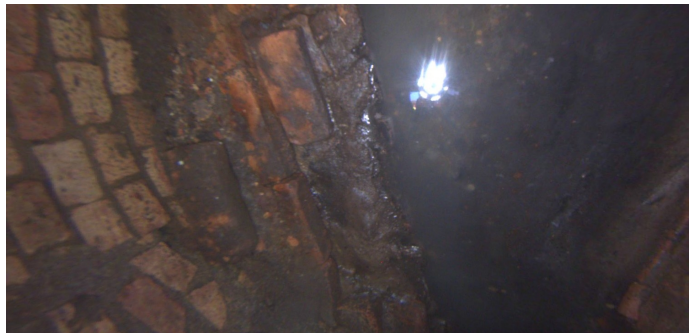
| | Position | Code | Observation | Video (sec) | Grade |
|--|---|---|---|---|---|
| | 7.7 | OBB | Obstacle Brick | 52 | M 2 |

Code: **OBB**  
Description: **Obstacle Brick**

Distance (ft): **7.7**  
Structural Grade: **0**  
O&M Grade: **2**  
Clock Start/From: **8**  
Clock To: **9**  
1st Value:  
2nd Value:  
Value Percent: **5.000**  
Step: **NO**  
Remarks:

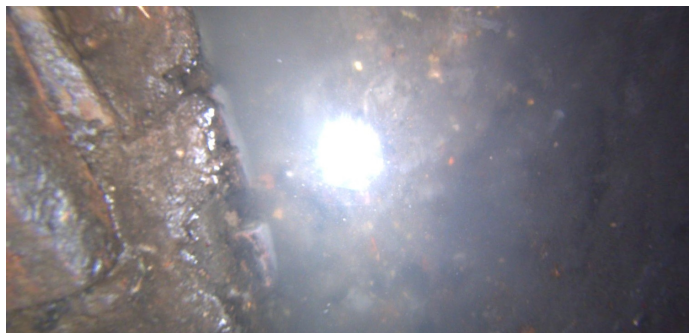
Code: **MGO**  
Description: **General Observation**

Distance (ft): **8.7**  
Structural Grade: **0**  
O&M Grade: **0**  
Clock Start/From:  
Clock To:  
1st Value:  
2nd Value:  
Value Percent:  
Step: **NO**  
Remarks: **end survey**
