Manhole Inspection Report

Date:	04/28/2018	Weather:		Coding:	RZMACP
MH#:	M-706-022	Owner:	NA	Len. Surveyed:	6.3
P.O.#:		Surveyor:	Jen Costello	Rim to Invert:	6.3
Customer:		Cert. #:	U-907-5518	Wall Material:	Brick

Street:	Hwy 51. 215' South of 7th St.	Project:	Hobart, IN
City:	Hobart, IN	GPS Northing:	41.52661133
Location:		GPS Easting:	-87.25228119
Drain Area:	South	GPS Accuracy:	Nearest Meter
Cover Shape:	Circular	Evidence of Surcharge:	No
Cover Size:	22.5	Potential for Runoff:	None
Comments:

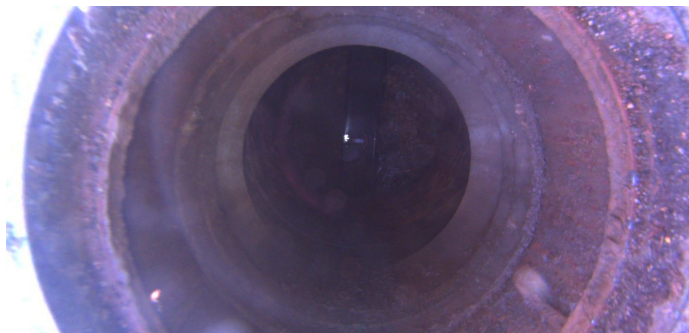
Code: **MGO**
Description: **General Observation**

Distance (ft): **.0**
Structural Grade: **0**
O&M Grade: **0**
Clock Start/From:
Clock To:
1st Value:
2nd Value:
Value Percent:
Step: **NO**
Remarks: **ACCESS MH**

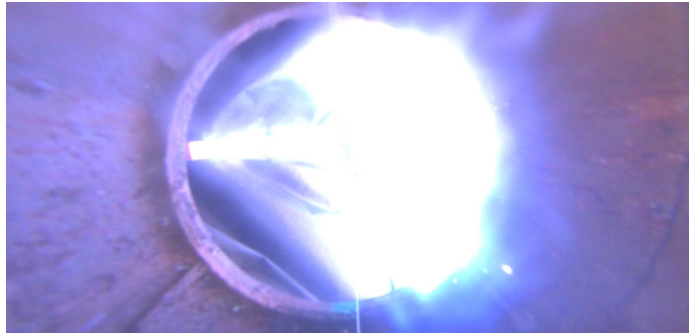
Code: **MGO**
Description: **General Observation**

Distance (ft): **1.8**
Structural Grade: **0**
O&M Grade: **0**
Clock Start/From:
Clock To:
1st Value:
2nd Value:
Value Percent:
Step: **NO**
Remarks: **UNDERSIDE OF FRAME**

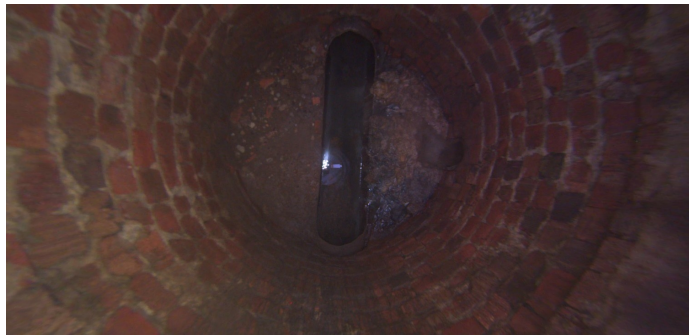
Code: **MMC**
Description: **Material Change**

Distance (ft): **3.3**
Structural Grade: **0**
O&M Grade: **0**
Clock Start/From:
Clock To:
1st Value:
2nd Value:
Value Percent:
Step: **NO**
Remarks: **BRICK**

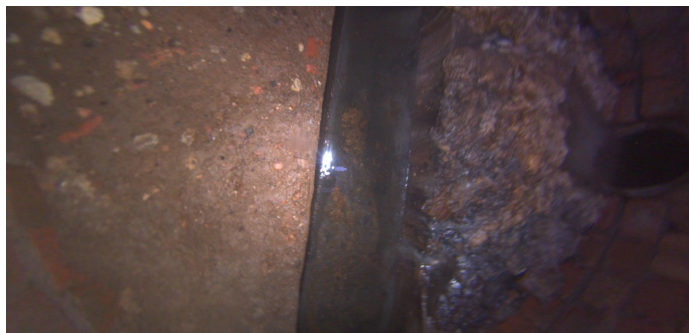
Code: **DSF**
Description: **Deposits Settled Fine**

Distance (ft): **5.5**
Structural Grade: **0**
O&M Grade: **2**
Clock Start/From: **12**
Clock To: **12**
1st Value:
2nd Value:
Value Percent: **5.000**
Step: **NO**
Remarks:

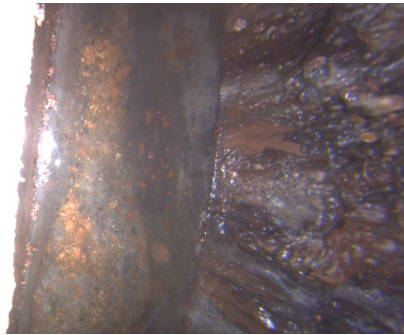
Code:	MGO
Description:	General Observation

Distance (ft):	6.3
Structural Grade:	0
O&M Grade:	0
Clock Start/From:	
Clock To:	
1st Value:	
2nd Value:	
Value Percent:	
Step:	NO
Remarks:	END SURVEY
