Manhole Inspection Report

Street:	Hwy 51. 221' South of 9th St.	Project:	Hobart, IN
City:	Hobart, IN	GPS Northing:	0.0
Location:		GPS Easting:	0.0
Drain Area:	Southeast	GPS Accuracy:	Nearest Meter
Cover Shape:	Circular	Evidence of Surcharge:	No
Cover Size:	22.5	Potential for Runoff:	None
Comments:

M-706-025

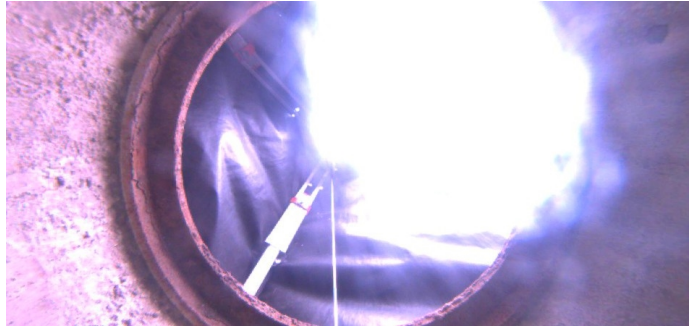
Code:	MGP
Description:	General Photo

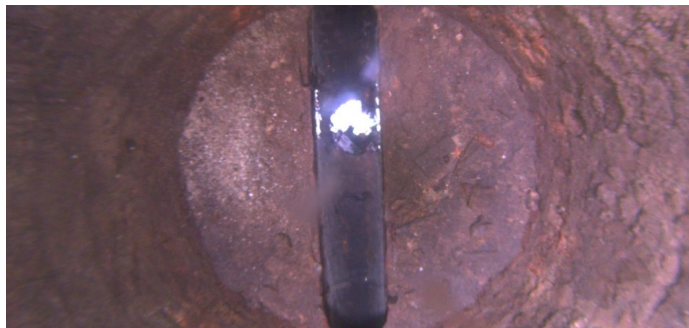
Code: **MGP**
Description: **General Photo**

Distance (ft): **2.4**
Structural Grade: **0**
O&M Grade: **0**
Clock Start/From:
Clock To:
1st Value:
2nd Value:
Value Percent:
Step: **NO**
Remarks:

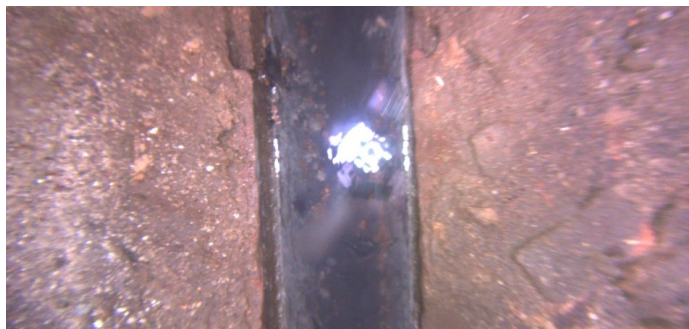
Code: **DAZ**
Description: **Deposits Attached Other**

Distance (ft): **5.4**
Structural Grade: **0**
O&M Grade: **2**
Clock Start/From: **12**
Clock To: **12**
1st Value:
2nd Value:
Value Percent: **10.000**
Step: **NO**
Remarks: **Mixed materials**
