Manhole Inspection Report

Date:	04/24/2018	Weather:		Coding:	RZMACP
MH#:	M-706-028	Owner:	NA	Len. Surveyed:	17.5
P.O.#:		Surveyor:	John Kuglmaier	Rim to Invert:	17.3
Customer:	8.7	Cert. #:	U-1215-07002349	Wall Material:	Concrete (reinforced)

Street:	Intersection of Linda St. and 10th St.	Project:	Hobart, IN
City:	Hobart, IN	GPS Northing:	0.0
Location:		GPS Easting:	0.0
Drain Area:	Southeast	GPS Accuracy:	Nearest Meter
Cover Shape:	Circular	Evidence of Surcharge:	Yes
Cover Size:	22.5	Potential for Runoff:	None
Comments:

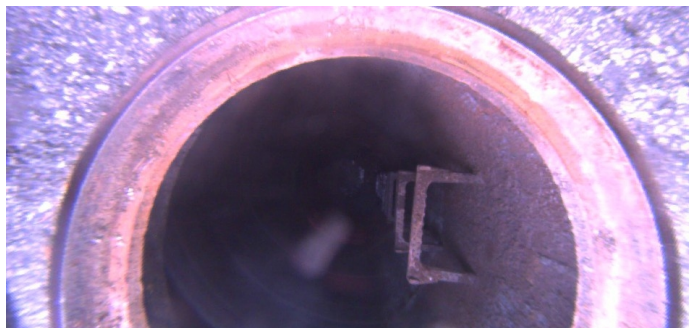
Code: **MGP**
Description: **General Photo**

Distance (ft): **.0**
Structural Grade: **0**
O&M Grade: **0**
Clock Start/From:
Clock To:
1st Value:
2nd Value:
Value Percent:
Step: **NO**
Remarks:

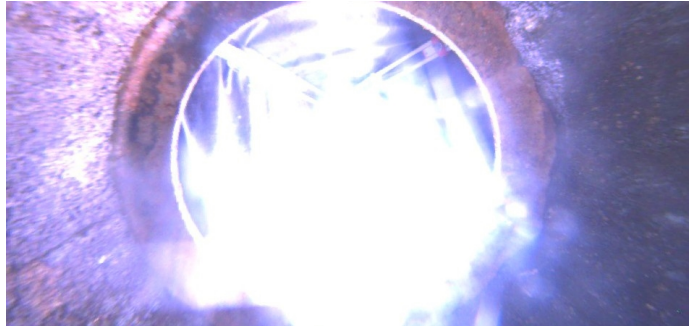
Code: **MGP**
Description: **General Photo**

Distance (ft): **2.8**
Structural Grade: **0**
O&M Grade: **0**
Clock Start/From:
Clock To:
1st Value:
2nd Value:
Value Percent:
Step: **NO**
Remarks:

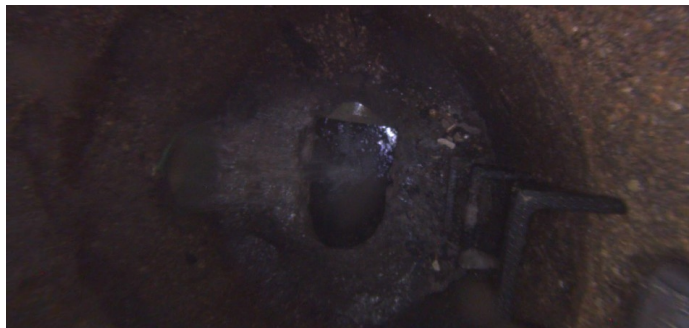
Code: **DAZ**
Description: **Deposits Attached Other**

Distance (ft): **13.4**
Structural Grade: **0**
O&M Grade: **3**
Clock Start/From: **12**
Clock To: **12**
1st Value:
2nd Value:
Value Percent: **15.000**
Step: **NO**
Remarks: **Mixed materials**

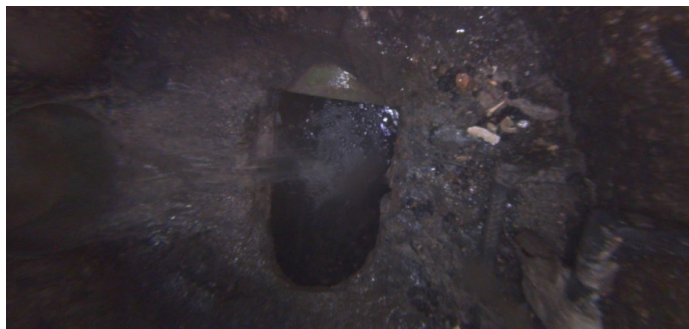
Code: **MGO**
Description: **General Observation**

Distance (ft): **15.2**
Structural Grade: **0**
O&M Grade: **0**
Clock Start/From:
Clock To:
1st Value:
2nd Value:
Value Percent:
Step: **NO**
Remarks: **Ins. Comp.**
