Manhole Inspection Report

Date:	04/27/2018	Weather:		Coding:	RZMACP
MH#:	M-706-029	Owner:	NA	Len. Surveyed:	5.8
P.O.#:		Surveyor:	Jen Costello	Rim to Invert:	4.8
Customer:		Cert. #:	U-907-5518	Wall Material:	Brick

Street:	State St. 302' South of 6th St.	Project:	Hobart, IN
City:	Hobart, IN	GPS Northing:	41.52822113
Location:		GPS Easting:	-87.25356293
Drain Area:	South	GPS Accuracy:	Nearest Meter
Cover Shape:	Circular	Evidence of Surcharge:	No
Cover Size:	22.5	Potential for Runoff:	None
Comments:

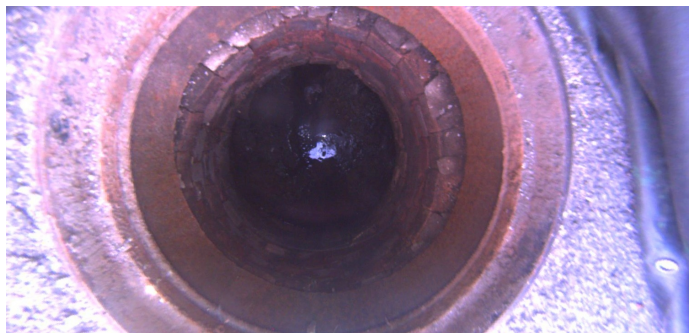
Code: **MGO**
Description: **General Observation**

Distance (ft): **.0**
Structural Grade: **0**
O&M Grade: **0**
Clock Start/From:
Clock To:
1st Value:
2nd Value:
Value Percent:
Step: **NO**
Remarks: **ACCESS MH**

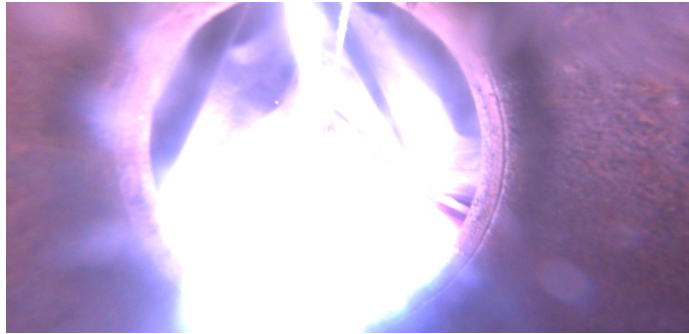
Code:	MGP
Description:	General Photo
Distance (ft):	2.1
Structural Grade:	0
O&M Grade:	0
Clock Start/From:	
Clock To:	
1st Value:	
2nd Value:	
Value Percent:	
Step:	NO
Remarks:	UNDERSIDE OF FRAME

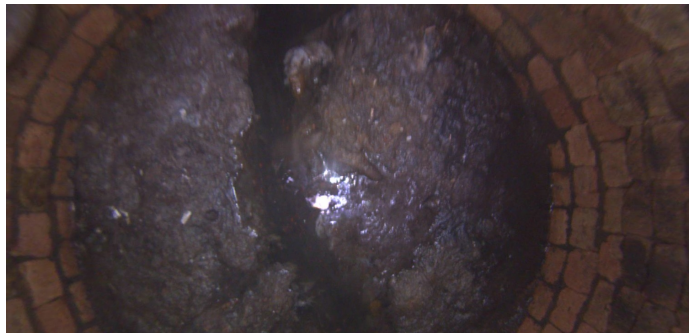
Code:	DSF
Description:	Deposits Settled Fine
Distance (ft):	3.9
Structural Grade:	0
O&M Grade:	2
Clock Start/From:	12
Clock To:	12
1st Value:	
2nd Value:	
Value Percent:	5.000
Step:	NO
Remarks:

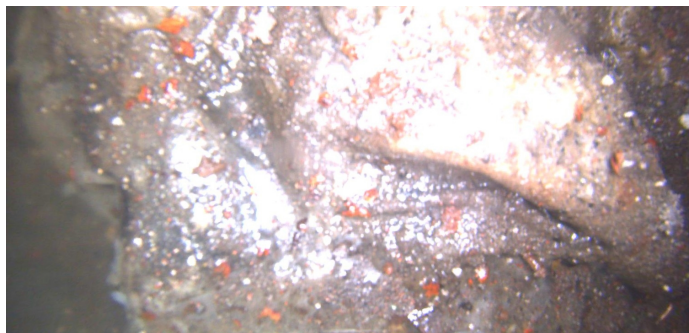
Code:	MGO
Description:	General Observation
Distance (ft):	5.8
Structural Grade:	0
O&M Grade:	0
Clock Start/From:	
Clock To:	
1st Value:	
2nd Value:	
Value Percent:	
Step:	NO
Remarks:	END SURVEY
