Manhole Inspection Report

Date:	04/27/2018	Weather:		Coding:	RZMACP
MH#:	M-706-030	Owner:	NA	Len. Surveyed:	6.7
P.O.#:		Surveyor:	Jen Costello	Rim to Invert:	7.0
Customer:		Cert. #:	U-907-5518	Wall Material:	Brick

Street:	Intersection of 7th St. and State St.	Project:	Hobart, IN
City:	Hobart, IN	GPS Northing:	41.5273819
Location:		GPS Easting:	-87.2536087
Drain Area:	South	GPS Accuracy:	Nearest Meter
Cover Shape:	Circular	Evidence of Surcharge:	No
Cover Size:	22.5	Potential for Runoff:	None
Comments:

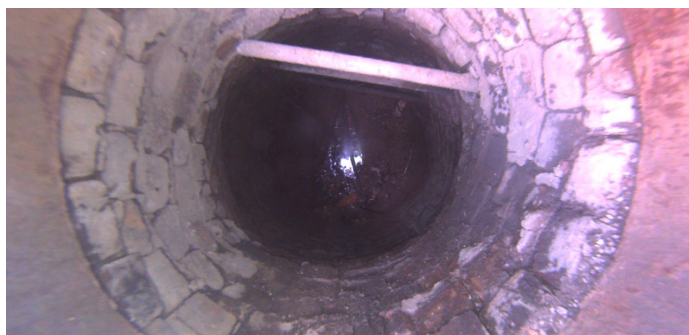
Code: **MGO**
Description: **General Observation**

Distance (ft): **.0**
Structural Grade: **0**
O&M Grade: **0**
Clock Start/From:
Clock To:
1st Value:
2nd Value:
Value Percent:
Step: **NO**
Remarks: **ACCESS MH**

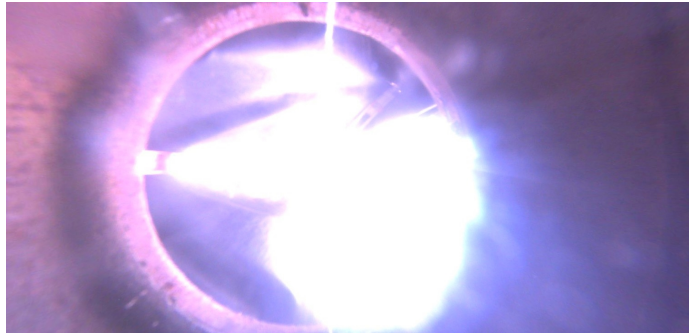
Code:	MGP
Description:	General Photo
Distance (ft):	1.2
Structural Grade:	0
O&M Grade:	0
Clock Start/From:	
Clock To:	
1st Value:	
2nd Value:	
Value Percent:	
Step:	NO
Remarks:	UNDERSIDE OF FRAME

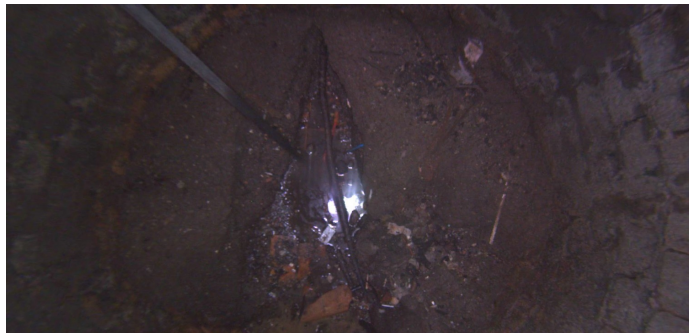
Code:	OBZ
Description:	Obstacle Other
Distance (ft):	4.3
Structural Grade:	0
O&M Grade:	2
Clock Start/From:	6
Clock To:	12
1st Value:	
2nd Value:	
Value Percent:	5.000
Step:	NO
Remarks:	MISC

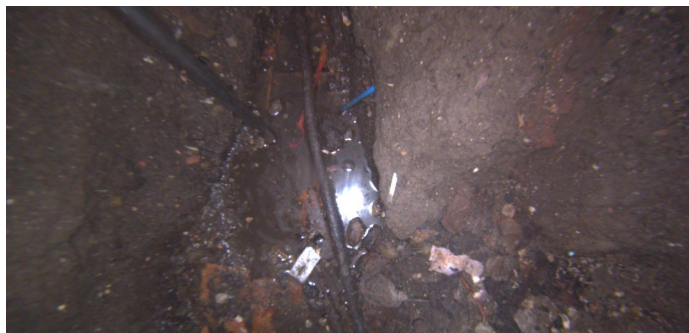
Code:	DSF
Description:	Deposits Settled Fine
Distance (ft):	5.7
Structural Grade:	0
O&M Grade:	2
Clock Start/From:	12
Clock To:	12
1st Value:	
2nd Value:	
Value Percent:	5.000
Step:	NO
Remarks:

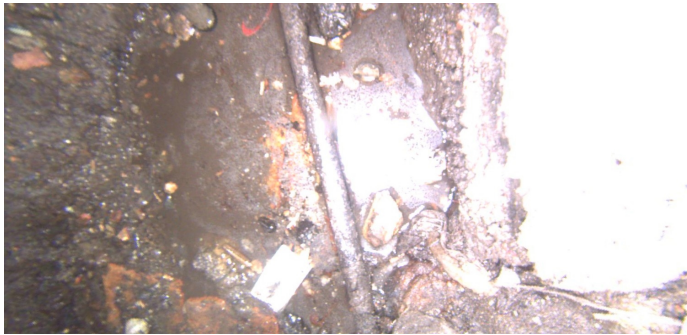
Code: **MGO**
Description: **General Observation**

Distance (ft): **6.7**
Structural Grade: **0**
O&M Grade: **0**
Clock Start/From:
Clock To:
1st Value:
2nd Value:
Value Percent:
Step: **NO**
Remarks: **END SURVEY**
